## 31/33 Porthcressa – Chimney leak investigation

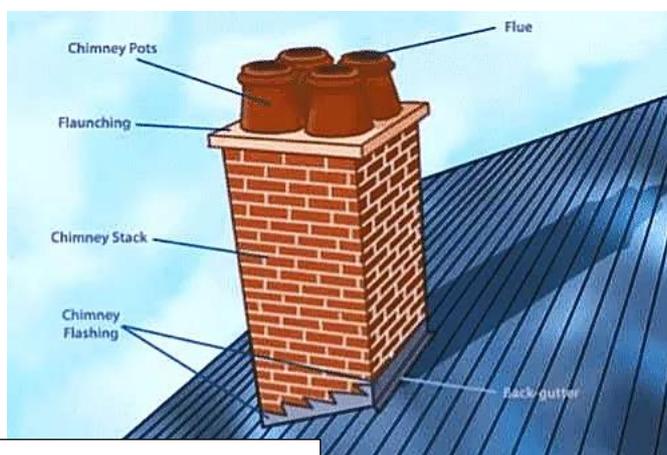
We also noted a vent to the rear of the chimney as a possible source of water ingress. It should be noted that ventilating unused chimney breasts is best practice, however, this can be achieved through the pot with a cowl to prevent water ingress (which is the case to all 3 pots here). Which brings into question if the vent located on the breast (which is a potential point of water ingress) is required.

Vent – We believe that the chimney is adequately ventilated at roof level (providing the pots vents are not sealed) and therefore this vent which is a potential cause of water ingress is not required. While undertaking the works to the chimney it should be considered if this vent could be removed and finished to match the rest of the chimney to remove a potential source of water ingress.

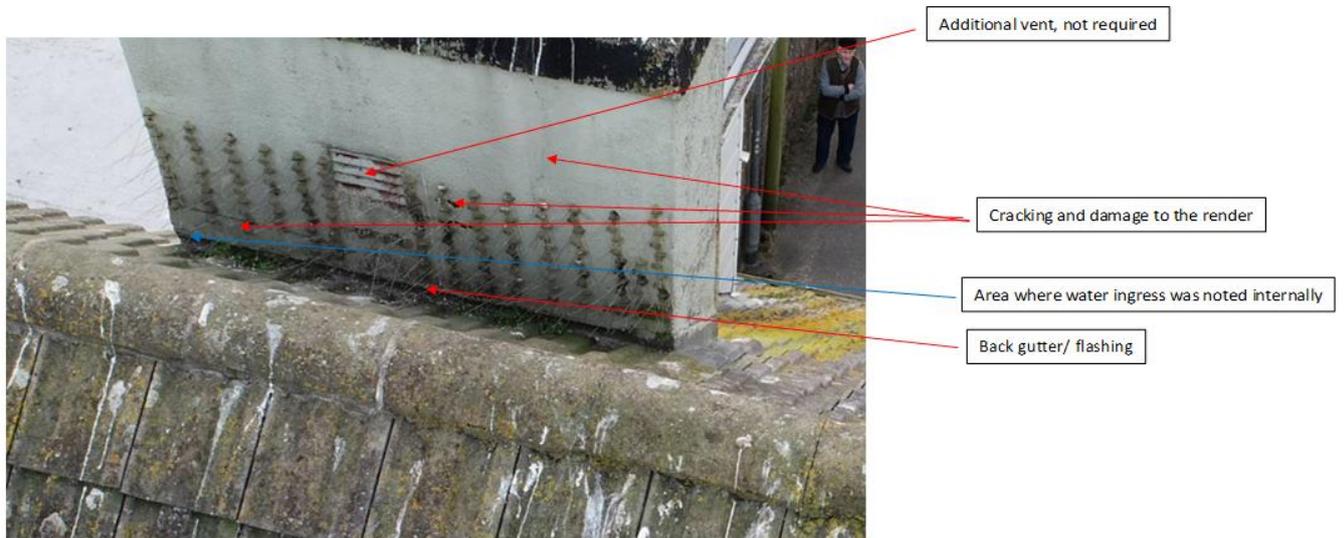
Standard chimney detail

Generally the chimney appeared in a reasonable condition and the flashing generally appeared in good condition. However, while there appears to be a flashing to the rear of the chimney it appears that at the junction between the flashing and the roof covering there is limited apron at the junction between the roof covering and chimney and less than would be typically expected from a back gutter detail (which is intended to prevent water ingress and redirect water from the rear of the chimney). It could be that the detail extends under the roof covering to the rear, however this was not clear on inspection. Nevertheless, this appears to be the area where water is entering the building and therefore that would suggest that the current flashing/ back gutter arrangement to the rear of the chimney is defective or insufficient.

Back gutter – We would recommend that the bird spikes and vegetation are removed and that a new back gutter/ flashing is installed the rear of the chimney. The new back gutter should have a sufficient apron detail and lapped over or under the roof covering capturing and redirecting water running down the roof covering. And also provide suitable protection to the low level render covering from water running down the roof.
