HOLY VALE TREE SURVEY

For works under Natural England Higher
Level Stewardship AG00596391

Written by Matthew Rogers B.A. (Hons.), NPTC
City and Guilds Level 3 Arboriculture

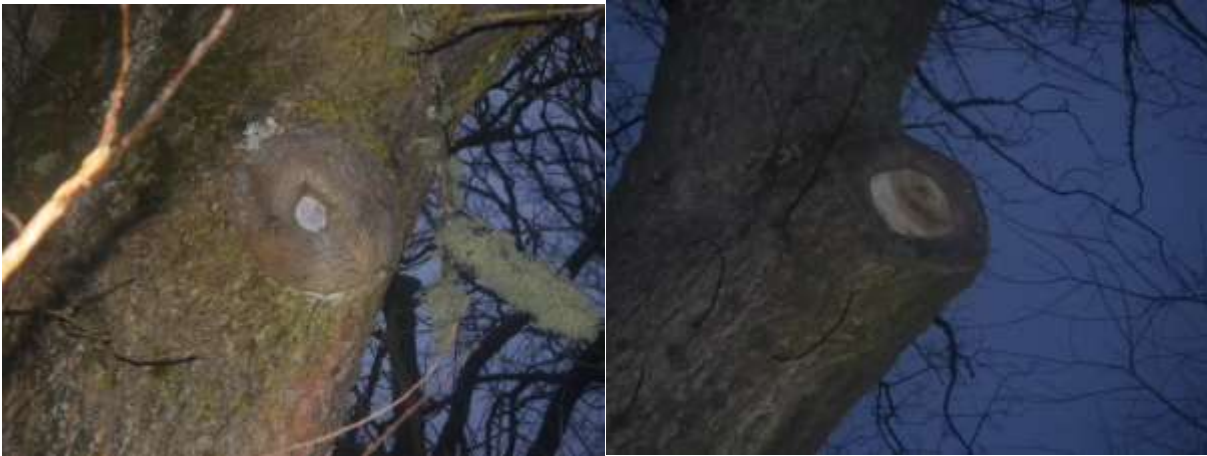
Fig 1.1 Two examples of correctly sited pruning cuts on Elms, showing good callousing and healing following the cut and no signs of rot or fungus

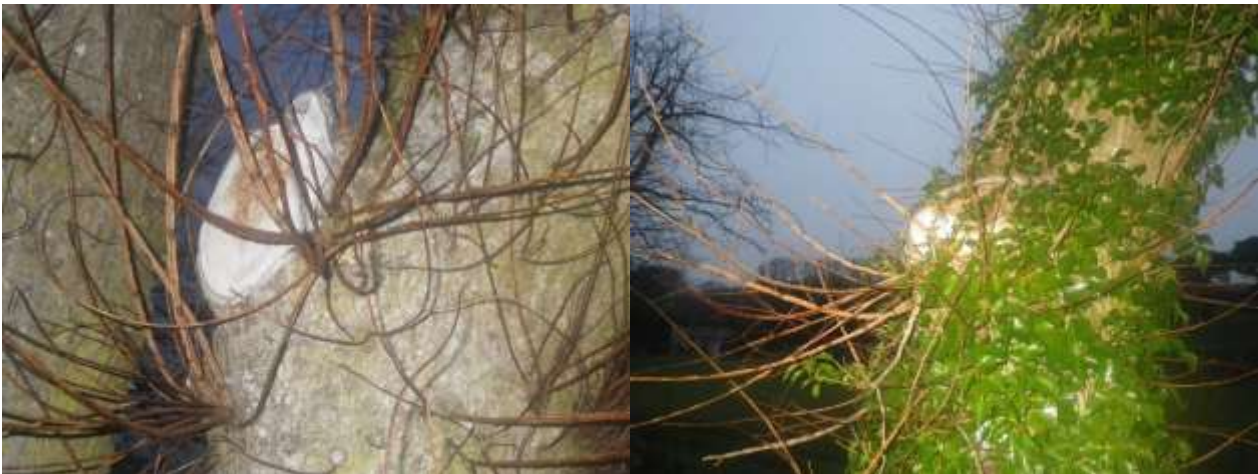
Fig 1.2 Two examples of poorly placed pruning cuts showing significant epicormic growth, poor callousing and healing around the cut, and evidence of rot and fungi beginning to show towards the centre of the cut

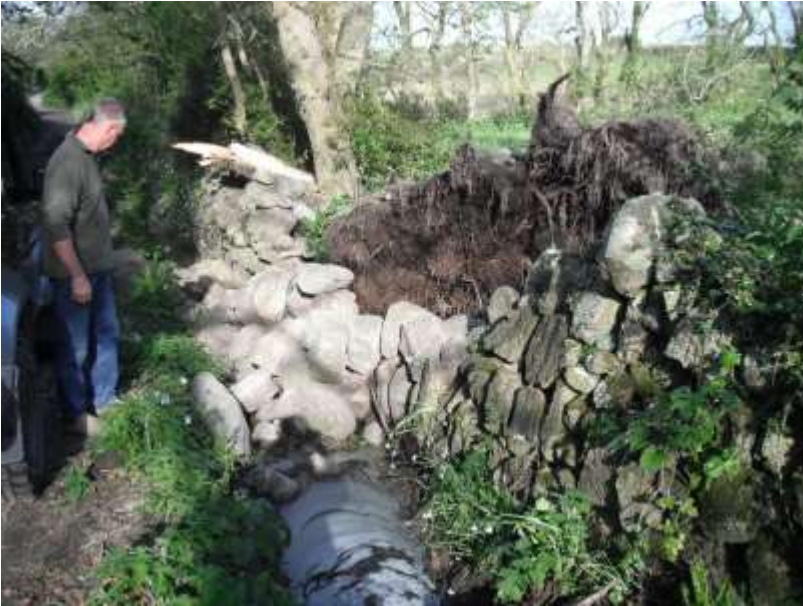
Fig 1.3 Mature Wind blown Elm with root ball damaging wall and run of water course (not on Holy Vale site)

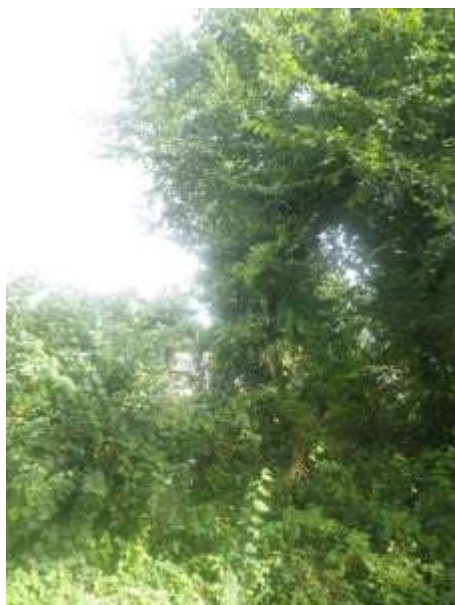
Tree 1A:

- 1. Unique ref no:** 1A
- 2. Grid Ref:**
- 3. Measurements:** Diameter of stem 1.40m (measured); Height 12m (est.); Spread 5m(est.)
- 4. Species:** Probably *Ulmus Procera*
- 5. Estimated Age:** 60 years
- 6. Tree Form and Vigour:** Appears to be maiden tree, slight lean to west probably to seek light, active live growth, some epicormics growth, nil veteran features noted
- 7. Tree associates:** Ivy growing freely over tree; some evidence of historic bird nesting within ivy.
- 8. Relationship to landscape features:** hedgerow tree
- 9. Photographic record above.**

- 10. **Evidence of previous management works:** None evident
- 11. **Nil additional historic/ cultural value associated with tree.**
- 12. **Potential threats:** Nil biological observed other than general points noted in main text. Lean probably caused by large lower limbs seeking light to south and west in dense canopy. Potential “sail” problem caused by ivy during strong winds.
- 13. **Management Recommendations:** Crown lift to approx. 5 metres.

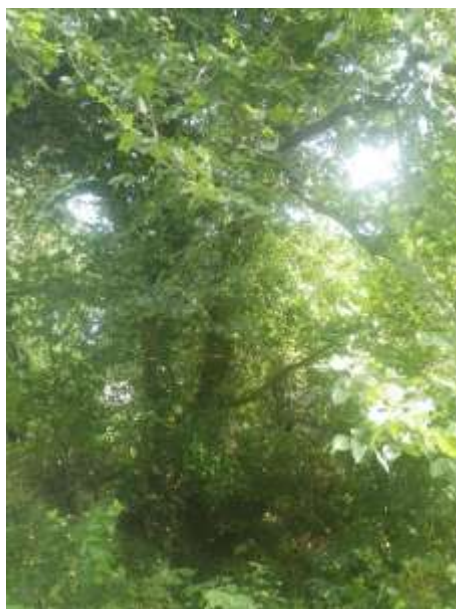
- 1. **Unique ref no:** 2A
- 2. **Grid Ref:**
- 3. **Measurements:** Diameter of stem 1.60m to historic lop (measured); Height 12m (est.); Spread 8m(est.)

- 4. **Species:** Probably Ulmus Procera
- 5. **Estimated Age:** 60 years
- 6. **Tree Form and Vigour:** Appears to have been previously lopped to approx. 1m probably causing two codominant stems, slight lean to west probably to seek light, active live growth, some epicormics growth, nil veteran features noted

- 12. **Potential threats:** Nil biological observed other than general points noted in main text. Lean probably caused by large lower limbs seeking light to south and west in dense canopy. Potential “sail” problem caused by ivy during strong winds.

- 13. **Management Recommendations:** Minimal Crown lift to approx. 5 metres, taking into consideration the recommendations for mitigating the risk to any potential bat roost.

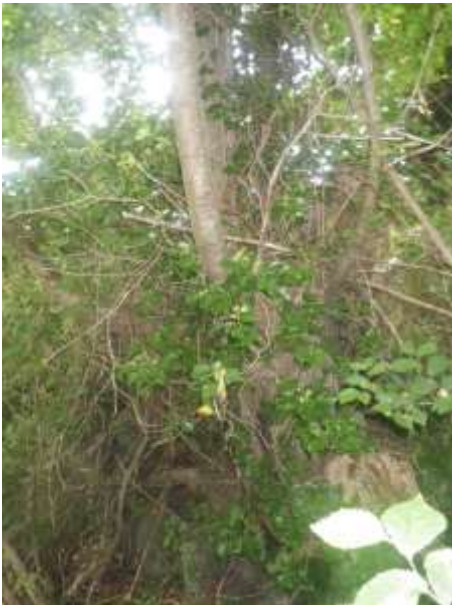
1. **Unique ref no:** 4A
2. **Grid Ref:**
3. **Measurements:** Diameter of stem 1.65m (measured) at previous lop; Height 12m (est.); Spread 5m(est.)
4. **Species:** Probably *Ulmus Procera*

5. **Estimated Age:** 70 years
6. **Tree Form and Vigour:** Appears to have been previously lopped at approx. 1.5m, probably caused growth of 4 codominant stems, slight lean to south and west probably to seek light, active live growth, some epicormics growth, nil veteran features noted

12. **Potential threats:** Nil biological observed other than general points noted in main text. Lean probably caused by large lower limbs seeking light to south and west in dense canopy. Potential "sail" problem caused by ivy during strong winds.

13. **Management Recommendations:** Crown lift to approx. 5 metres.

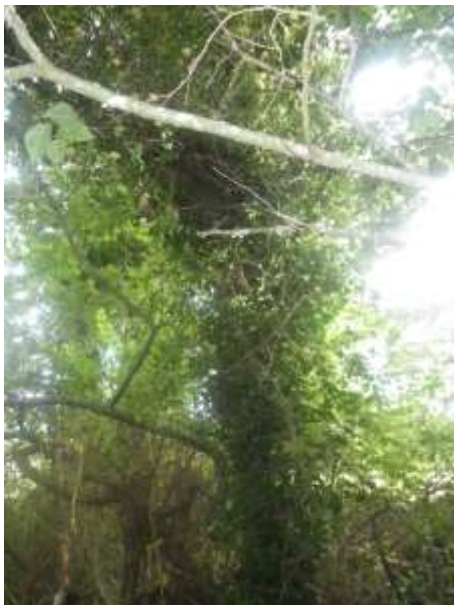
1. **Unique ref no:** 5A
2. **Grid Ref:**
3. **Measurements:** Diameter of stem 1.35m (measured); Height 14m (est.); Spread 8m(est.)
4. **Species:** Probably *Ulmus Procera*

5. **Estimated Age:** 60 years
6. **Tree Form and Vigour:** Appears to be maiden tree, slight lean to west probably to seek light, active live growth, large lower limb to south west, some epicormics growth, nil veteran features noted

7. **Tree associates:** Ivy growing freely over tree; some evidence of historic bird nesting within ivy.
8. **Relationship to landscape features:** hedgerow tree, some damage caused from windblow to granite wall (see picture)

12. **Potential threats:** Nil biological observed other than general points noted in main text. Lean probably caused by large lower limbs seeking light to south and west in dense canopy. Potential "sail" problem caused by ivy during strong winds.

13. **Management Recommendations:** Crown lift to approx. 5 metres.

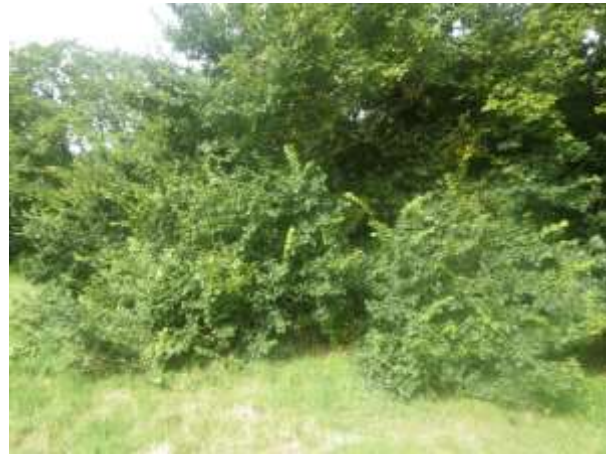
1. **Unique ref no:** 6A
2. **Grid Ref:**
3. **Measurements:** Diameter of stem 3.4m (measured); Height 18m (est.); Spread 20m(est.)
4. **Species:** Probably *Ulmus Procera*

5. **Estimated Age:** 100 years
6. **Tree Form and Vigour:** Tree is windblown and resting on ground having fallen to south west, root ball still not showing but area has lifted around stone hedge, probably been in this position for several years, appears to be maiden tree, active live growth, some epicormics growth, nil veteran features noted

12. **Potential threats:** Nil biological observed other than general points noted in main text. Tree has succumbed to windblow damage. Currently tree not in safe position as may fall further causing additional uprooting and damage to wall. Also hindering use of agricultural field and allowing prolific growth of new suckers where area not cultivated.

13. **Management Recommendations:** Lop stem to approx. 1.5 metres above root ball to encourage new more vertical growth

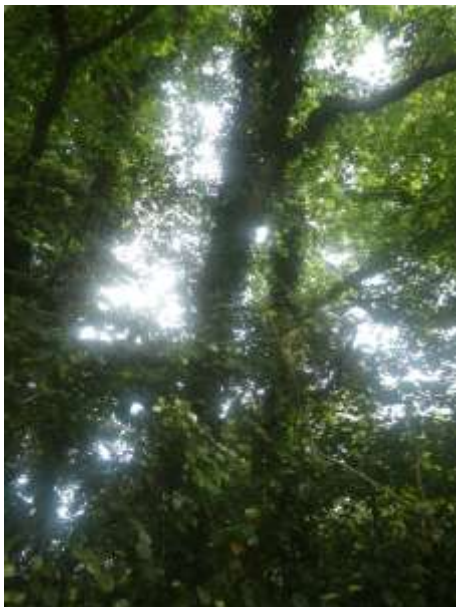
1. **Unique ref no:** 10A
2. **Grid Ref:**
3. **Measurements:** Diameter of stem 1.2m (measured); Height 15m (est.); Spread 12m(est.)
4. **Species:** Probably *Ulmus Procera*

12. **Potential threats:** Nil biological observed other than general points noted in main text. Lean probably caused by large lower limbs seeking light to south and west in dense canopy. Potential “sail” problem caused by ivy during strong winds.

13. **Management Recommendations:** Crown lift to approx. 5 metres.

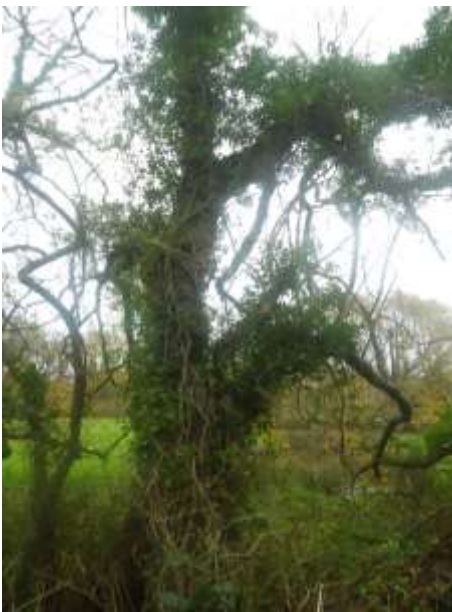
1. **Unique ref no:** 1B
2. **Grid Ref:**
3. **Measurements:** Diameter of stem 1.4m (measured); Height 16m (est.); Spread 8m(est.)
4. **Species:** Probably *Ulmus Procera*
5. **Estimated Age:** 60 years
6. **Tree Form and Vigour:** Appears to be maiden tree, significant lean to east probably to seek light as crowded out to west, active live growth, some deadwood near base and tips of lower limbs
7. **Tree associates:** Ivy growing freely over tree; some evidence of historic bird nesting within ivy.
8. **Relationship to landscape features:** hedgerow tree
9. **Photographic record above.**
10. **Evidence of previous management works:** None evident
11. **Nil additional historic/ cultural value associated with tree.**

- 12. Potential threats:** Nil biological observed other than general points noted in main text. Lean probably caused by tree seeking light in dense canopy. Likely to fall to east in near future. Potential “sail” problem caused by ivy during strong winds.
- 13. Management Recommendations:** Crown lift east side to approx. 5 metres.

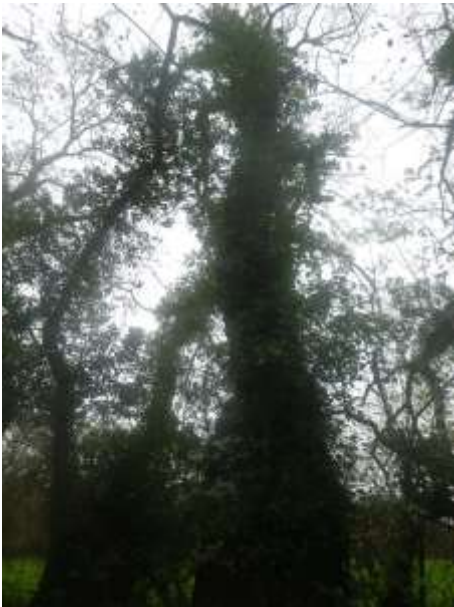
1. **Unique ref no:** 3B
2. **Grid Ref:**
3. **Measurements:** Diameter of stem 1.6m (measured); Height 17m (est.); Spread 12m(est.)
4. **Species:** Probably *Ulmus Procera*

12. **Potential threats:** Nil biological observed other than general points noted in main text. Lean probably caused by large lower limbs seeking light to south and west in dense canopy. Potential "sail" problem caused by ivy during strong winds.

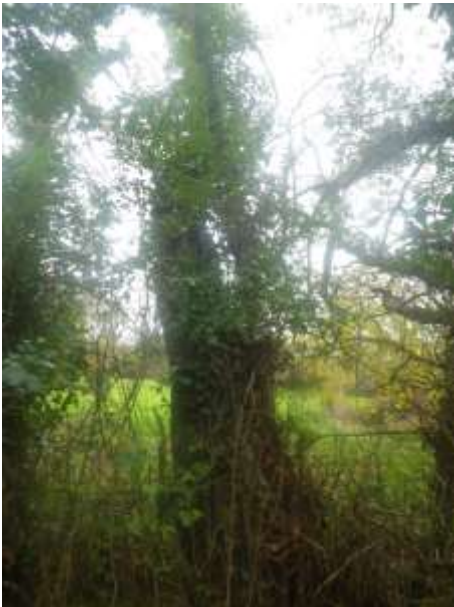
1. **Unique ref no:** 4B
2. **Grid Ref:**
3. **Measurements:** Diameter of stem 1.6m (measured); Height 6m (est.); Spread 14m(est.)
4. **Species:** Probably *Ulmus Procera*

13. **Management Recommendations:** Lop at approx. 3 metres.

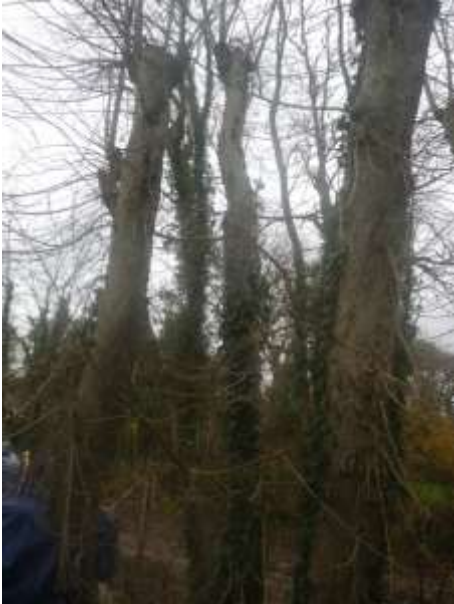
1. **Unique ref no:** 3C
2. **Grid Ref:**
3. **Measurements:** Diameter of stem 0.8m (measured); Height 7m (est.); Spread 5m(est.)
4. **Species:** Probably *Ulmus Procera*
5. **Estimated Age:** 50 years
6. **Tree Form and Vigour:** upright, active live growth, recent pollard at approx. 4m, significant epicormics growth
7. **Tree associates:** Ivy growing sparsely over tree
8. **Relationship to landscape features:** hedgerow tree
9. **Photographic record above.**
10. **Evidence of previous management works:** One recent pollard point obvious
11. **Nil additional historic/ cultural value associated with tree.**
12. **Potential threats:** Nil biological observed other than general points noted in main text.
13. **Management Recommendations:** Re-pollard above old wounds

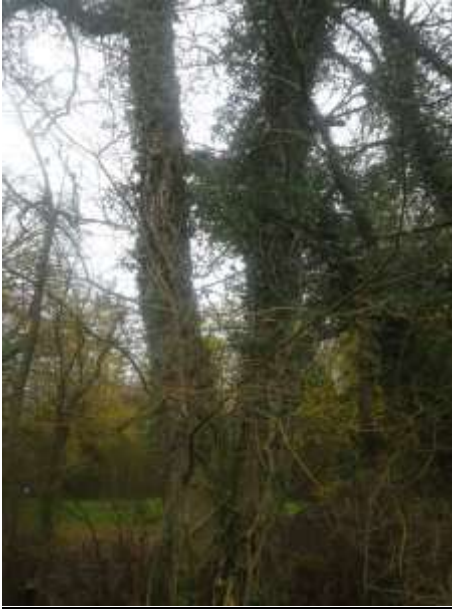
1. **Unique ref no:** 2D
2. **Grid Ref:**
3. **Measurements:** Diameter of stem 3.6m (measured); Height 23m (est.); Spread 18m(est.)
4. **Species:** Probably *Ulmus Procera*
