TREE REPORT

Old School Site/
Turnstones, St.
Mary's

13 JULY 2020

Matthew Rogers BA (Hons)
NPTC Level 3 Arboriculture
Client: Council Isles of Scilly

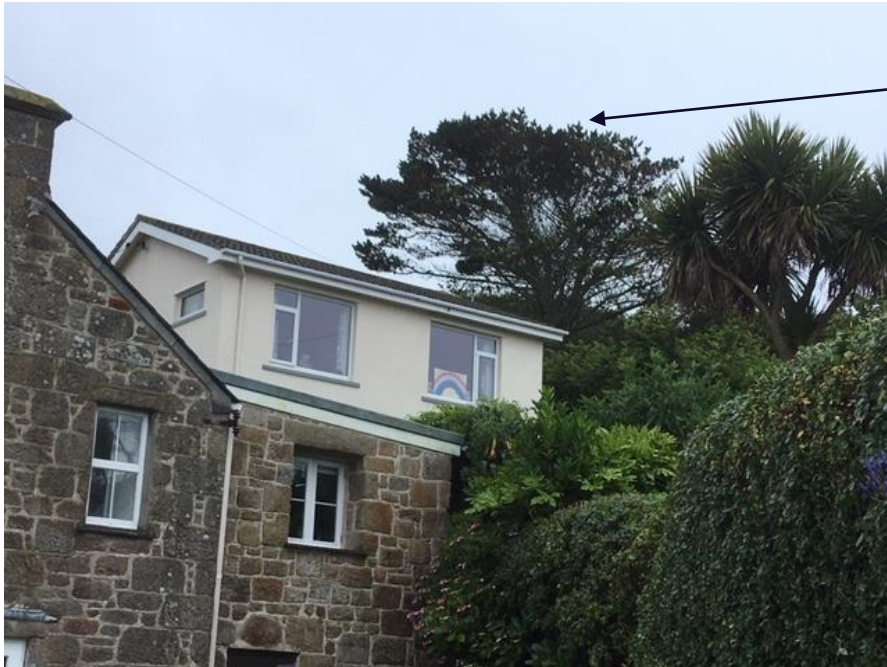
Fig 1.2 View of tree and Turnstones looking in a south westerly direction

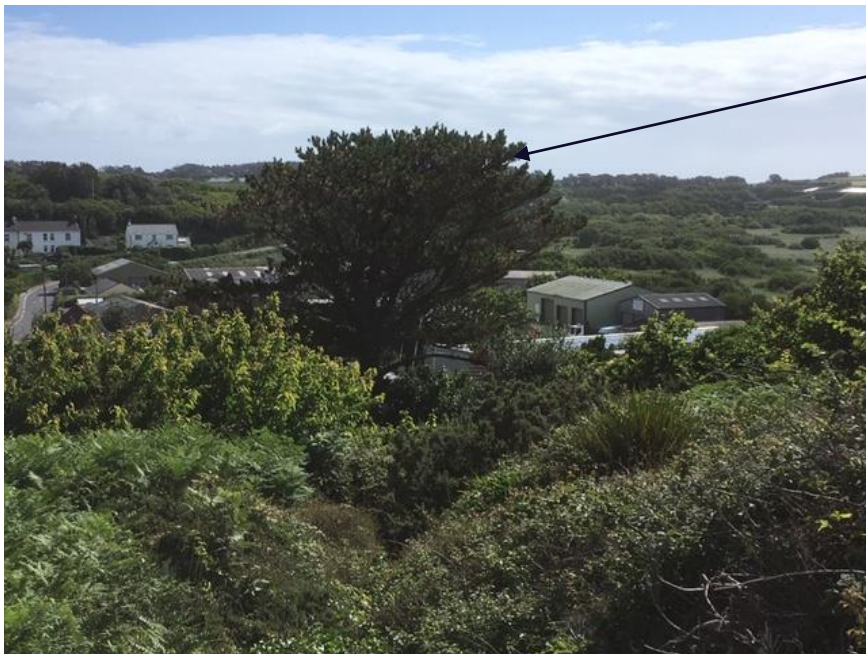
Fig 1.3 View of tree from summit of adjacent hill looking in an Easterly direction

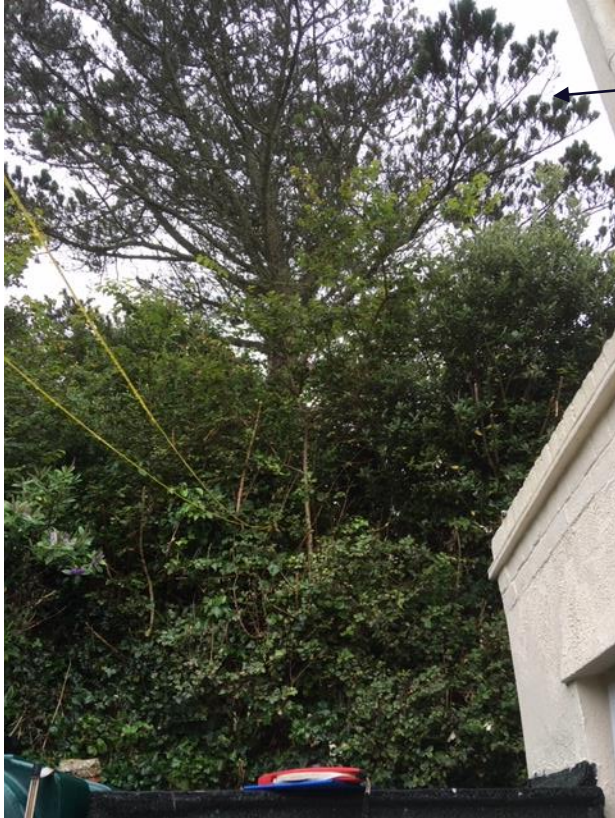
Tree in question

Fig 1.4 Showing tree from ground level at Turnstones. Note *Pittosporum* and *Ulmus* in foreground. Also note sheer drop from tree level to ground level and Turnstones. Picture taken looking approx. West.

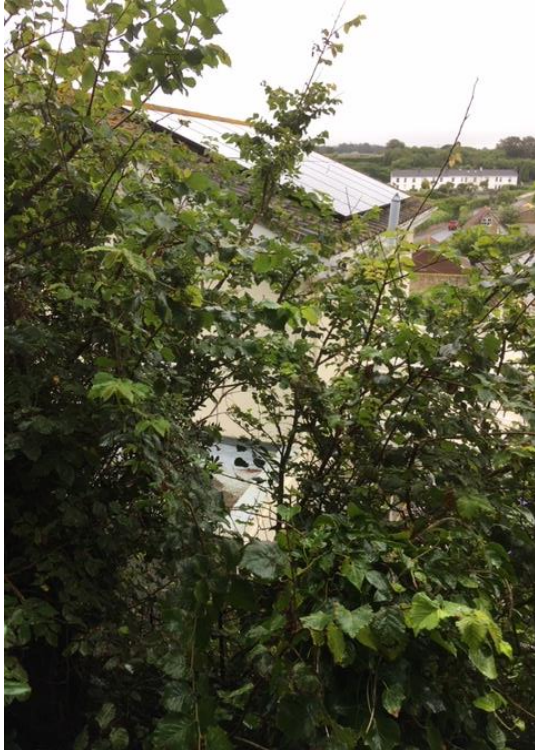
Fig 1.5 Showing Turnstones roof from position of tree trunk looking approximately East. Note the presence of numerous *Ulmus* in the foreground

Recommendation	Justification
<p>Removal of tree within next 6 months.</p> <p>Scrub vegetation should be managed and suckering Elm (Ulmus) will cause a similar problem in the future if they are not managed or removed. Suggest monitoring and removal of suckering Elm (qualified person not required for this, and planning not required as at present trees are below size necessary for planning).</p>	<ul style="list-style-type: none">• Risk of windblow and severe damage to adjacent property• Shallow/ rocky soil and topography may increase chance of windblow• Tree does not have high amenity value• Vertical drop adjacent to tree may cause instability and likely to increase force of fall and chance of windblow• Roots may have been damaged by works to sewage pipe at adjacent property• Roots may continue to further damage pipes and underground services

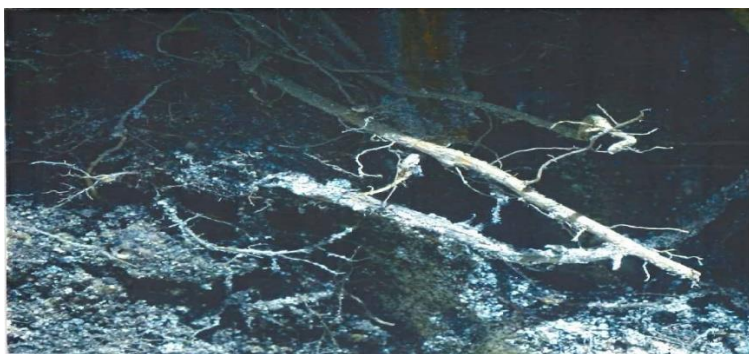
Turnstones,
Porthor
SI

Fig 1.6 Photograph of tree root damaging sewage pipe system at Turnstones during works. Picture provided by Council Isles of Scilly.

Unfortunately, this picture is not of sufficient quality to be certain that this root extends from the Pine tree in question. The root in the picture does look like a Pine root and, given the lack of other larger trees in the immediate vicinity, it is possible – roots of a 25 year old *Pinus Radiata* have been documented to extend laterally beyond 10.4 metres.¹ In addition, as calculated in BS 5837, the boundary of the house and the position of the damaged pipe lies inside the Root Protection Area – this is defined in BS 5837 as the “minimum area around a tree deemed to contain sufficient roots and rooting volume to maintain a tree’s viability, and where the protection of the roots and soil structure is treated as a priority.” It is calculated at 12 times the diameter of the tree at 1.5 metres above ground – in this case, 12 x 0.6m, which gives a Root Protection Area out to 7.2 metres from the tree. Given the above, it is likely but not certain, that the root which damaged the sewerage pipe at Turnstones was from the *Pinus Radiata* in question.

Having spoken to the contractor who carried out the work and the owner of the property, in order to remedy the issue with the pipe, a significant amount of the root was removed.

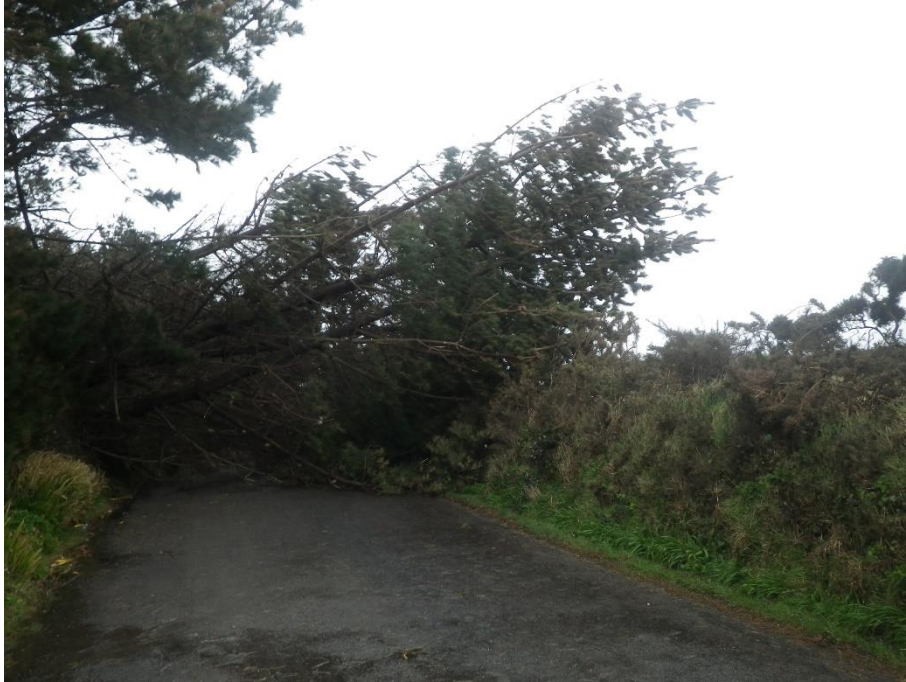
Fig 1.7 *Pinus Radiata* windblown across highway, Bishop’s View, Telegraph, February 2014

This shows that during high winds, these trees are susceptible to falling from wind blow in various states of maturity. Although a solitary tree may have more resistance to extreme wind, the exposed nature of this tree means that failure from windblow is a possibility, and this is made more likely by the sheer drop immediately to the East of the tree. This issue is compounded by the fact that the prevailing winds are from the South West, and therefore any failure is likely to be in the direction of the adjacent property.
