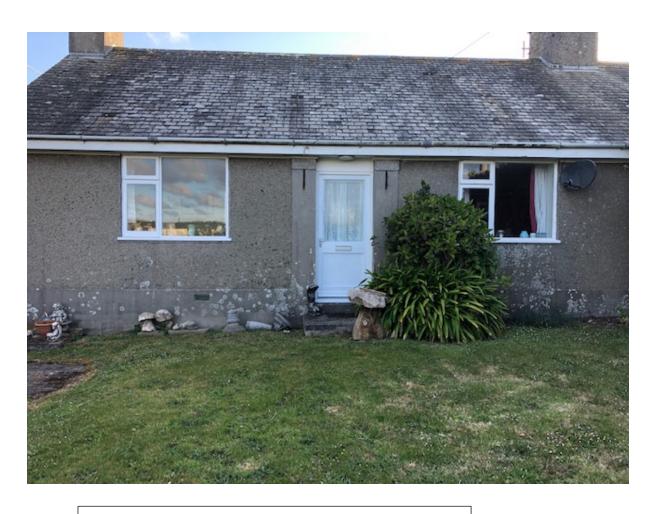
Existing front wooden single glazed windows and door.

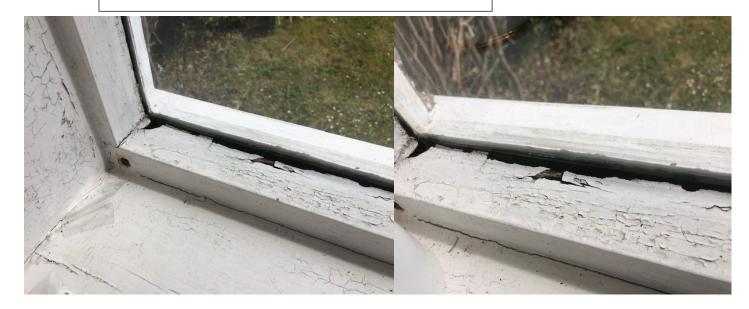
Inside view of rotten windows frames.
