PRELIMINARY ROOST ASSESSMENT (PRA)

1 BUZZA STREET
HUGH TOWN, ST MARY'S, ISLES OF SCILLY

Report date: 17th September 2021

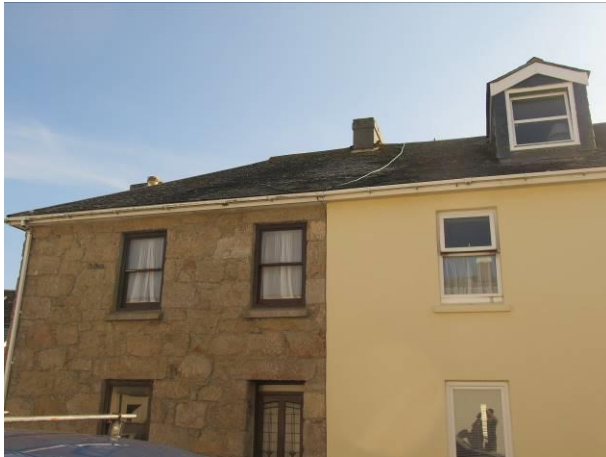
The exterior facades of both properties are in good condition – 1 Buzza Street has exposed granite blocks with well-maintained pointing; 2 Buzza Street is rendered with the covering in good condition.

Photograph 1: Showing the western aspect of 1 and 2 Buzza Street. The granite blockwork of 1 Buzza Street and the rendered façade of 2 Buzza Street distinguish the two properties.

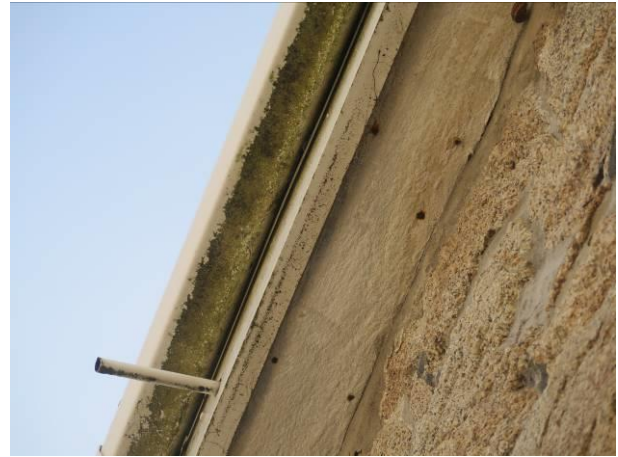
The boxed eaves on the western aspect of both properties are in good condition and tightly sealed. Guttering runs below the eaves of the tiled roof.

Photograph 2: Showing the underside of the boxed eaves illustrating the tight fitting and lack of access. The guttering attached to a fascia board can be seen to the left.

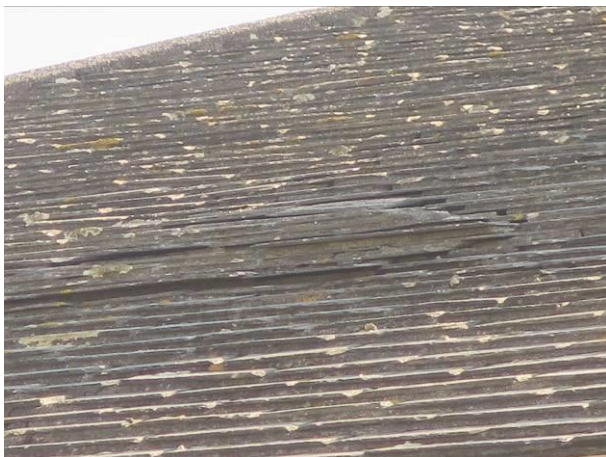
The only potential access points or roosting opportunities for bats are associated with the location where the tiles have slipped. These remain tight and, though not water-resistant, they are still in good enough condition that they offer very little scope for access by roosting bats. Whilst it cannot be ruled out, it is considered unlikely that this low-suitability feature which arose during Storm Evert in July 2021 would be occupied by roosting bats in the short term.

Photograph 3: Showing the area of the roof where the tiles have slipped.

The tiles around the area where the slippage occurred should be removed carefully in such a way that in the highly unlikely event of a bat being present beneath, they are not crushed by the removal of the tile.

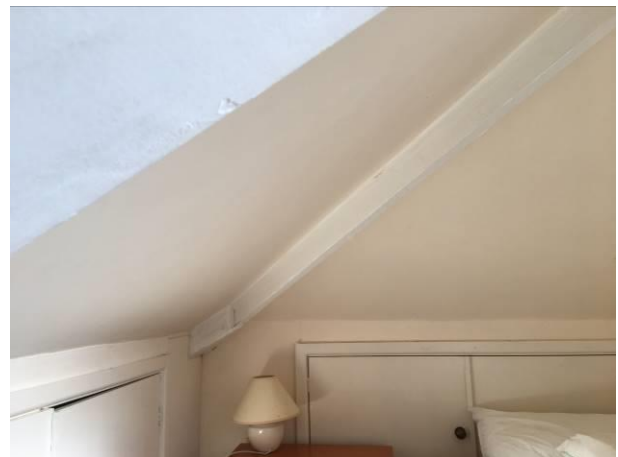
The upper roof space of both properties has been converted to residential use with no loft space present. In each property, the lower pitches of the roof are boxed for cupboard storage – these are fully boarded out in the case of 1 Buzza Street whilst the underside of the tiles are directly visible from the cupboard in 2 Buzza Street. This latter location allowed for an inspection of the tiles from beneath, confirming that the only light visible from within is associated with the slipped tiles identifying this as the only potential access location.

Photograph 4: Showing the interior of the roof space at 1 Buzza Street where the residential conversion has occurred. The built-in storage close to eaves level can also be seen.

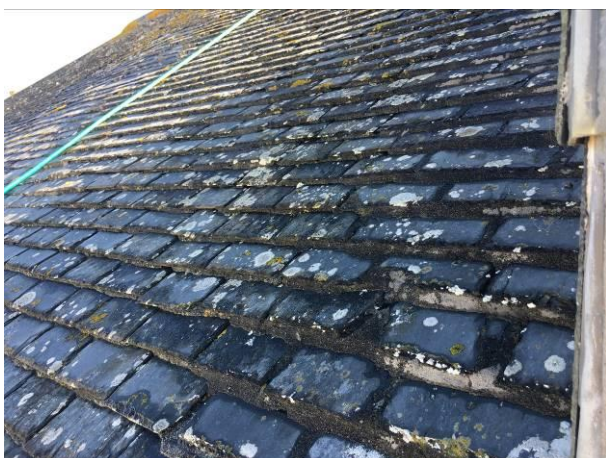
The tiled roof was evidently tightly sealed prior to the slippage which necessitated the current roof replacement works. Small, well-fitted slate tiles with gaps sealed by cement pointing comprise the western pitch offering no opportunities for access by bats aside from the location of the slippage itself. The tiles on the ridge and hip are well fitted and sealed, as are the chimneys. Prior to the slippage, it is considered highly unlikely that bats would be able to gain access beneath tiles or into the roof.

Photograph 5: Showing the tight cement pointing between slate tiles which characterises the roof

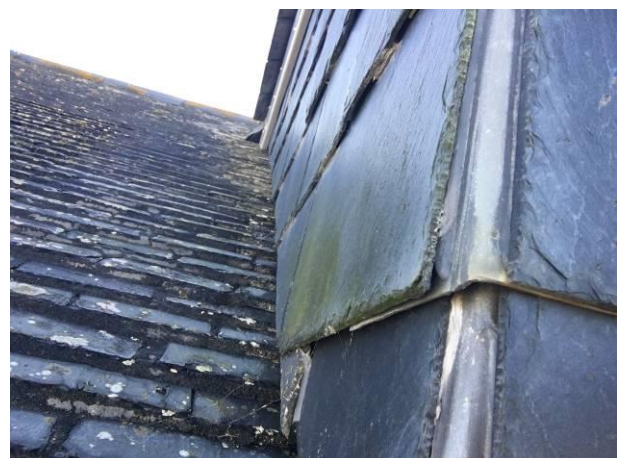
The roof replacement works would extend as far as the dormer window of 2 Buzza Street – this structure was inspected from the dormer itself. The vertical hanging tiles associated with this dormer are well-fitted though minor gaps do occur in places and roosting bats have been identified associated with similar features in the vicinity of the property. Like-for-like roof replacement works running up to this feature should not impact upon these potential features either at the time of replacement or post-completion, however care would be required to ensure that the hanging tiles are not impacted during roof replacement works.

The dormer of 2 Buzza Street – an adjacent structure – could potentially support individual common pipistrelle bats though this is considered to be **low potential**.

Photograph 6: Showing generally well-fitted hanging tiles of the dormer at 2 Buzza Street – minor cavities have low potential to support individual bats.

Care should be taken during works to ensure that this structure is not disturbed or damaged. This may include a contractor briefing to ensure that those working on the roof understand the requirement, or other measures such as a temporary sign, tape or physical barrier if deemed necessary.
