PRELIMINARY ROOST ASSESSMENT (PRA)

6 BAY VIEW TERRACE, PORTHMELLON, ST MARY'S, ISLES OF SCILLY

Report date: 5th August 2021

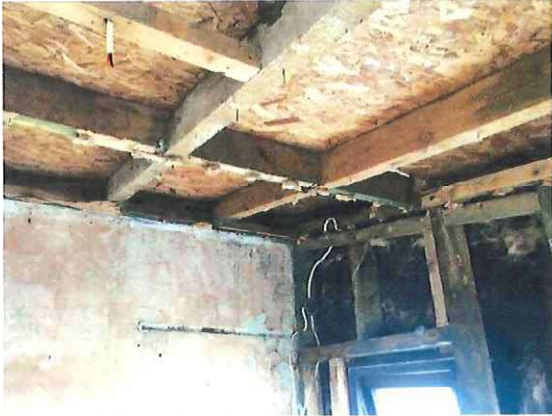
DORMER BATHROOM	<p>The dormer provides an upstairs bathroom and is located on the eastern aspect of the property. The two walls adjacent to the property comprise the exterior walls of the main dwelling whilst the remaining two walls which face externally are constructed from timber frames with membrane and a timber cladding externally. The external cladding is well-fitted thereby offering no voids between the cladding and the membrane. Where the dormer abuts the residential property to the north-west, there is a small retaining wall sealed with fibreglass and a gully where it meets the pitch of the adjacent roof.</p> <p>There is a well-fitted fibreglass roof which has a gentle single pitch. The roof is supported by timber battens – these are exposed internally with no ceiling void. Chipboard is visible above the timbers and the fibreglass is laid directly onto this offering no voids or gaps associated with the structure. The fibreglass is tightly lapped over the eaves offering no roosting opportunities associated with this area.</p> <p>The proposals involve tying the new structure into the existing roof of the residential property; therefore this roof was included within the assessment to fully assess potential impacts. The roof of the main dwelling is open internally due to ongoing renovation works and the felting upon which the tiles are placed can be seen – no loft void or other cavity is present. The slate tiles are very well fitted offering no access beneath. There are no potential access points beneath the tiles from the eaves – these are well fitted and guttering further blocks any potential access to these.</p> <p>The proposals will also involve the replacement of soffits along the north-eastern aspect of the residential property. Sparrows were observed accessing a hole in this soffit in a manner which indicates an active nest at the time of survey. This use by nesting birds close to the entrance would make it highly unlikely for bats to use this feature.</p>

Photograph 1: Showing the interior of the bathroom dormer. The wall of the residential building is visible to the left with the timber frame of the external wall visible to the right. The timber roof structure and chipboard can also be seen above.

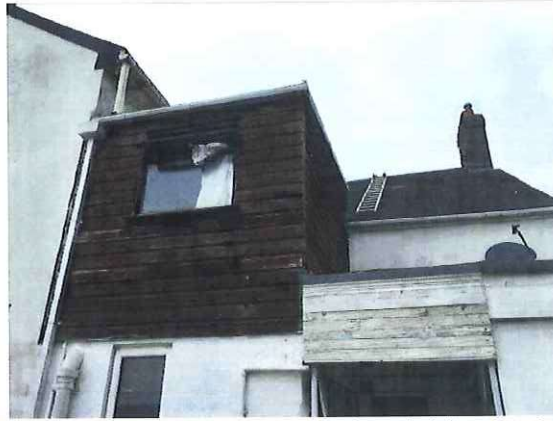
Photograph 2: Showing the timber cladding on the exterior of the bathroom dormer.

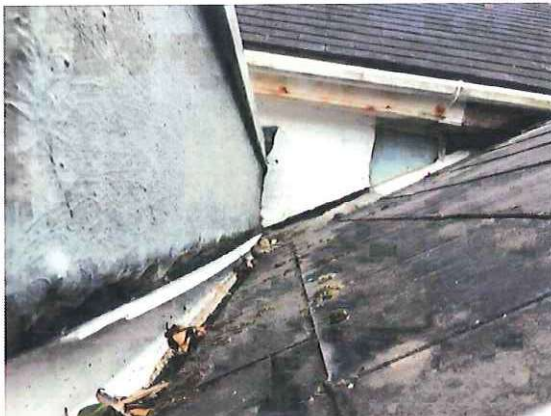
Photograph 3: Showing the existing gully between the fibre-glassed back wall of the dormer and the slate roof of the main property

The current external structure of the first floor bathroom extension means there is a problematic gulley, which is difficult to access and maintain. It is the source of a substantial leak which penetrates through to the ground floor. We would like to slightly amend the design so the new flat roof cuts into the pitched roof of the side return, in order to eliminate the gulley.

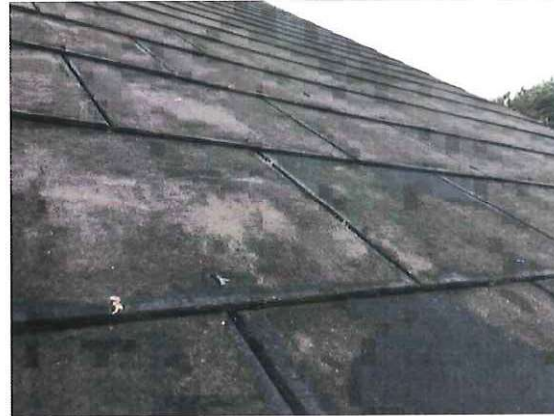
Photograph 4: Showing the tightly fitted slate roof on the existing property. This is the retained roof into which the new roof structure of the bathroom dormer will be tied.

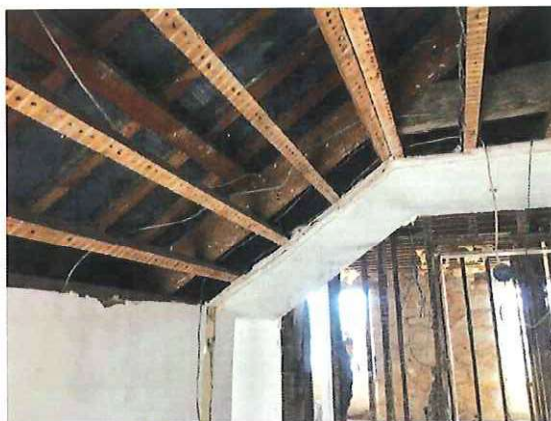
Photograph 5: Showing the interior of the roof of the main residential dwelling. This is the roof into which the new roof structure of the replacement bathroom dormer will be tied.

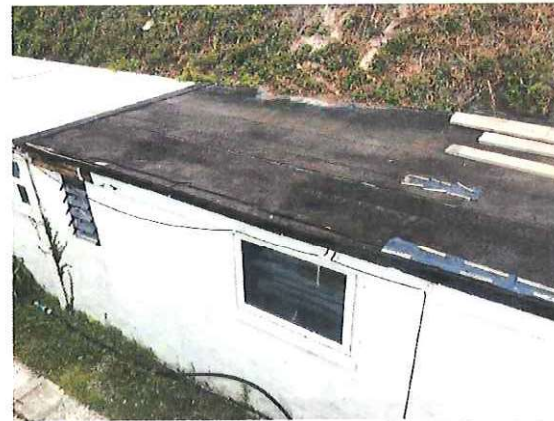
CHALET	<p>The chalet is a breeze-block structure situated to the rear of the main residential property. It has single-skin walls and a flat, bitumen felted roof. There is a small uPVC porch area at the entrance and uPVC windows continue throughout the building – all of these features are tightly fitted. The walls are rendered externally – this is in good condition providing an effective seal to the breeze block walls. The breeze blocks are exposed internally with no plasterboard remaining.</p> <p>The roof is supported by timber battens – these are exposed internally with no ceiling void. Chipboard is visible above the timbers and the felting is laid directly onto this offering no voids or gaps associated with the structure. The felting is tightly lapped over the eaves offering no roosting opportunities at this location.</p> <p>There is potential access for bats or birds to enter the building through a hole in the wall close to the eaves in the bathroom, or through open windows. Internally there are suitable niches for use by nesting birds including ledges. Potential roosting opportunities for bats entering through openings would be restricted to free-hanging from the timbers, or minor discreet gaps between the wall plate and the timber above. These gaps are occasional and were all well-cobwebbed showing no evidence of occupation at the time of survey.</p> <p>The chalet was stripped bare of fittings and internal decoration at the time of survey and was unused, awaiting renovation. A full inspection for signs of bat occupation including droppings or feeding remains identified no evidence of current or historic presence.</p>

Photograph 6: Showing the exterior of the chalet building with the rendered wall, uPVC window and felted roof visible.

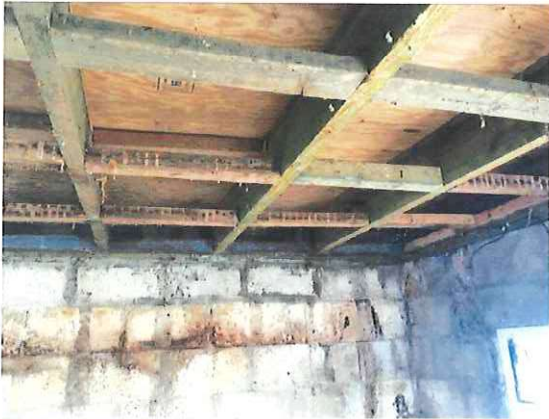
There is a negligible potential for bats to find roosting opportunities on top of the wall plate in the chalet. Any roosting opportunities, if present, would be between the blockwork and attached timbers. These timbers should be removed carefully by hand such that, in the unlikely event of bats being present, they are identified before they are harmed.

Photograph 7: Showing the interior of the chalet with exposed timber framework and chipboard above. The exposed breezeblock walls can also be seen.

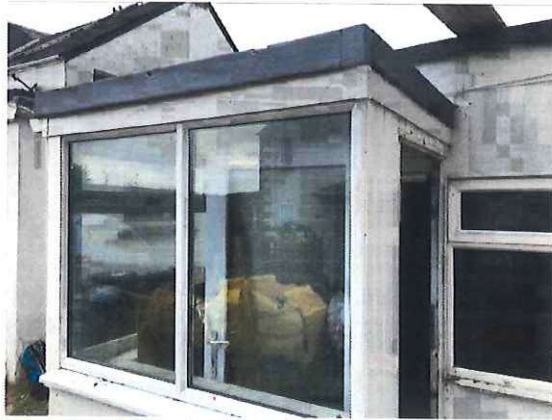
Photograph 8: Showing the porch entrance to the chalet.

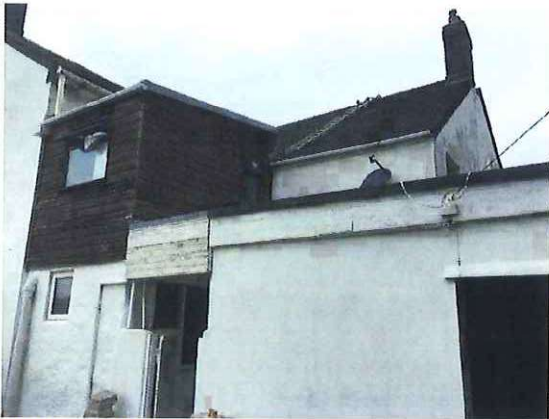
GARAGE	<p>The garage is a single-story construction attached to the main residential property on the north-eastern aspect. It is a twin-skinned breeze block construction with no insulation in the void between the blocks. It has a flat, bitumen felted roof. There is no external door fitted at present with the void partially filled allowing free access above. uPVC windows are present on the north-eastern aspect - these are tightly fitted.</p> <p>The walls are rendered externally – this is in good condition providing an effective seal to the breeze block walls which are exposed internally. The void between the blocks is accessible where the door has been removed, but this is open at the top internally which both minimises its suitability as a roosting opportunity (offering no apex niches) and ensures that in the unlikely event of bats accessing this temporarily exposed void, there is no risk of entombment.</p> <p>The roof is supported by timber battens – these are exposed internally with no ceiling void. Chipboard is visible above the timbers and the felt is laid directly onto this offering no voids or gaps associated with the structure. The felting is tightly lapped over the eaves offering no roosting opportunities.</p> <p>There is potential access for bats or birds to enter the building through the missing garage door at present. Internally there are suitable niches for use by nesting birds. Potential roosting opportunities for bats entering through openings are restricted to free-hanging from the timbers.</p> <p>The garage remained in use for storage at the time of survey. A full inspection for signs of bat occupation including droppings or feeding remains identified no evidence.</p> <p>A fibreglass roof connecting the garage to the main dwelling was also inspected – no potential features suitable for use by roosting bats or nesting birds associated with this element of the construction were identified.</p>

Photograph 9: Showing the garage (bottom right) with the open door visible. The bathroom dormer can be seen to the upper left of the image.

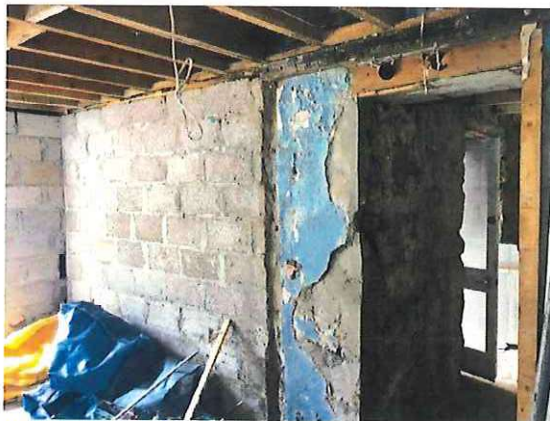
Photograph 10: Showing the interior of the garage with exposed breeze block walls and exposed timber roof structure above.

In the case of the garage and chalet, it is recommended that the internal ledges and niches within the buildings are carefully inspected before the roof is removed if undertaken during the nesting season. Nests are only protected if they are active (i.e. being used to rear young) or in the process of being built.
