RIDGEWAY
HERITAGE CONSULTANCY

A Heritage Statement

Kavorna, 21 Hugh Street, St Mary's Isles of Scilly TR21 0PT

RHC Project No. 2022-36

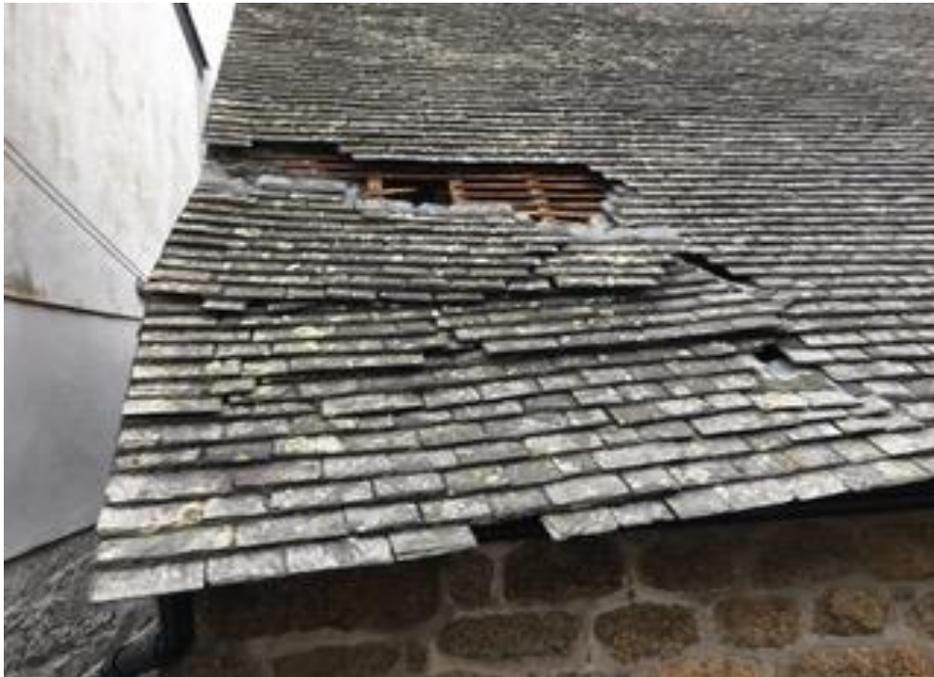
1.3 The rear, south wing of Kavorna has suffered from severe rippling of the slate scantle tiles on its northern side (Figs. 4, 15 and 16). The area affected by rippling finally collapsed during a storm in August, 2021. In 2019, the southern side of the south wing also suffered from a rippling slip, which was successfully repaired at that time (Figs. 7 and 16). Accordingly,

Fig. 4: Slippage of slates on the south roof of the rear south wing, in 2021 (Paul Osborne).

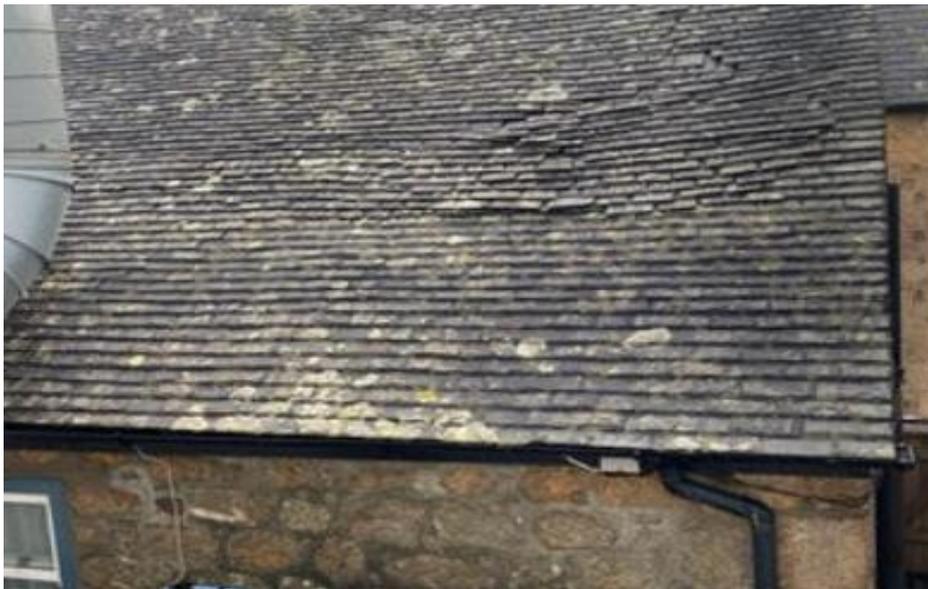
Fig. 7: The north-west elevation of the south wing of Kavorna, showing slate rippling, with details of traditional vernacular construction.

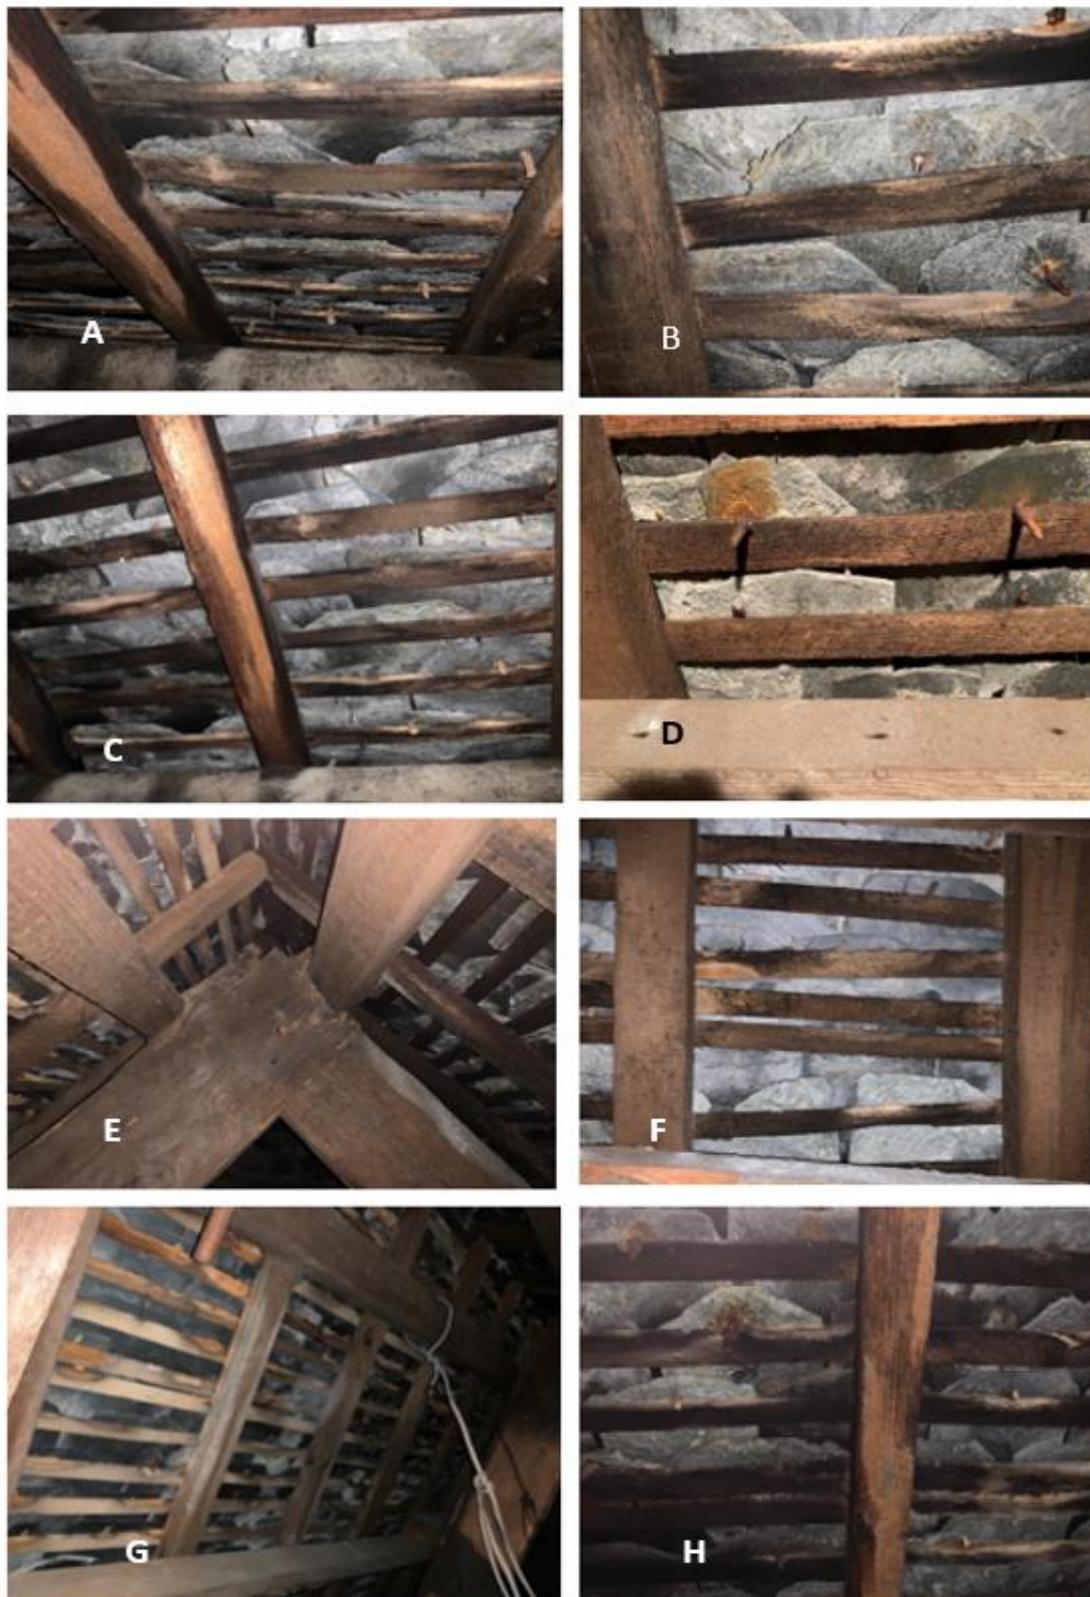
5.4 Fixing of timbers throughout appears to be with iron nails, and there is no evidence of mortising or pegging of major timber joints. Individual wet-laid slates are head-nailed and hung on battens, with nails protruding below battens in many cases (Figs. 13 A and D; 17 C and H). Occasionally, particularly at lower levels of the roof-slope, slates have been secured by wooden pegs. The scangle slates display considerable irregularity along the battens, and some display evidence of shifting in relation to battens. The slates are consistently of uneven,

grey-green colouration, presumably of imported, but otherwise unknown origin (Figs. 13 B, C and D; 15A; 17 A, D and F).

Fig. 13, A-H: Internal details of roof construction.

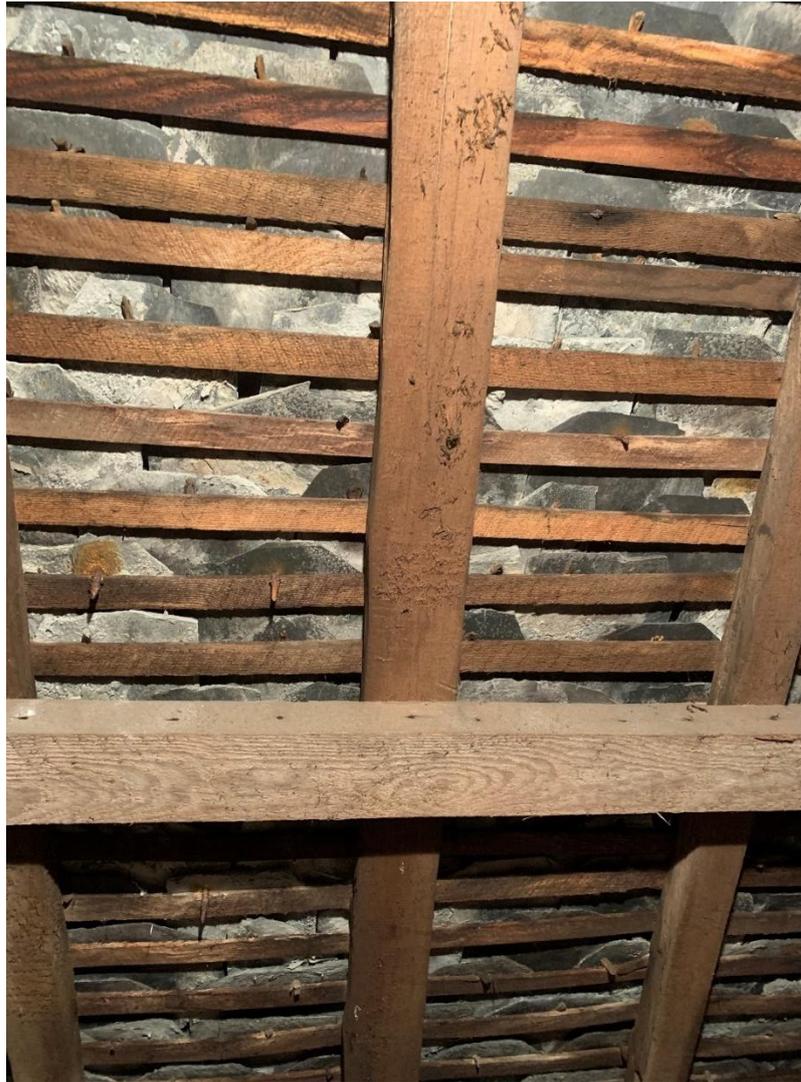
5.3 The purlins support jack rafters, which are set at irregular intervals of between 300mm and 400mm. These are also of machined softwood, mostly measuring approximately 70mm by 50mm in section, although some are of thinner, flatter section (Figs. 13 A-H; 14; 15 C and D). Battens are highly irregular, mostly comprising rough-sawn strips averaging 40mm to 50mm in width, and displaying considerable variation in thickness and section (Figs. 13 A-H; 14; 15 A-F). These are set on rafters, at intervals of between 60mm and 100mm. In some areas, the condition of rafters and battens suggests relatively recent repair and replacement (Fig. 14).

Fig. 14: Internal details of roof construction: purlin, common rafters and battens.

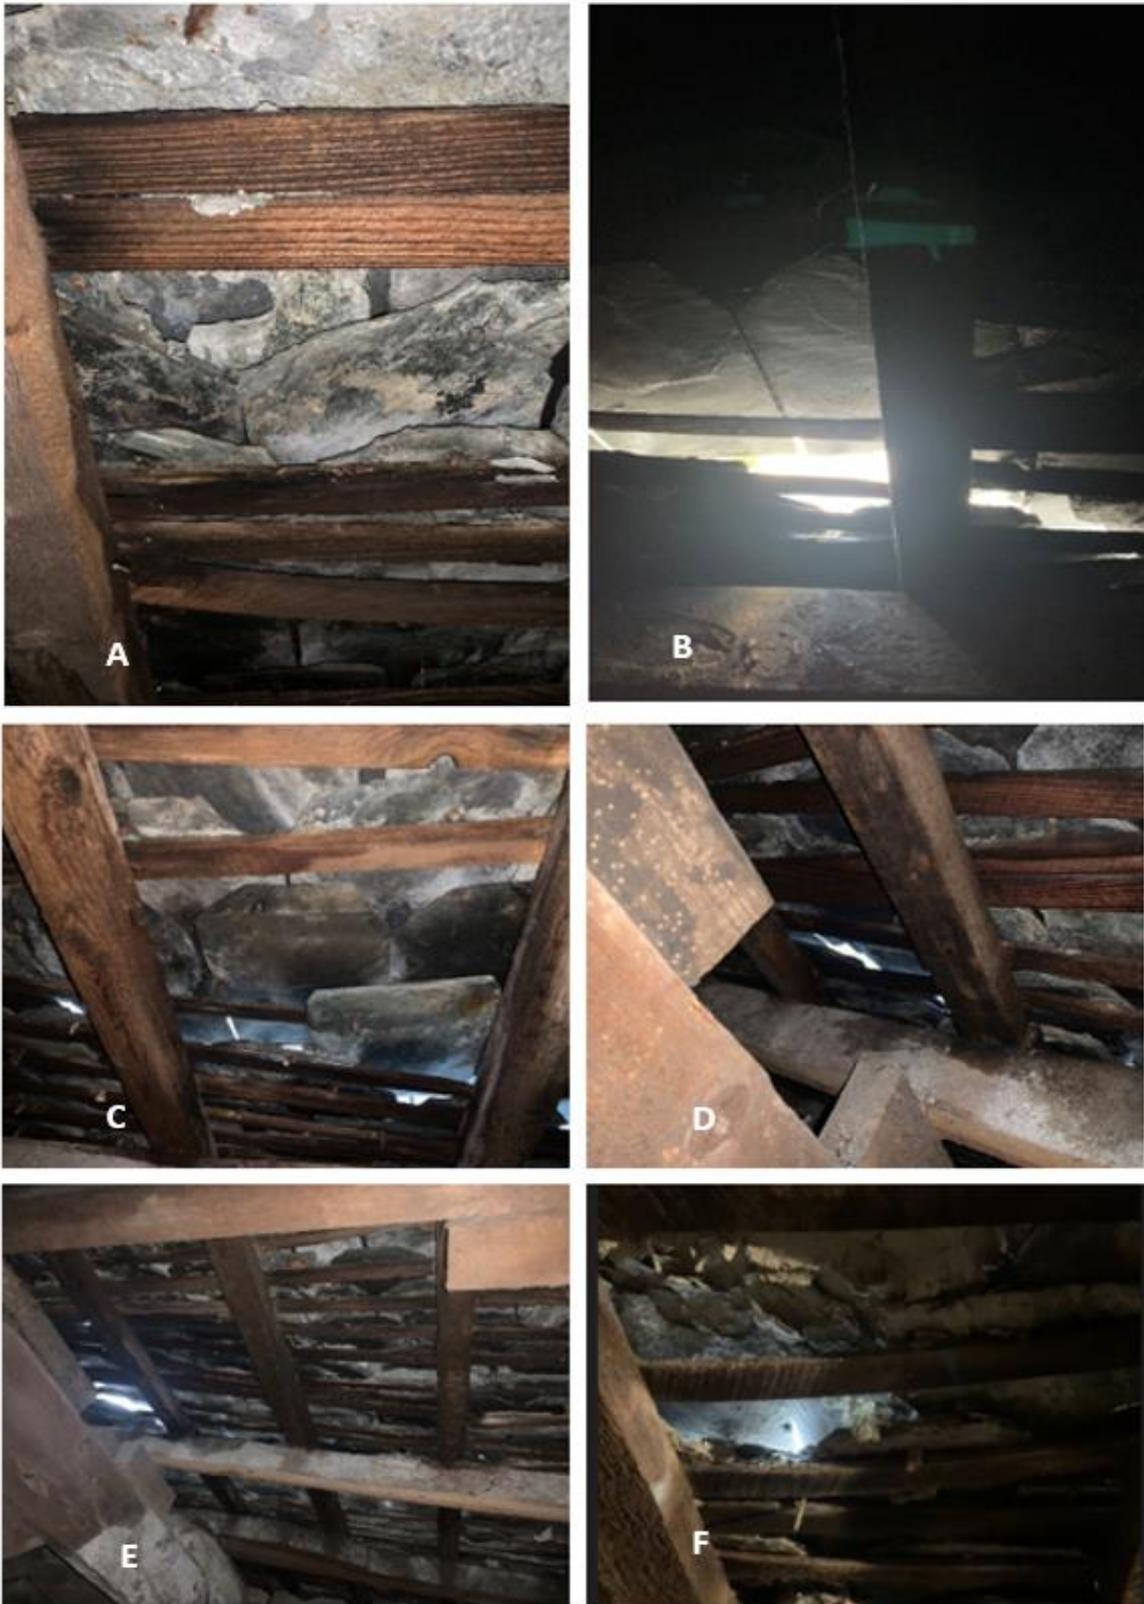
- 5.5 The failure of parts of the slate roof results from deficiencies in original roof construction and choice of materials. None of this work can reasonably be dated earlier than the mid-nineteenth century, when it is assumed that a thatched roof was replaced. Within close proximity to the shoreline, the maritime climate has resulted in extensive corrosion of iron fixings, particularly of the iron nails securing the scantle slates (Fig. 13D). This is evident in the iron-staining visible on the undersides of a number of slates. In addition, it is clear that the smaller iron nails securing battens to rafters have also been subject to corrosion and failure, resulting in the downward slippage and displacement of battens under the accumulated weight of slates (Figs. 13F; 15B, C and F; 17B and F). A number of battens appear to be of insubstantial thickness, and are possibly not adequate to support the weight of slates, and a number of these

display evidence of *in situ* decay, possibly as a result of slight water ingress during winter storm conditions (Figs. 15A-F; 17A-H).

Fig. 15, A-F: Internal evidence of deterioration of roof battens and slate slippage.

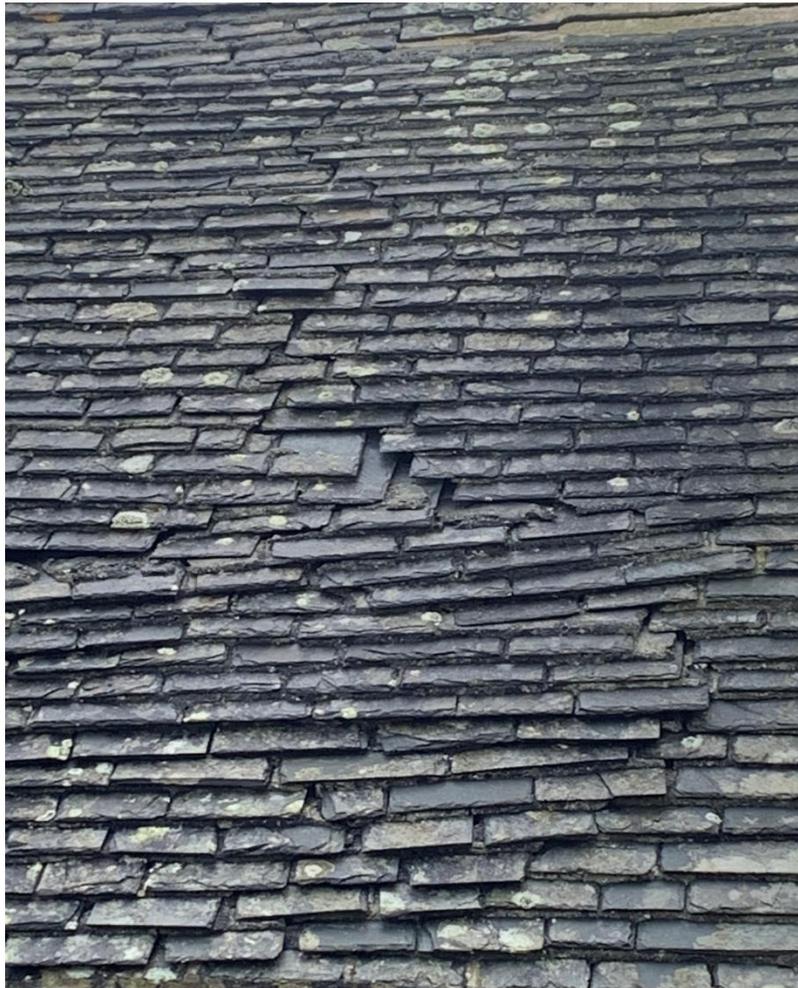
5.6 It is also possible that the corrosion and failure of head-nails has enabled downward slippage and displacement of slates which have imposed additional weight on battens further down the roof-slope, thus causing them to break or become displaced, particularly if iron fixings have become corroded (Figs. 15B, C, D and F; 16; 17B). Given the cumulative weight and down-pressure of slates at mid-point on the roof-slope, this could result in a cumulative effect, causing the rippling noted on the north-west side of the south wing (Fig. 16).

Fig. 16: Cumulative downward displacement of slates on the north-west side of the south wing of Kavorna.

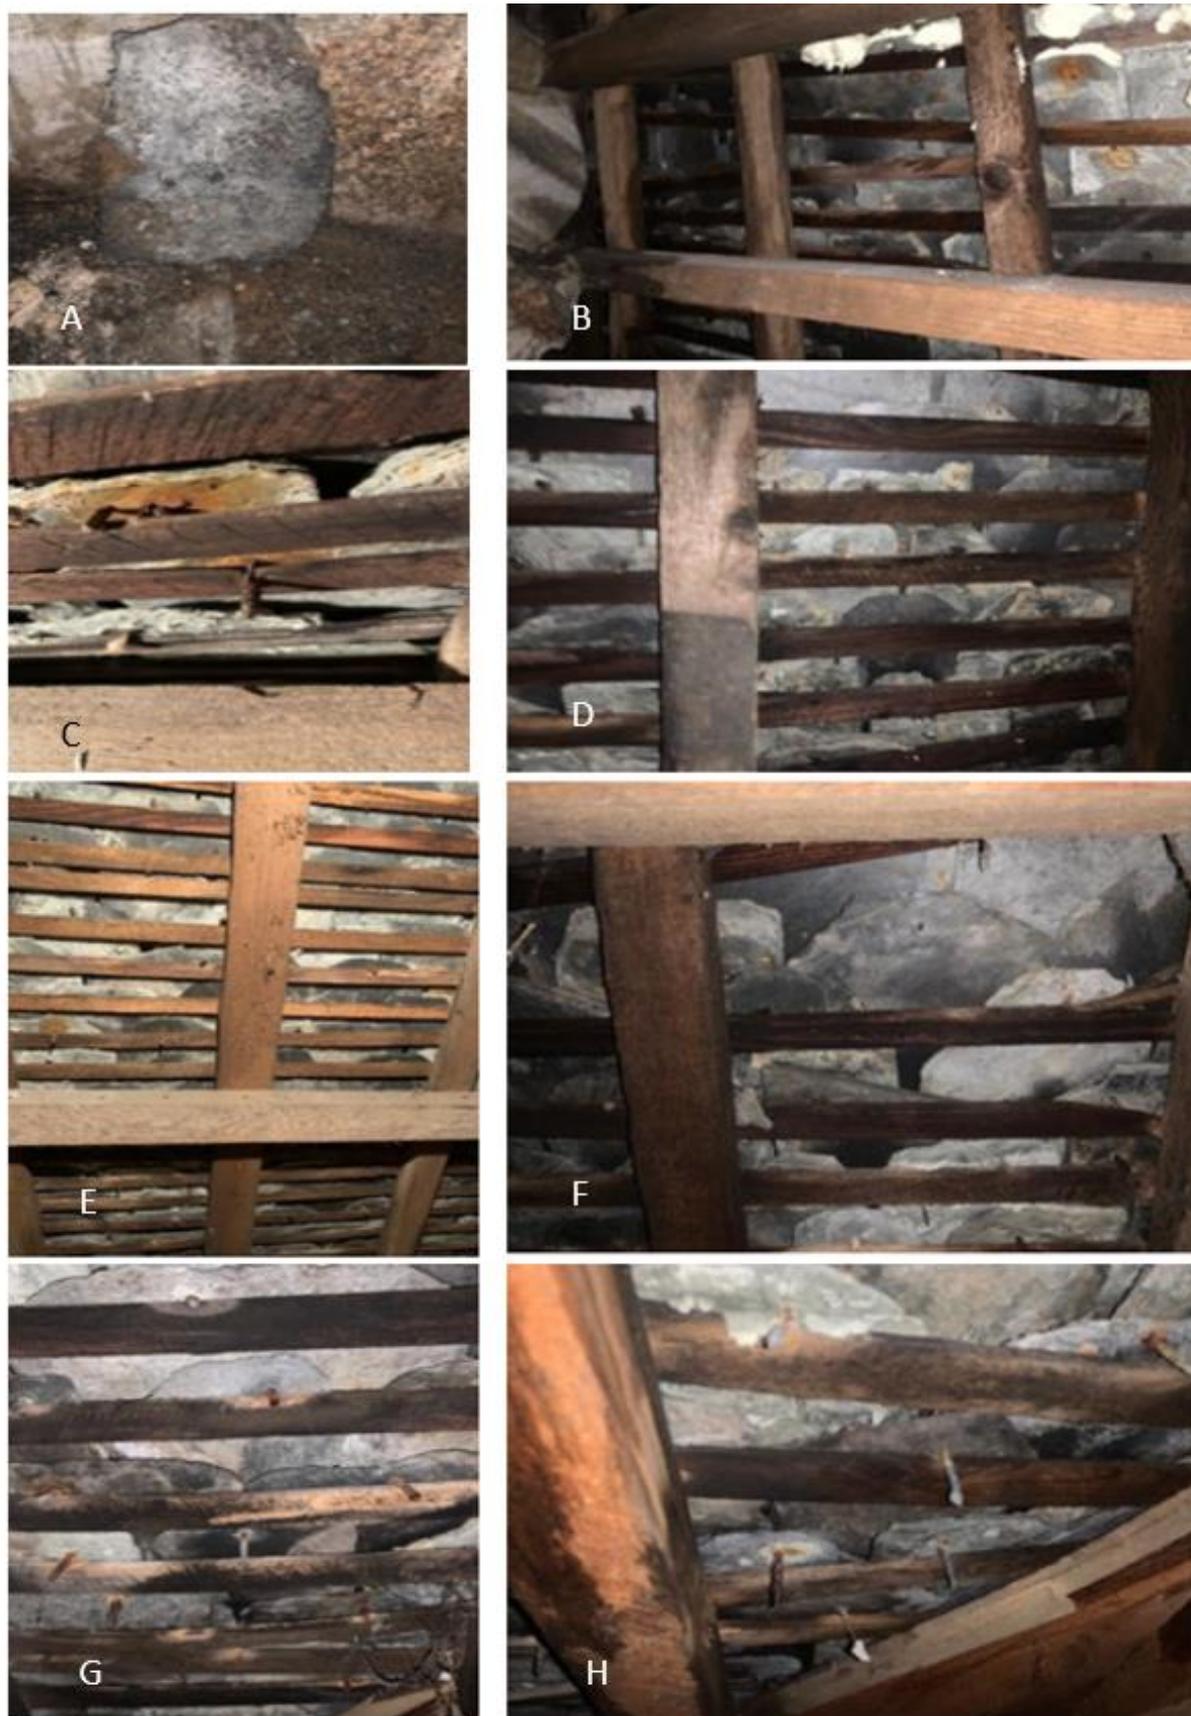
Fig. 17, A-H: Internal evidence of roof structure and deterioration.

5.8 Internal inspection further confirmed that damaged parts the roof were now affected by water ingress, but that the battens appeared to be in a moderate condition. Consequently, the roof failure was considered to be principally due to corrosion of the iron head-nails. It was also noted that many slates were in a poor condition, having become porous and fragmented, with some displaying a white, powdery texture. This may indicate the long-term exposure of these slates to weathering, particularly in a relatively exposed, coastal environment.

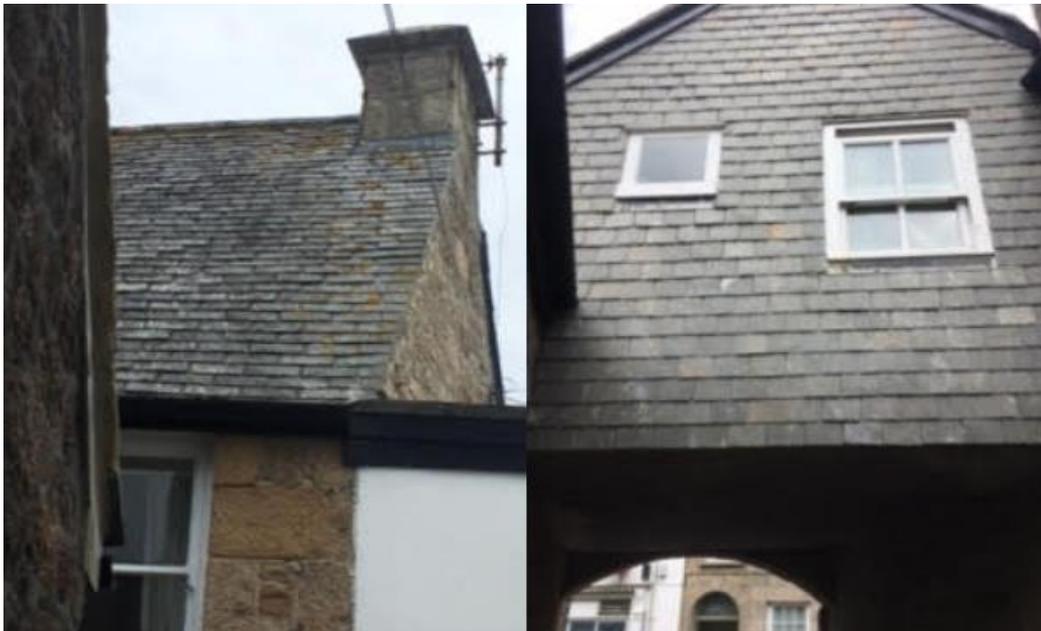
Fig. 20: Natural 'Camborne' slates on the roof and clad wall of the adjoining Post Office building (Paul Osborne).

5.13 It is recommended that Natural 'Camborne' Slate would represent an historically authentic source, which would be both durable and provide a good match for the existing scantle slates in terms of texture and colour. The local planning authority has approved the replacement of scantle slates with Natural Slates of this type on a number of historic buildings within Hugh Town and elsewhere. These have been used on both roofs and clad walls of the adjoining Post Office (Fig. 20). A standard size for natural slates of 195mm by 400mm would be appropriate to the removed scantle slates.
