PRELIMINARY ROOST ASSESSMENT (PRA)

SELECTED ASPECTS OF SANTA MARIA, HUGH TOWN, ST MARY'S, ISLES OF SCILLY

Our reference: 22-9-1

Report date: 20th September 2022

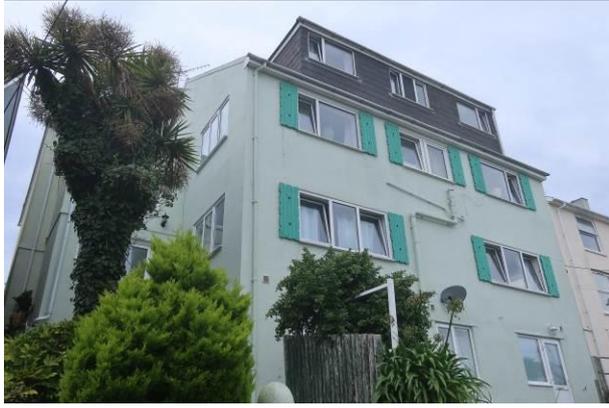
There are wooden window shutters on the eastern frontage of the property – these appear to be aesthetic and are attached directly to the wall by battens in an ‘open’ position. Whilst window shutters can provide suitable roosting habitat for bats, especially on the continent, the width and open character of this void behind these features would be too wide to provide suitable roosting opportunities for bats.

Photograph 1: Showing the front aspect of the property with the shutters visible.

Removal of the wooden shutters should be undertaken outside of the breeding season which runs from March – September inclusive. If this is not possible, then contractors should visually inspect behind the shutters before their removal to confirm that no nests are present. In the unlikely event that a birds nest is present, it must be left undisturbed until chicks have fledged the nest, at which point removal works can proceed.

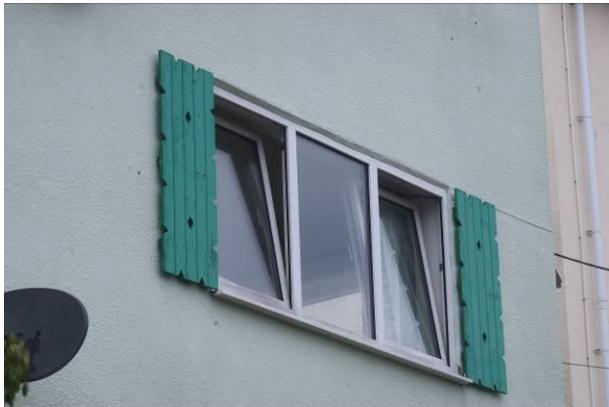
Photograph 3: Showing detail of the shutters on the front of the property.

There is a small risk of bats making transient or exploratory use of the cavity behind the wooden shutters. These shutters should be removed carefully in such a way that in the highly unlikely event of a bat being present in the apex of the gap between the shutter structure and the wooden batten attached to the wall, they are not crushed by the removal of the feature.

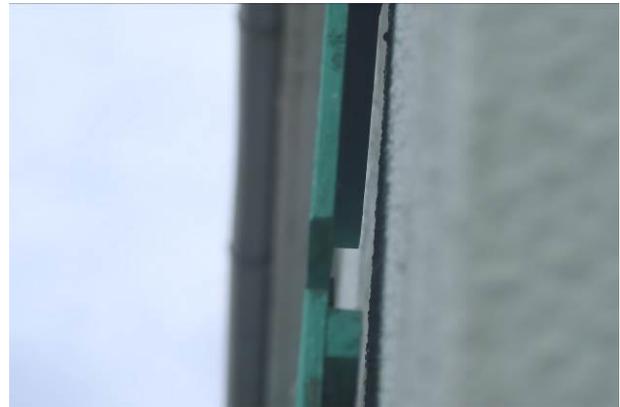
- The gaps behind the shutters – these appear unsuitable due to their wide and exposed dimensions but occasional transient or exploratory use by individual bats cannot be ruled out;
- The very minor gaps where lead flashing has lifted – these appear too small and lack a suitable fly-in but occasional transient or exploratory use by individual bats cannot be ruled out.

Photograph 4: Showing the battens attaching the shutters to the wall and the cavity created behind.

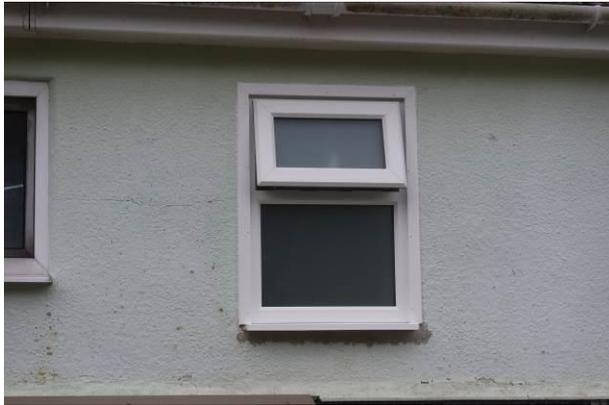
The windows and doors throughout the property are uPVC and are well-fitted with no gaps noted between the frames and the walls. No roosting opportunities were identified associated with these windows.

Photograph 5: Showing a typical example of a well-fitted uPVC window found throughout the property.

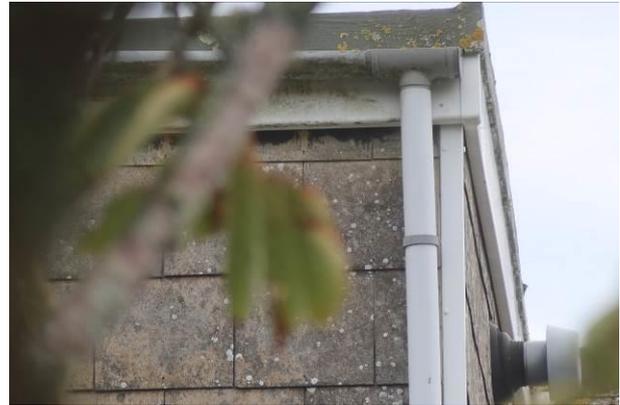
The asbestos tiles around the windows were thin and well-fitted throughout. Their manufactured character means there is negligible variation in shape or surface which could offer natural gaps beneath tiles. The tiles were well fitted and in good condition throughout. Although a fully comprehensive inspection could not be achieved from ground-level due to angles of visibility, the inspection was sufficient to provide a high degree of confidence that there were no roosting opportunities for bats associated with the tiles either on the dormer windows or the adjacent roof sections.

Photograph 6: Showing the well-fitted asbestos tiles on the front and side of the dormer window on the rear of the property.

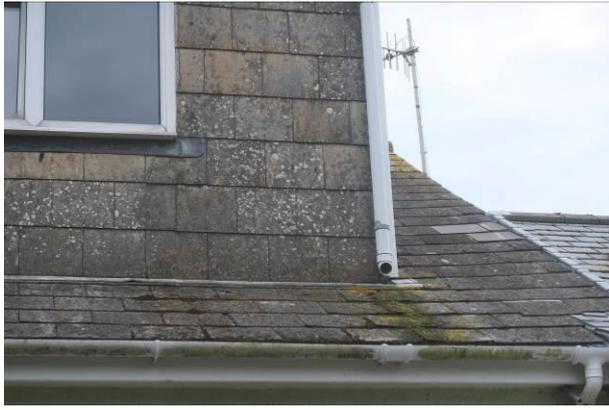
The lead flashing which seals the joints between dormer windows and roof tiles appeared to be in good condition – very occasional superficial gaps were noted.

Photograph 7: Showing the join between the dormer window and the roof in which it is situated.

Very minor lifted sections occur within the lead flashing where the dormers meet the roof. If these are to be removed as part of the works, locations where the flashing is lifted should be exposed carefully such that if any bats were present behind the lifted element, they would not be crushed or otherwise injured by the operation.

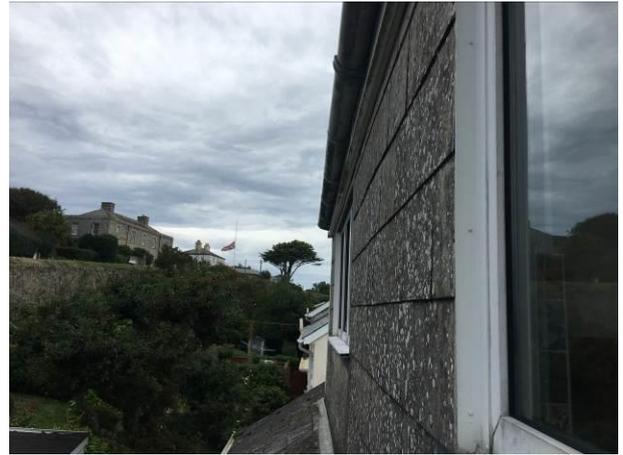
Photograph 8: Showing the hanging tiles on the dormer window viewed at height.
