Ian Galliers  
EGV Consultancy Ltd

28<sup>th</sup> October 2023

**Re Wingletang, The Parade, Hugh Town, Isles of Scilly, Cornwall**

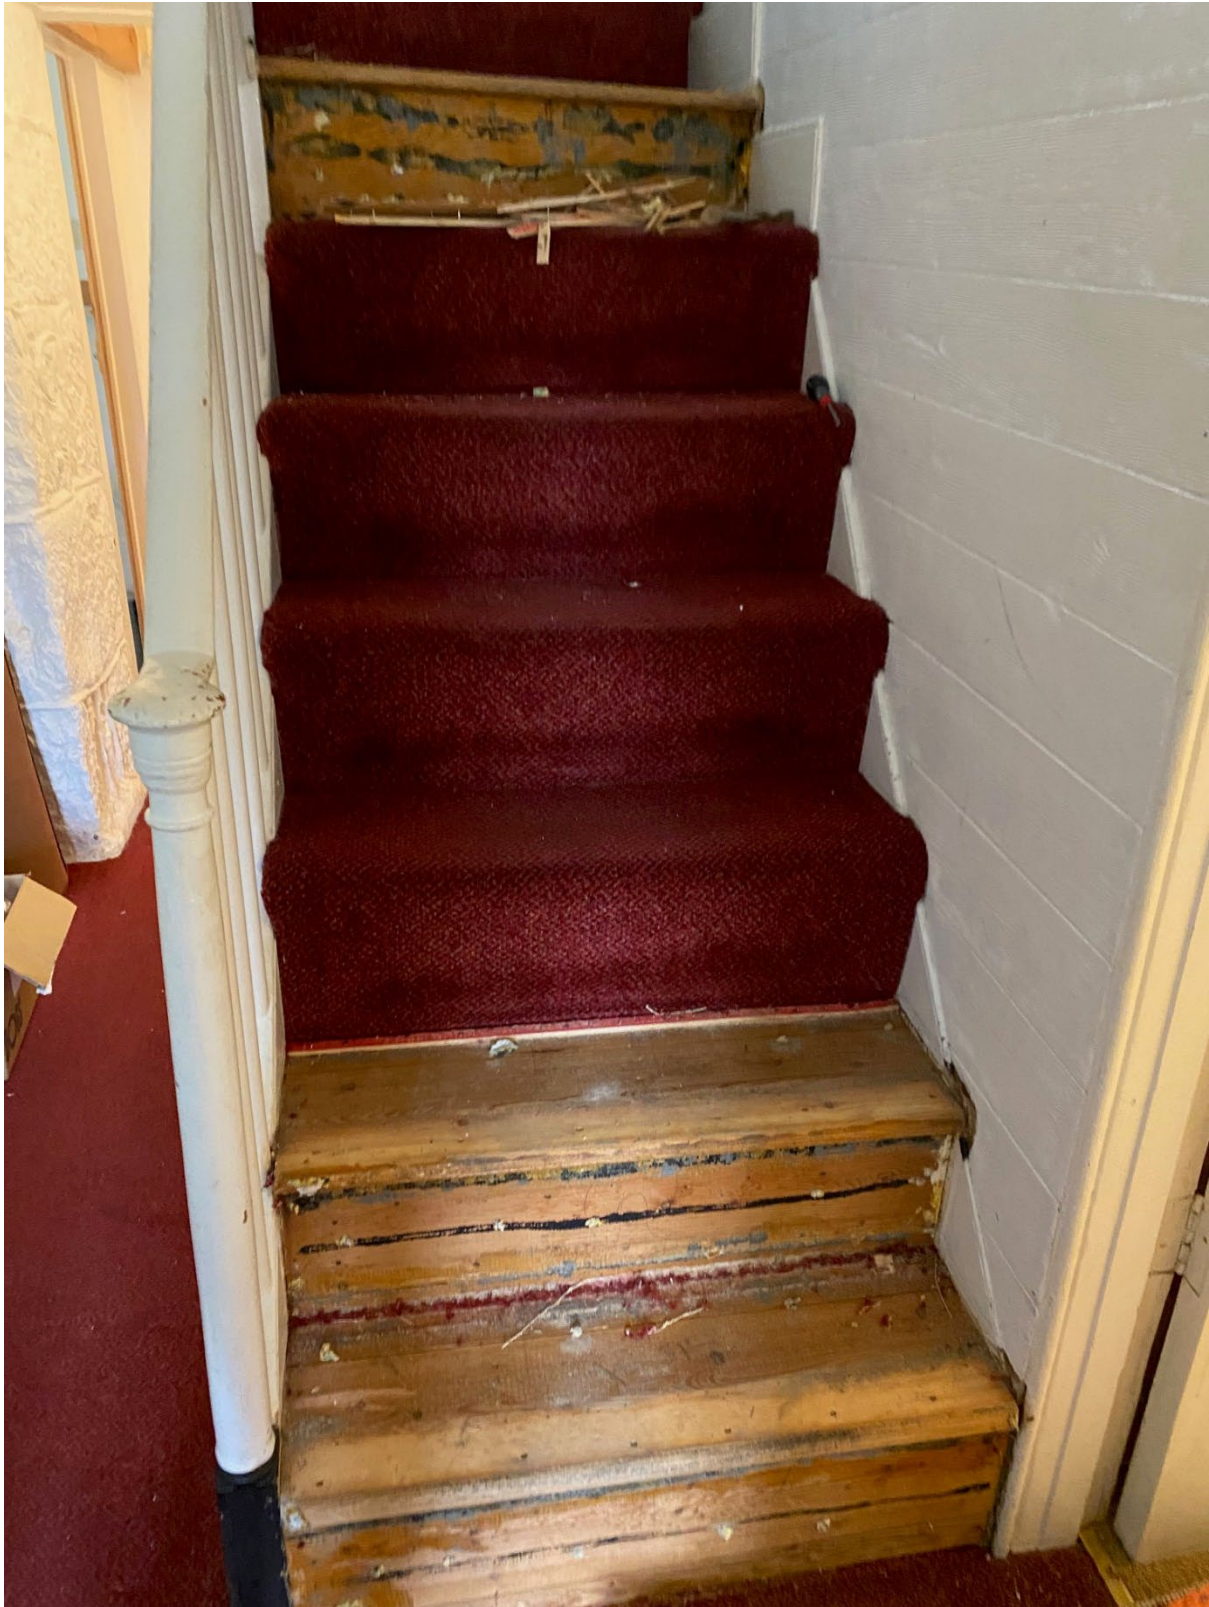
**No1.** This picture shows how the treads and risers have been re-fabricated and nailed together using modern round head nails to secured the treads and risers to a softwood sub frame underneath. Note how the treads come past the side strings as opposed to being housed into the string.

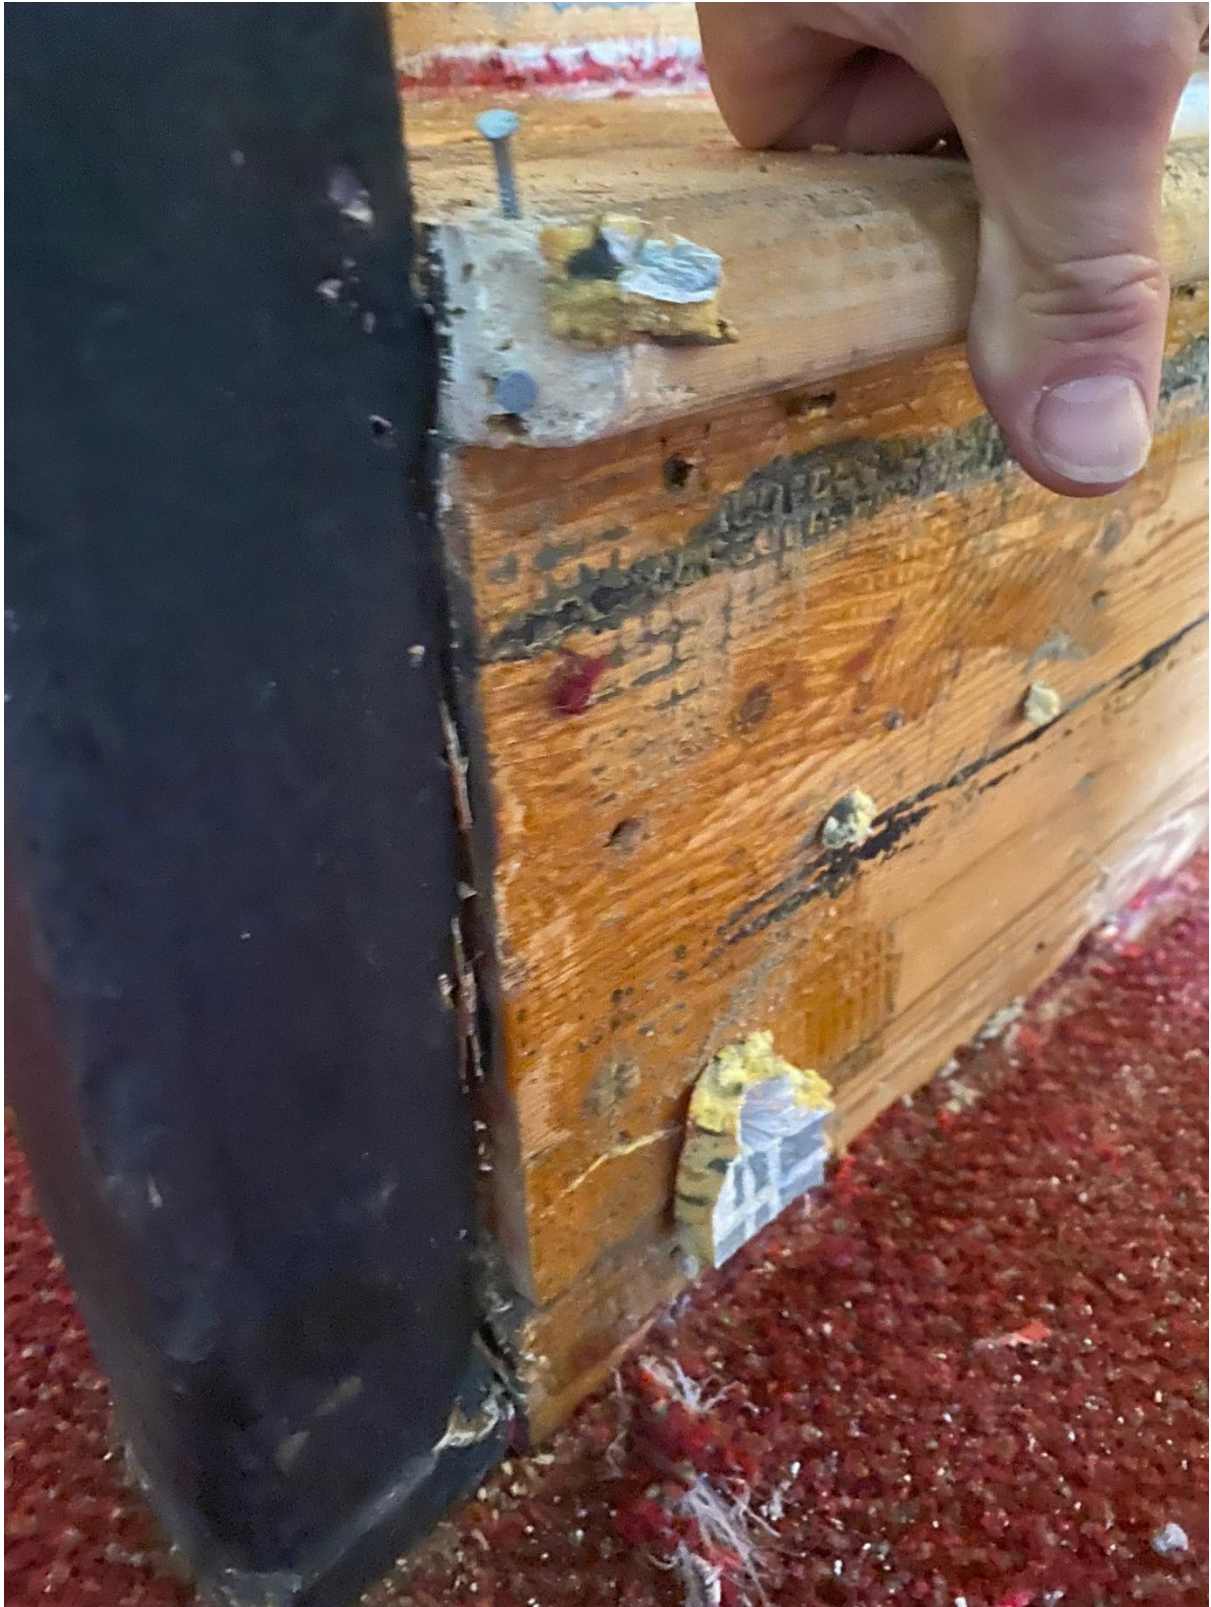
**No2.** This picture indicates how the bottom tread comes in front of the newel, traditionally the original riser would be housed into the centre of the newel post. The tread also extends beyond the newel.

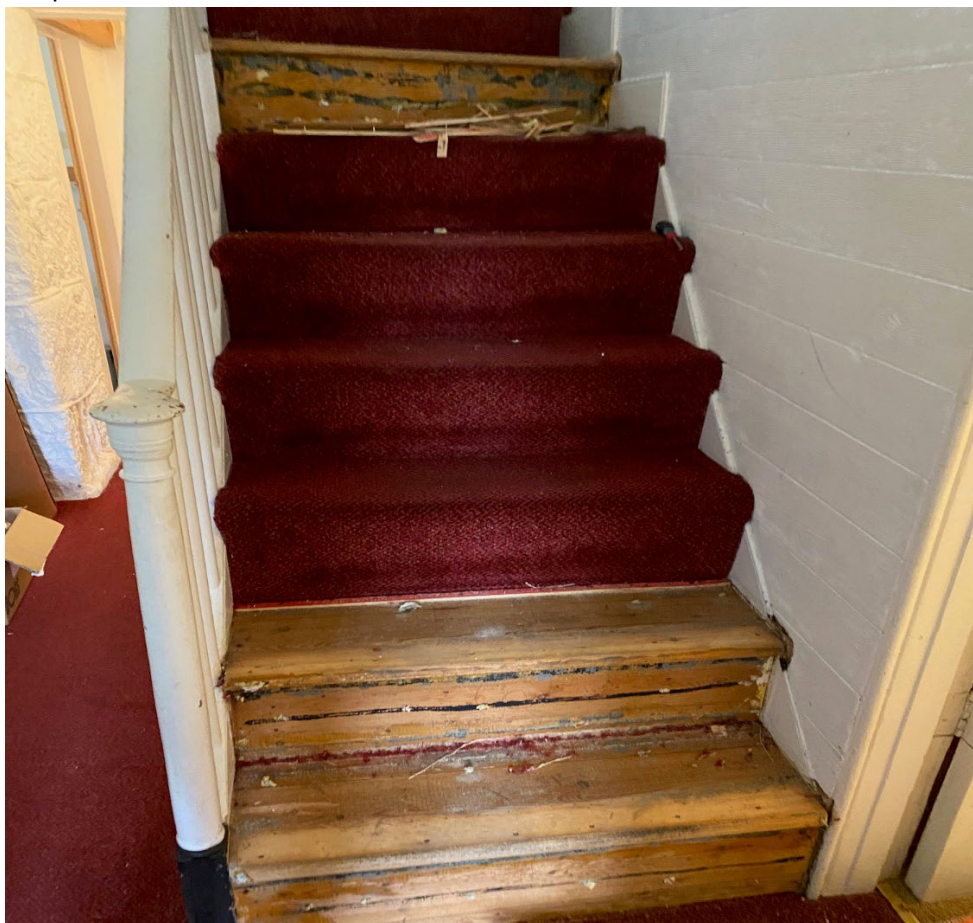
**No3** Existing Stairs ground to first floor with part carpet removed to show construction. Note the original newel post and handrail junction on top of the newel.

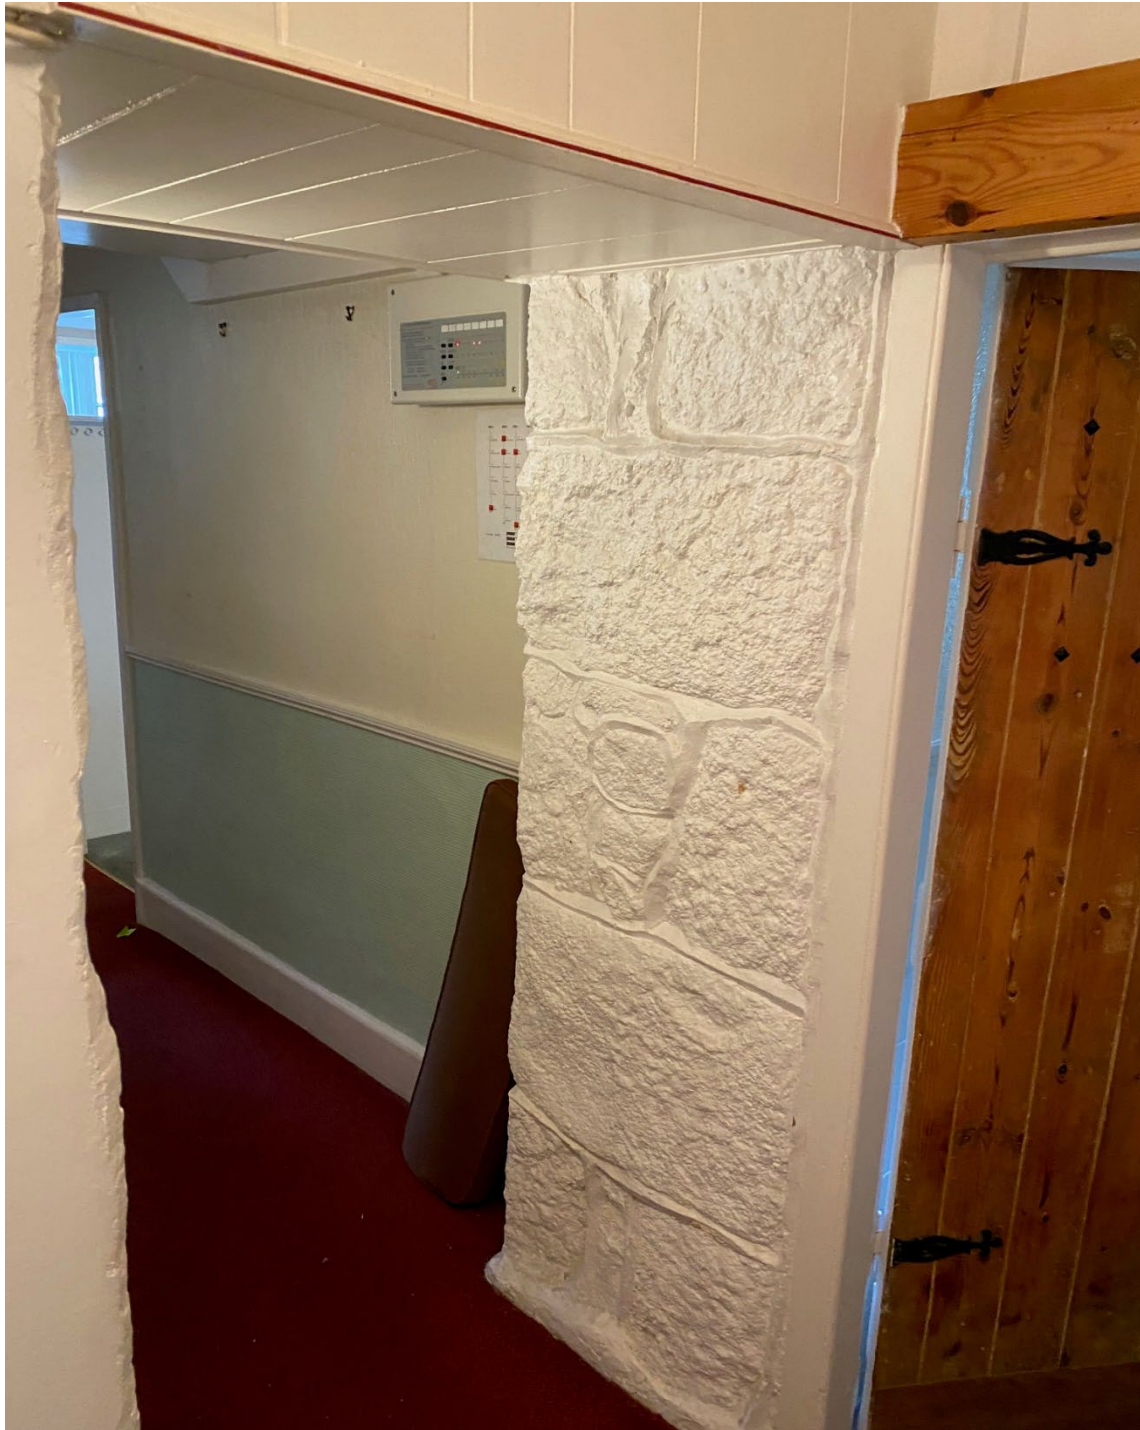
**No4** This is the entrance to the rear extension looking back into the original house, formed through the rear wall of the stair well to provide access to the new rear extensions. The door to the right is the WC in the new extension. This cut through will remain in the new proposal to minimise further demolition of the original rear granite wall.

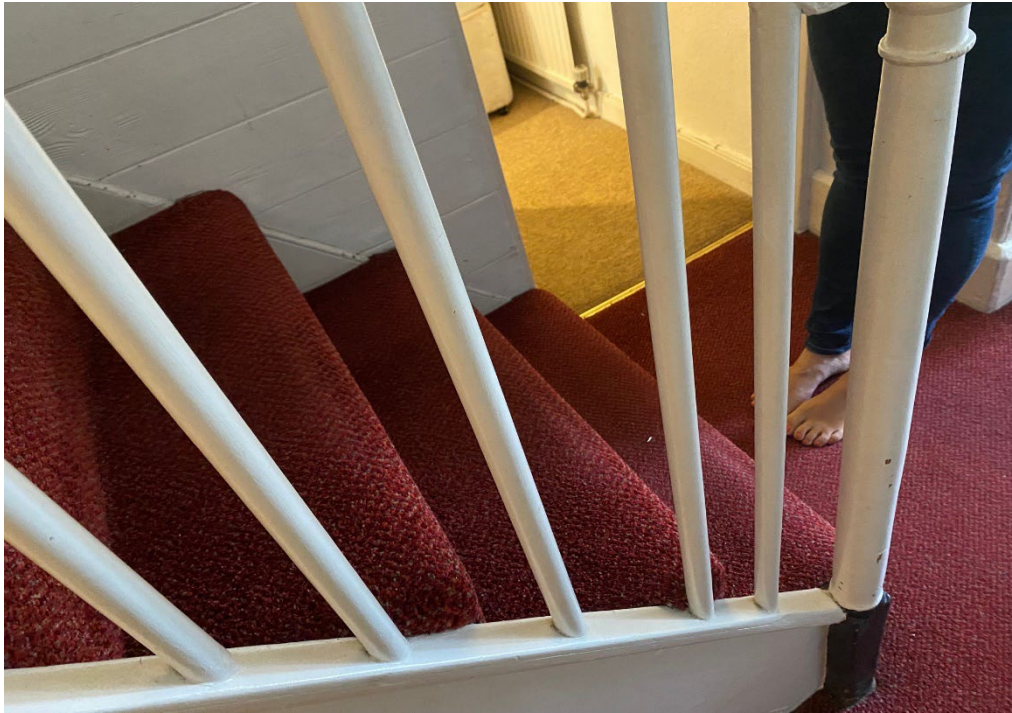
Richard Morris mentions that the balustrades have been formed out of modern dowel of possibly broom stails, these are at irregular spacings. It is also evident that the handrails have been cut and jointed to construct the different runs on both flights using salvaged sections from the original staircase.

**No5** Modern balustrades at irregular spacings.

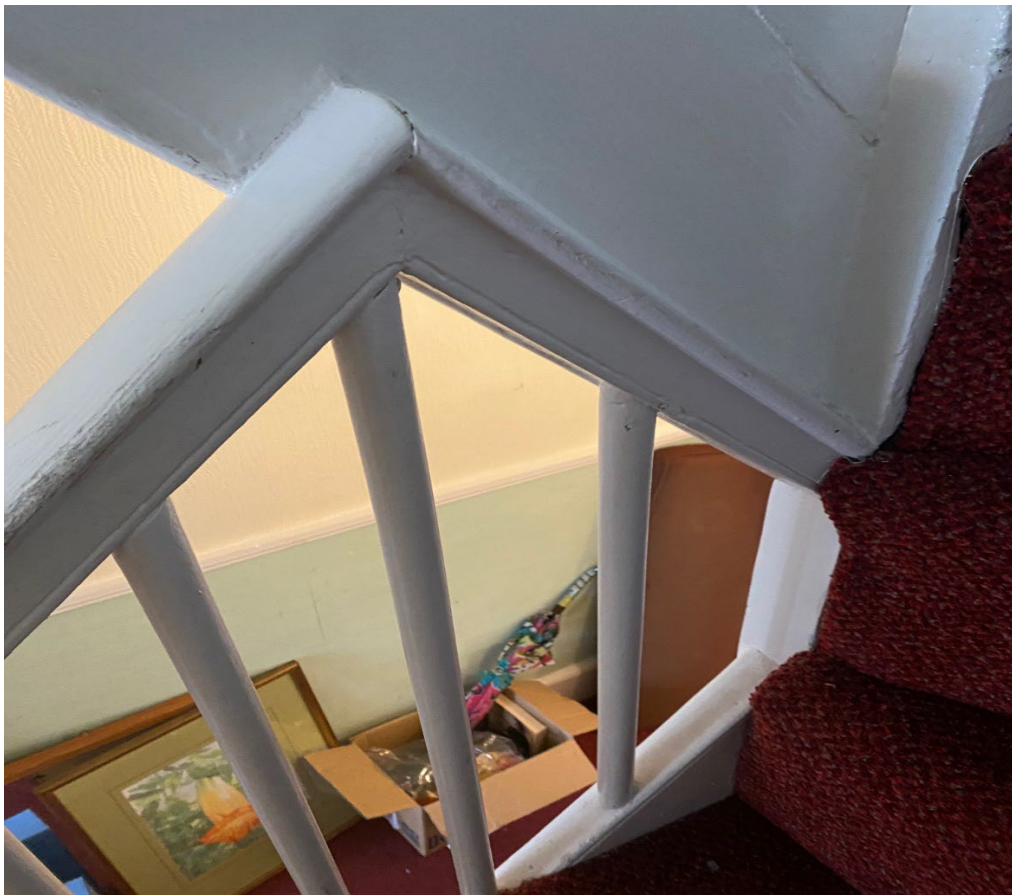
**No6** Pl.12: The base of the main stairs; note odd balusters and boxing. This indicates the retention and re use of sections of the original handrail.

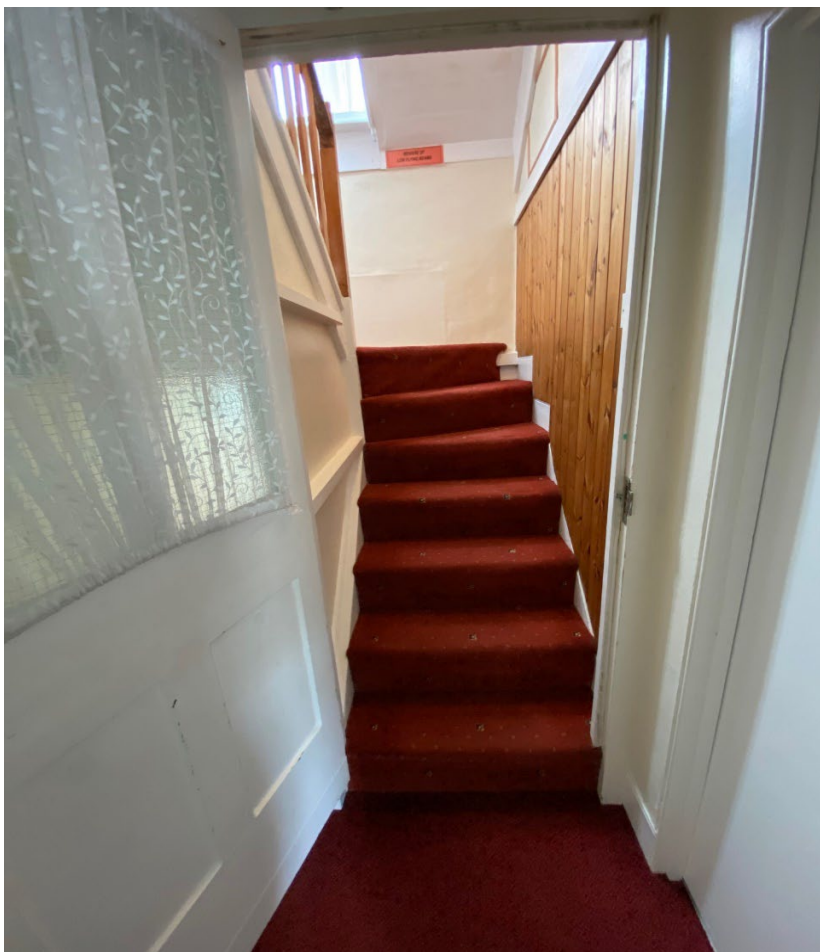
**No7** This picture shows the foot of the stairs up to the second floor. This will be replaced with a straight flight as the floor plans.

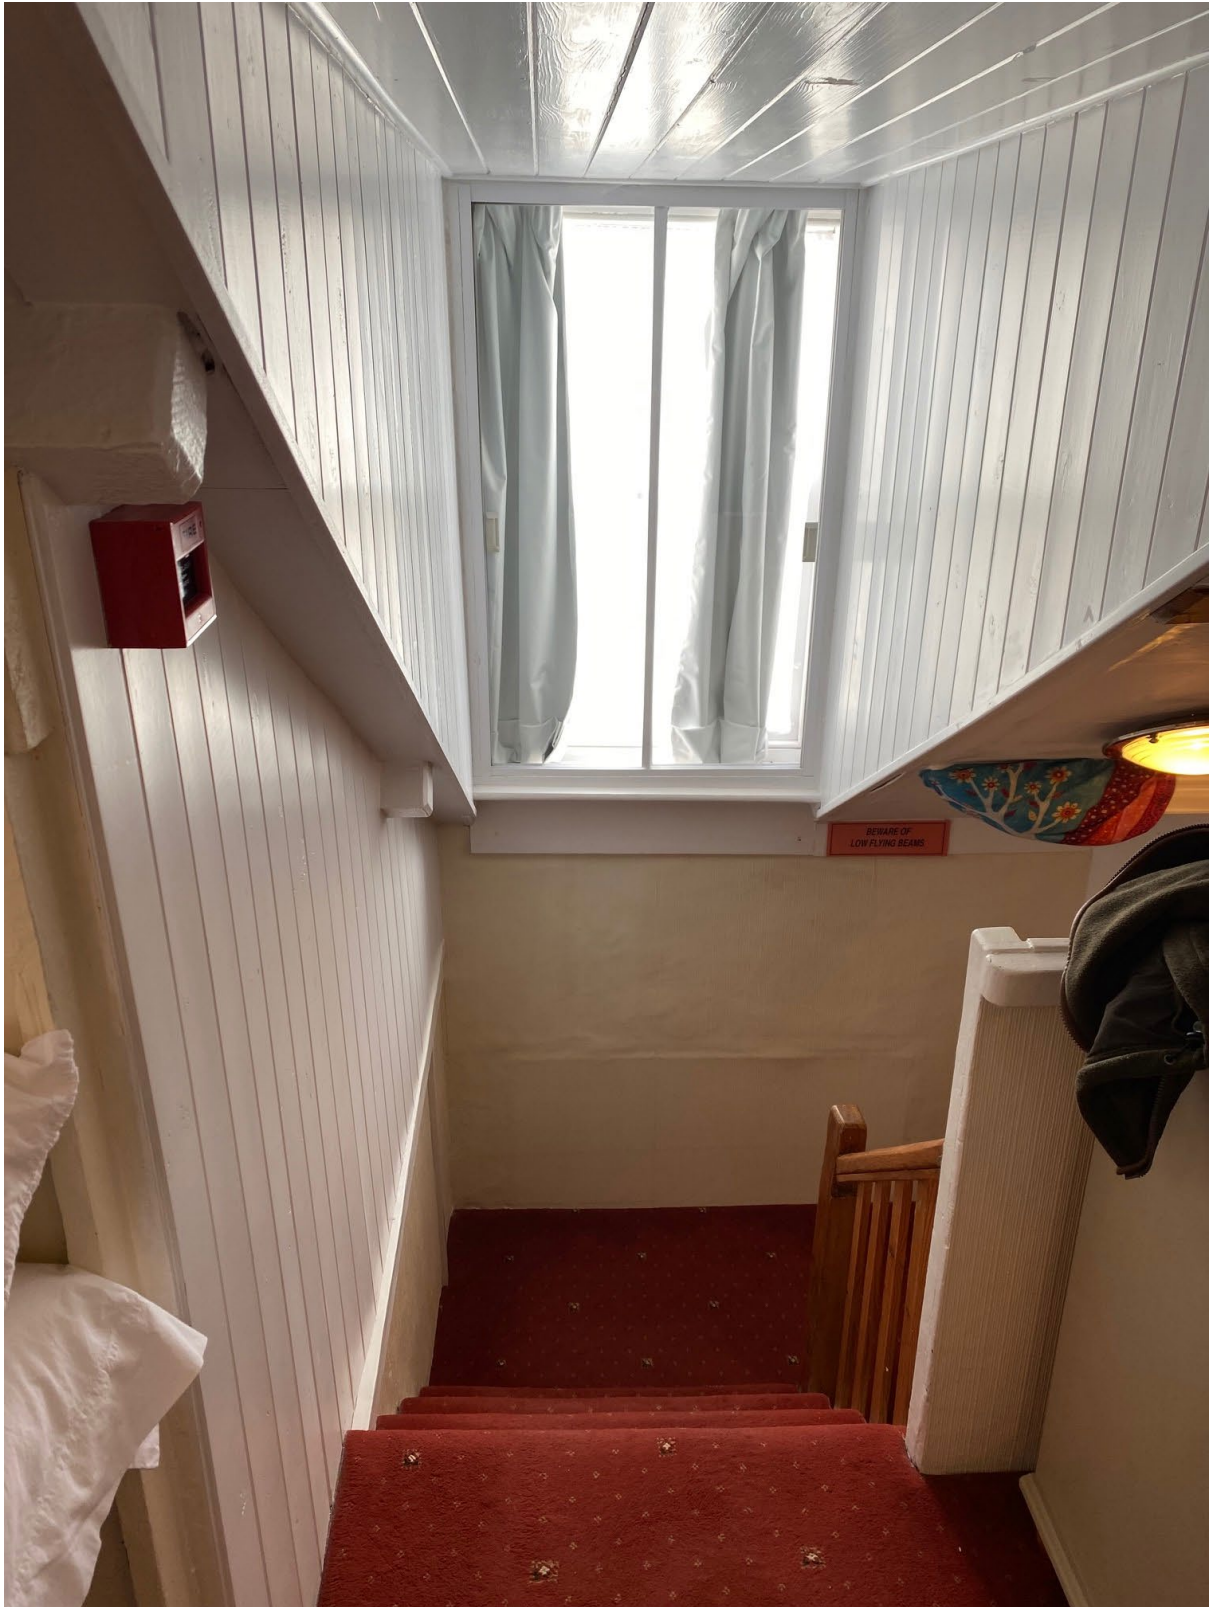
**No8** This is looking down from the second-floor landing. The proposed new staircase will land at the same location and continue down on a single pitch through the quarter landing to the foot as the drawings indicate.

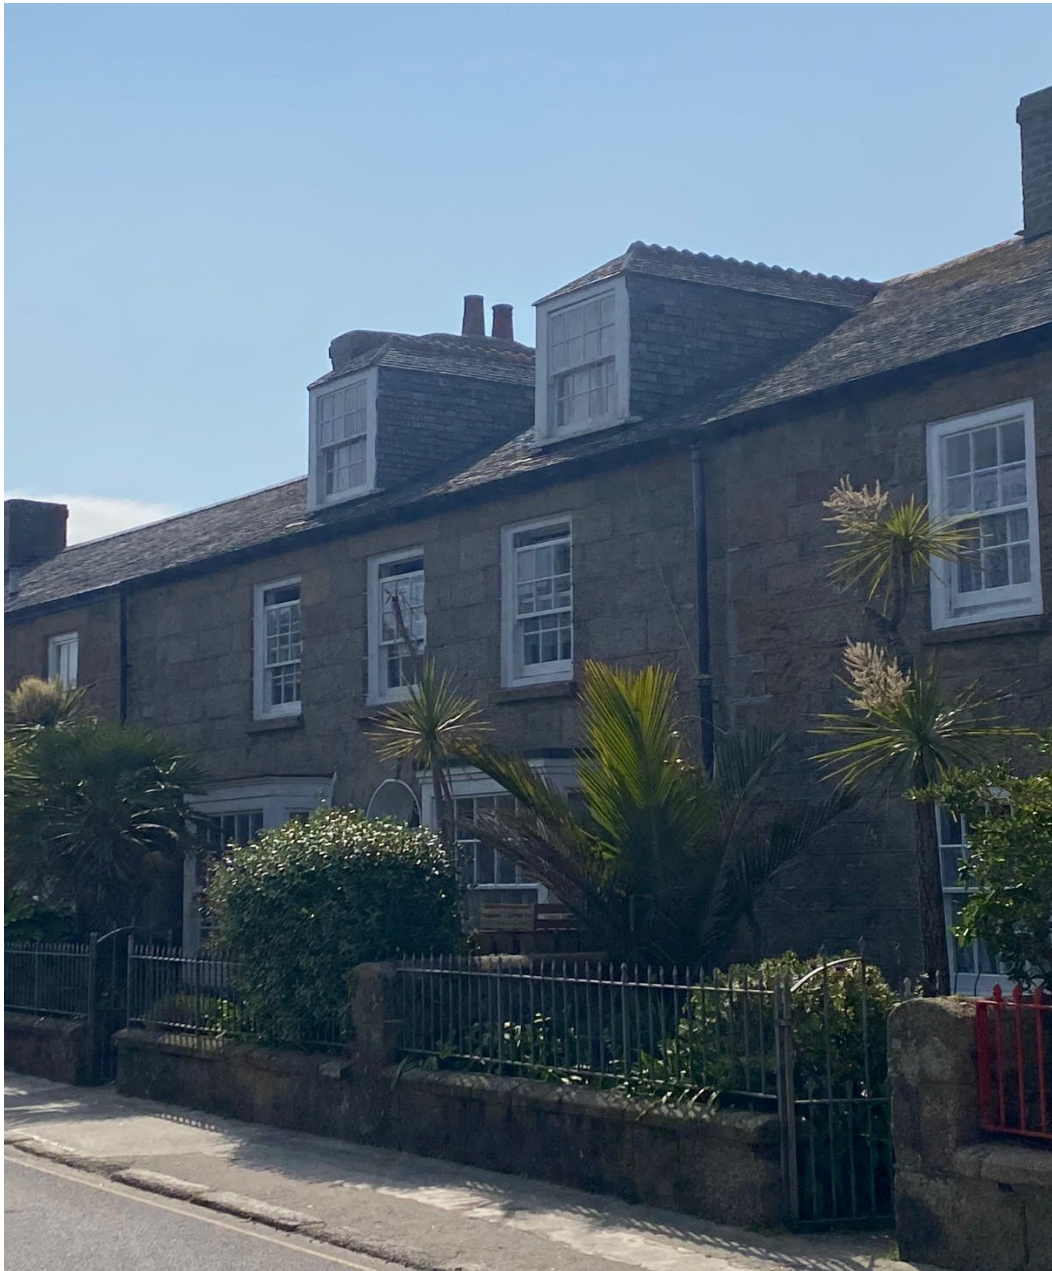
**No9** Front Elevation showing the three first floor windows and the second-floor dormers.

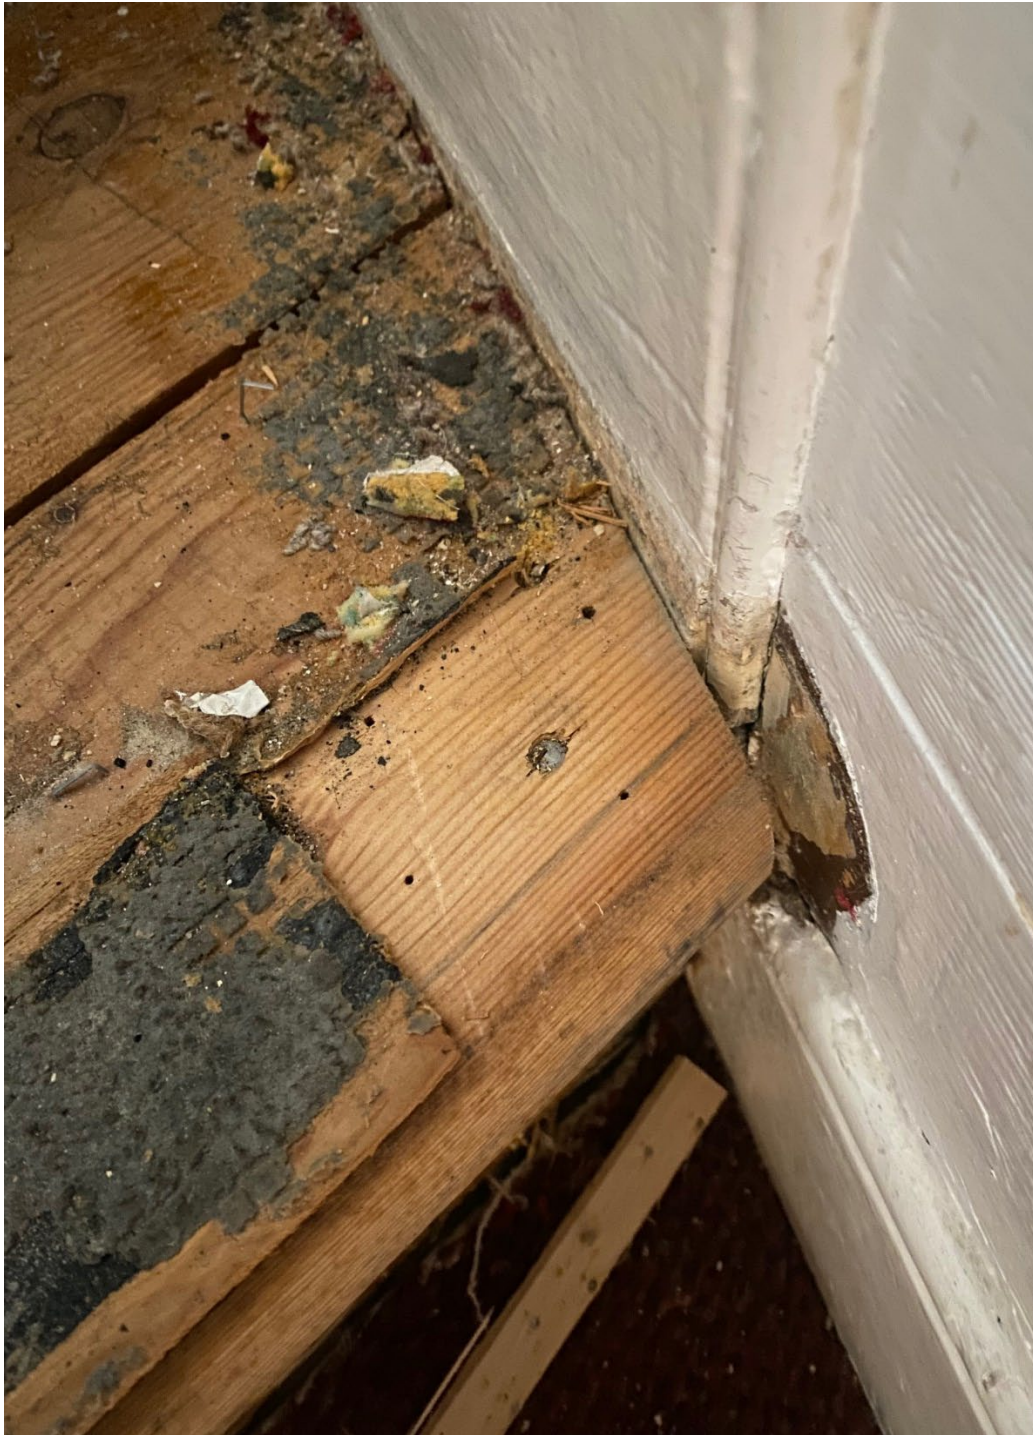
**No10** Tread construction detailing the modern round head nails used

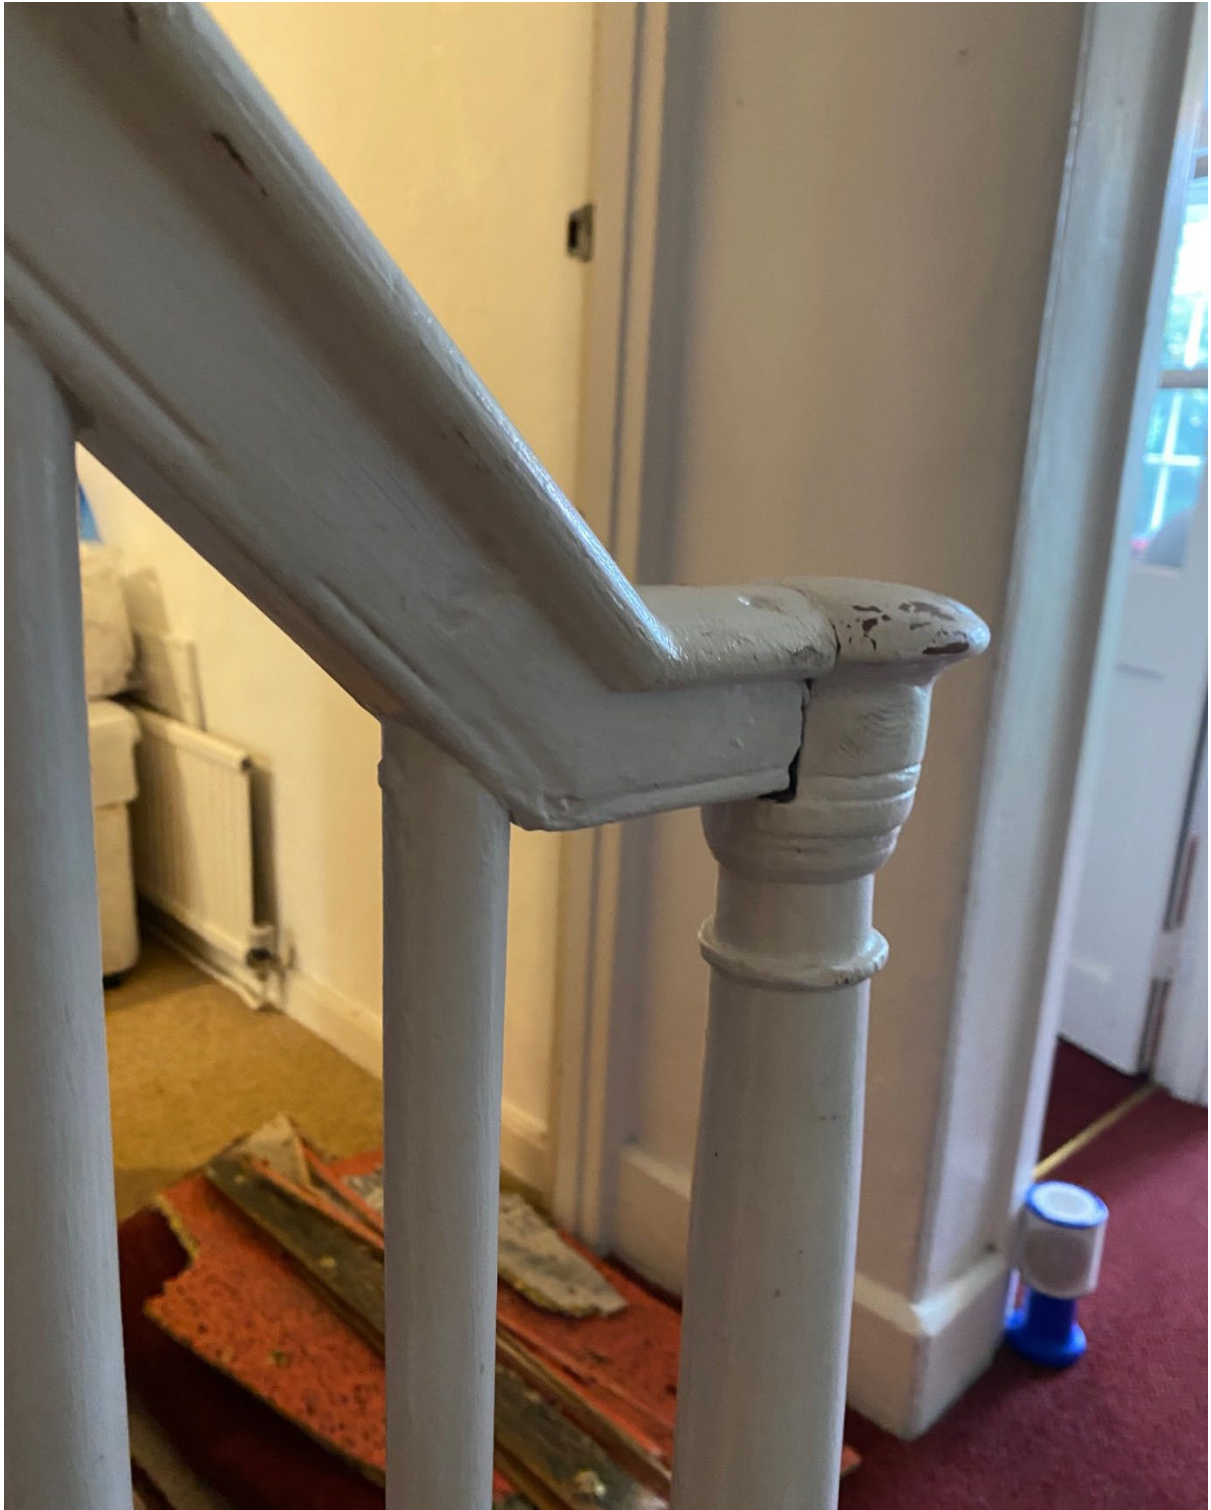
**No11** Newel and handrail detail

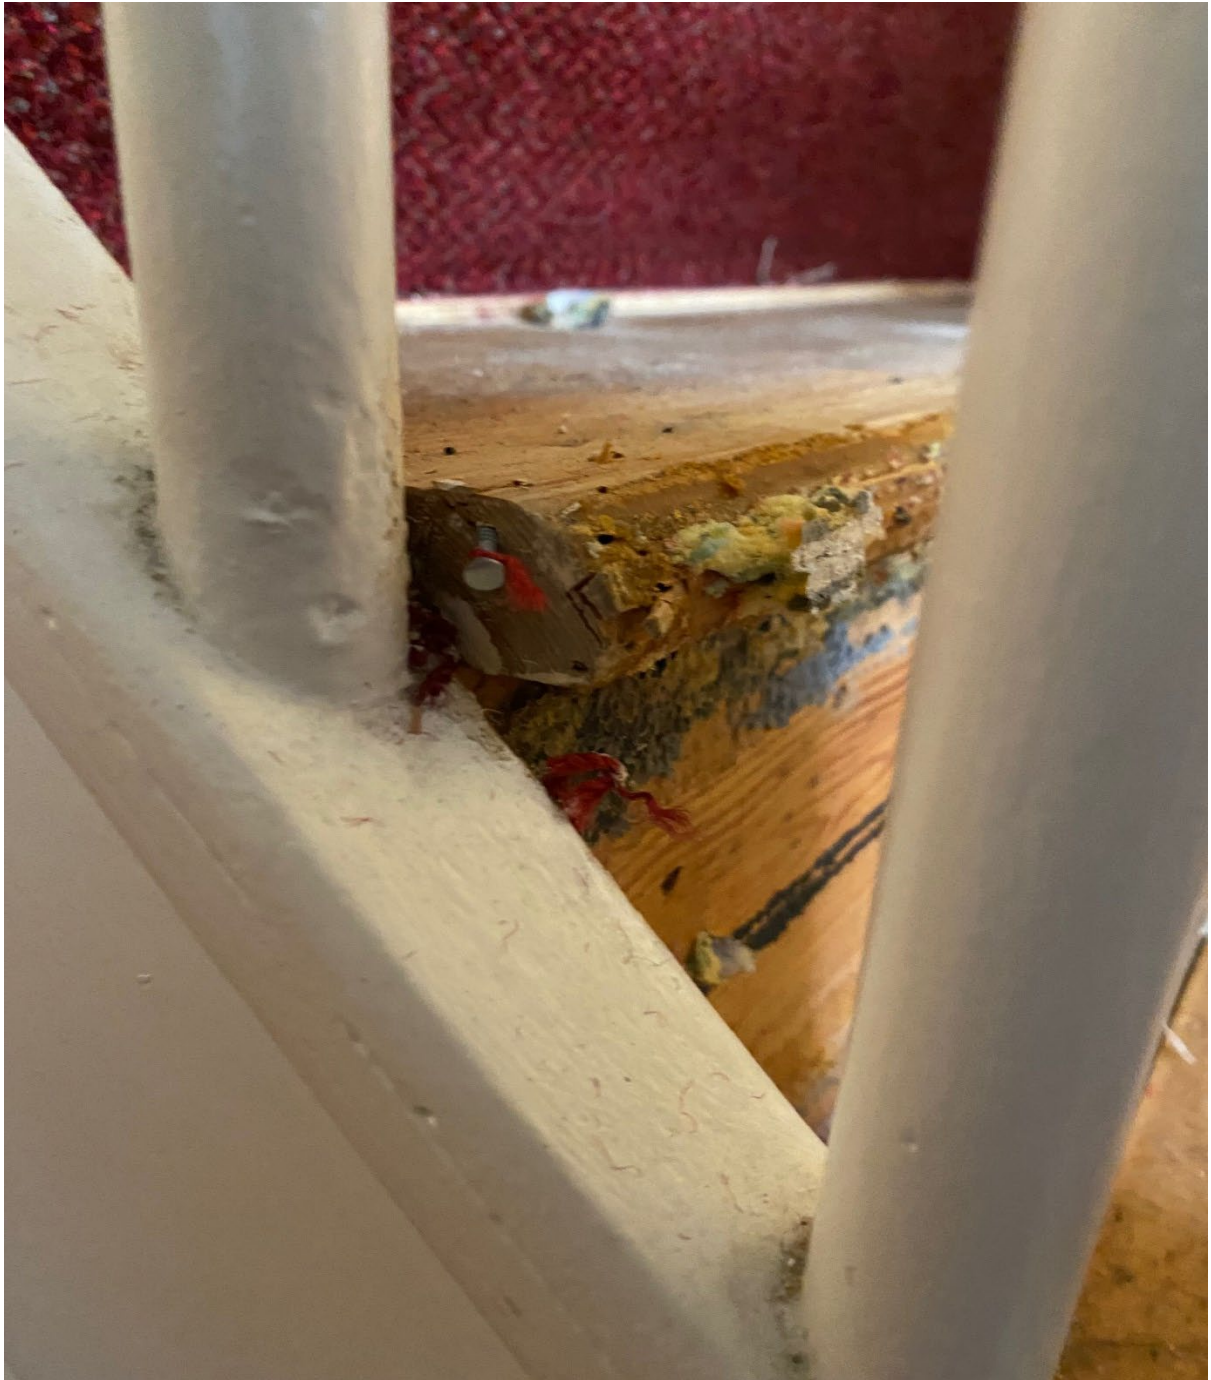
**No12** Tread protruding past the string and modern balustrades

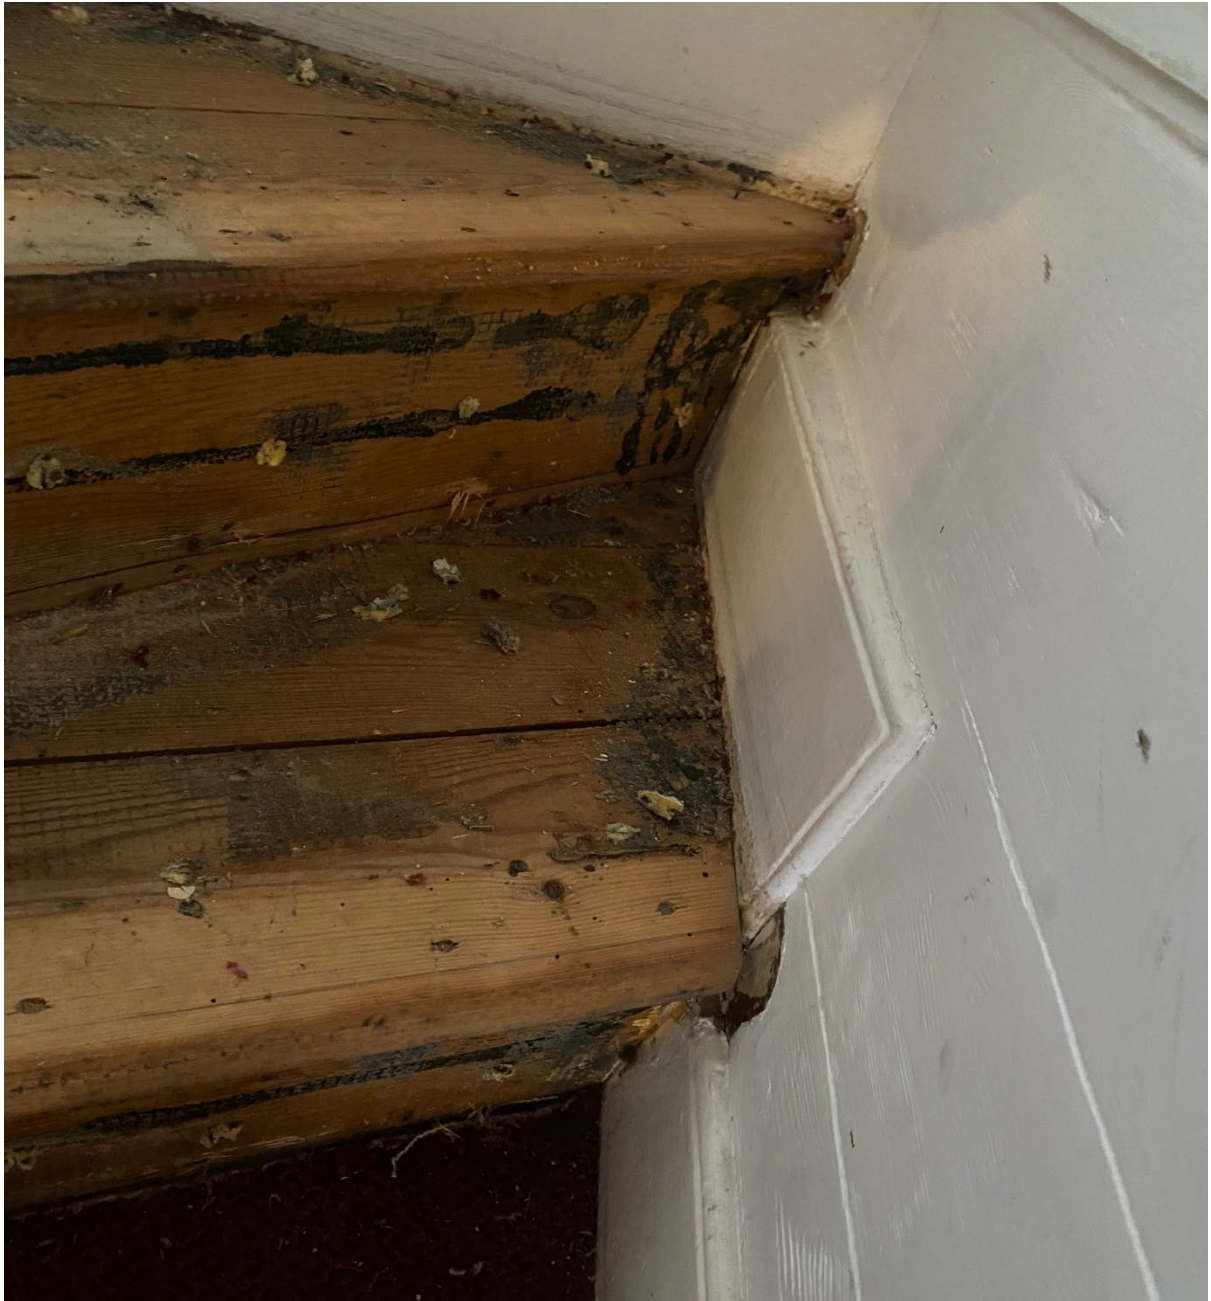
**No13** Winder construction, original wall string on the left wall

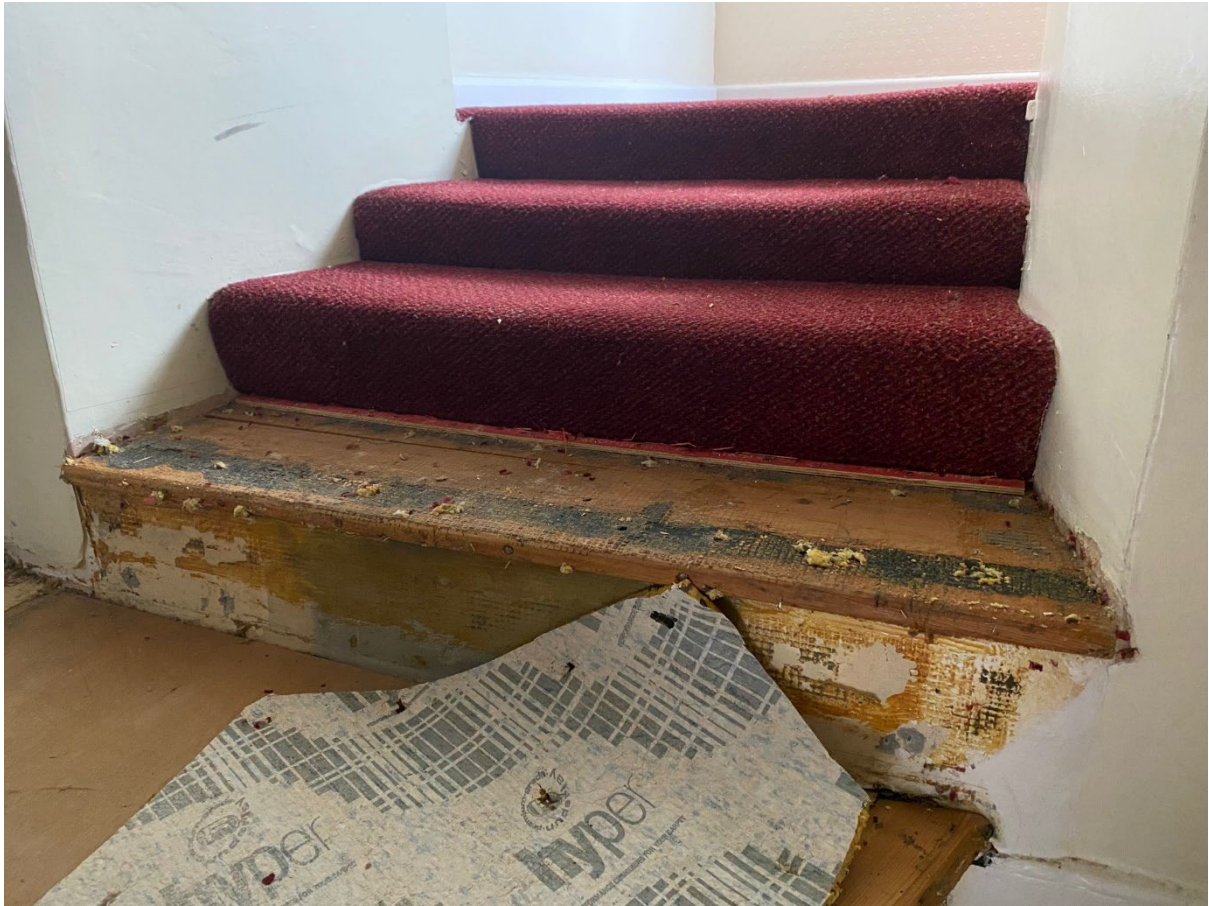
**No14** Steps to rear extension showing the irregular risers and plywood to the landing.
