# PRELIMINARY ROOST ASSESSMENT (PRA)

## 4 PORTHCRESSA TERRACE, HUGH TOWN, ST MARY'S, ISLES OF SCILLY

*Our reference: 23-10-1*

*Report date: 28<sup>th</sup> October 2023*

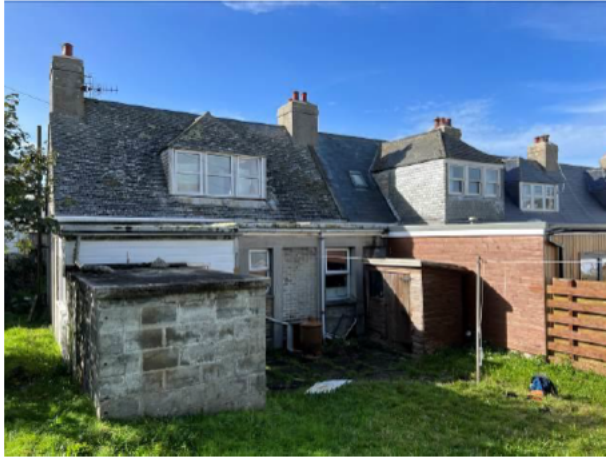
**Photograph 1:** Showing the property – the main property of 4 Porthcressa Terrace spans the length between the two chimneys on the left-hand side. The flat-roof extension can be seen in the foreground with the enclosed water-tank.

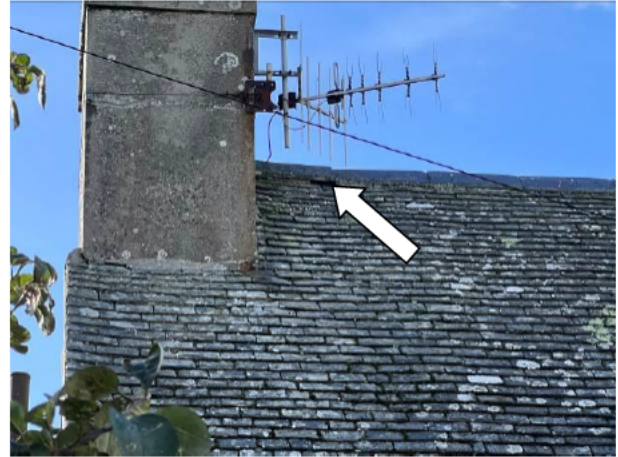
The roof tiles on the eastern aspect are generally in good condition and any gaps present are too small for access by bats. Minor gaps occur at the apex of the dormer and at a ridge tile on the southern edge of the aspect – these appear superficial through inspection with close-focusing binoculars. The join between the roof of this property and the adjacent 3 Porthcressa Terrace is marked by a low concrete parapet – no gaps or other features are noted associated with this feature. There is a concrete chimney at each edge of the roof under consideration – these appear well-sealed and in good condition.

There are minor gaps noted beneath individual ridge tiles on the apex of the dormer and the southern edge of the main roof, close to the chimney. These appear superficial but it is possible that minor niches may occur. In addition, further gaps may appear if the condition of tiles deteriorates between the time of survey and the time of works.

**Photograph 2:** Showing the roof structure – this is largely well-sealed with no gaps noted; however, occasional minor gaps are noted including the gap in the ridge highlighted.

If there are gaps beneath tiles, these tiles and those adjacent to them should be lifted carefully in such a way that if any bats were roosting beneath, they would not be crushed or injured by the action. The undersides of the tiles should be carefully checked before being set aside. Contractors should satisfy themselves that no bats are present before proceeding with works in these areas.

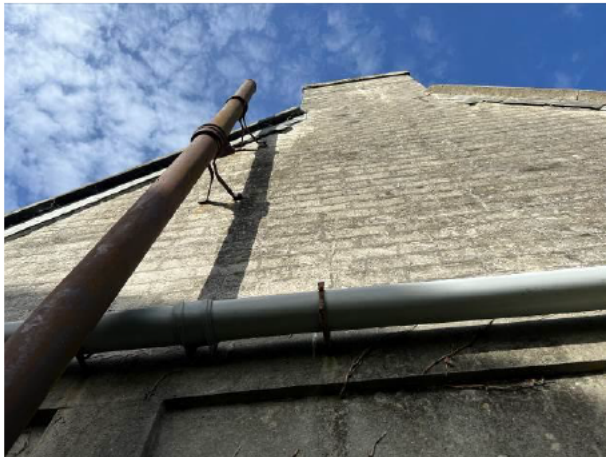
Minor gaps occur behind the drop tiles on the southern gable of the building – these appear superficial through inspection with a torch and close-focusing binoculars.

**Photograph 3:** Showing the southern gable of the property – there are superficial gaps behind the drop-tiles on the eastern aspect, which can be seen on the right-hand side. Those on the western aspect would not be affected.

The following protocol also applies to the drop tiles on the southern gable.

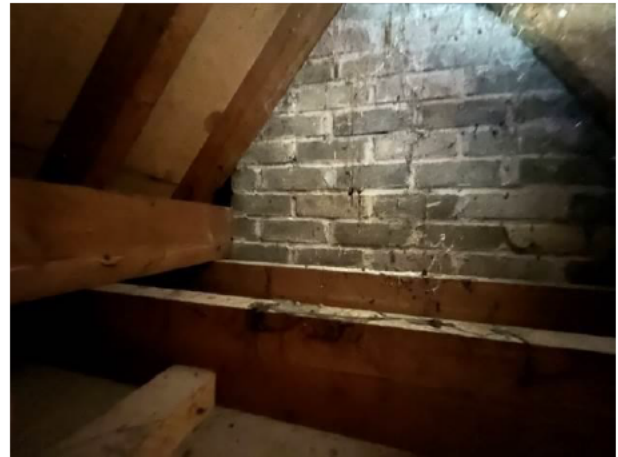
The loft space was inspected throughout – this is a small space built above the collar of the A-frame timbers with the living space built into the lower part of the roof. The loft is boarded out above the rafters and appears very well sealed. There is no insulation present between the joists. The loft space was densely cobwebbed with dusty, old webs indicating no recent flight by bats within the space. A full inspection of the floor identified no droppings or other evidence of bats – individual small rodent droppings were noted.

**Photograph 4:** Showing the loft space with boarding visible between the rafters.

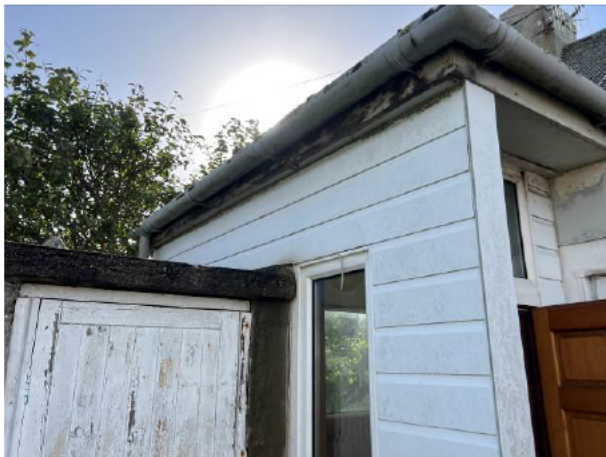
A flat-roof single-storey extension is attached on the eastern aspect of the property. This is block-built and uPVC-clad in places. No features were noted associated either with the pointing or the cladding. Window frames are well-fitted with no gaps noted at the edges.

The fascias throughout the flat-roof extension are well-fitted and tightly sealed. In places, there are small gaps behind the roof cladding where it overlaps the top of the wall; however the guttering attached to the fascia below would prevent a clear fly-in and would significantly

**Photograph 5:** Showing the flat-roof extension with uPVC cladding.

There are occasional gaps where the fascias and the overhang of the roof covering meet the walls. Where these are to be removed or impacted as part of the proposed works, they should be carefully removed and the gaps behind them exposed in such a way that, in the highly unlikely event that bats are present, they are not injured or killed by the action. Contractors should satisfy themselves that no bats are present before proceeding with works in these areas.

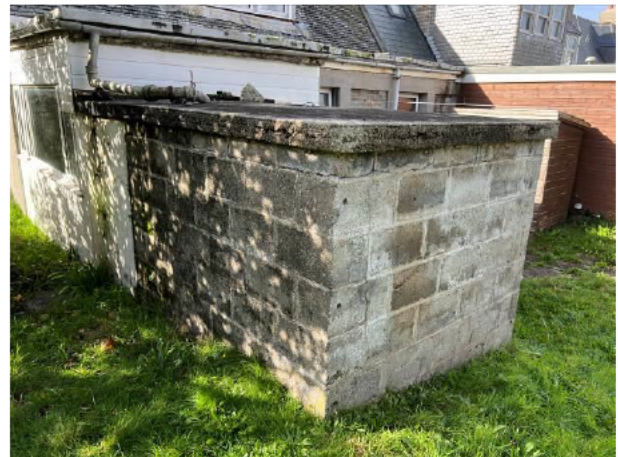
There is a flat-roofed water tank enclosure attached on the eastern edge of the flat-roof extension. This also houses a small shed/garage unit which was accessed and inspected and found to provide no roosting opportunities.

The structure did not have any gaps, cracks or other features which would provide roosting opportunities for bats.

**Photograph 6:** Showing the enclosed water tank.
