HERITAGE APPRAISAL

PROJECT: REFURBISHMENT AND ALTERATIONS . BISHOP & WOLF . HUGH ST, ISLES OF SCILLY, TR21 0LL
PREPARED BY: SAM MAYOU PGDip Arch Cons

REPORT NO: 3258.HIA.01

VERSION: 1 ISSUED: APRIL 2024

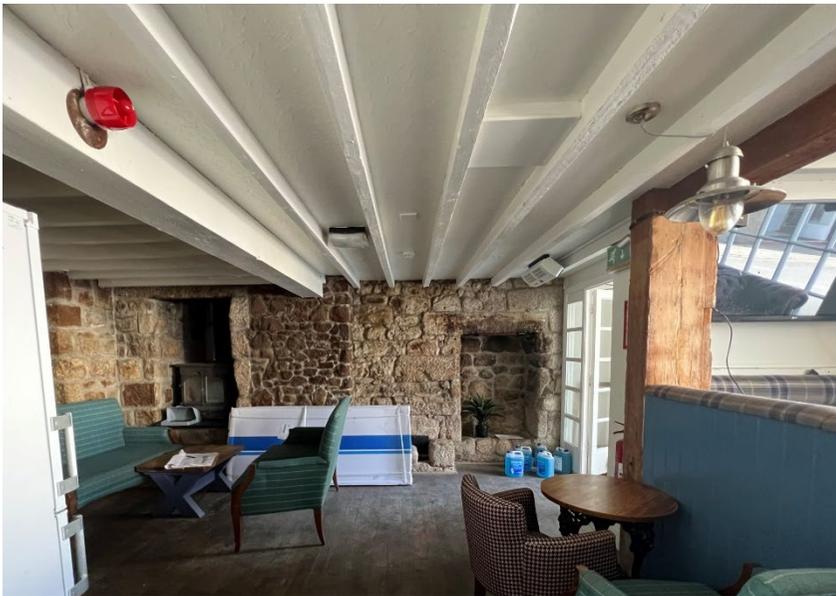
Fig 22 Main Range, Ground Floor – internal view of western gable. Note apparent former fireplace/range apertures in stone work. All timber elements are 'false' or introduced during the mid-late C20.

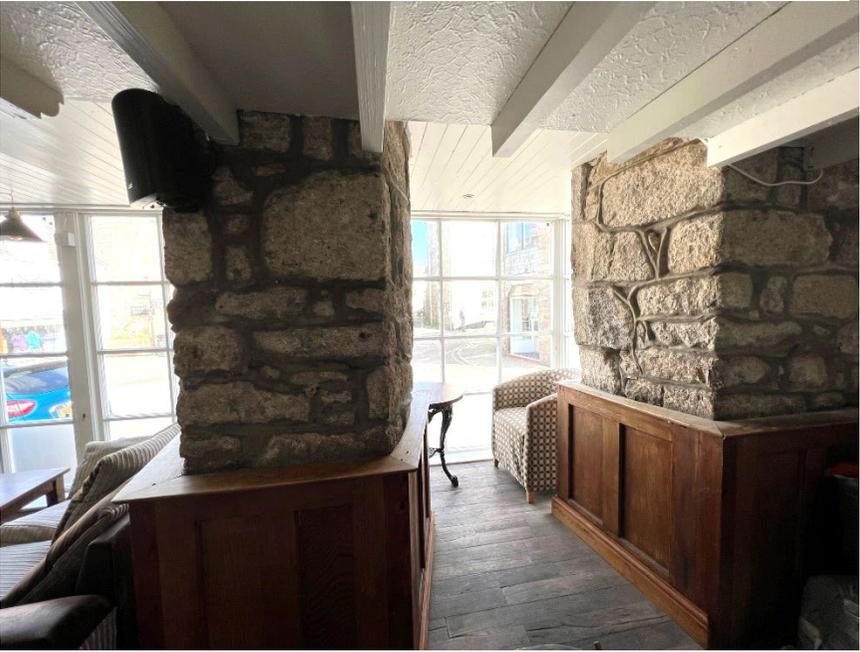
Fig 25 View toward eastern end of 'shopfront' extension including remnants of largely removed front wall of the Steward House. Note unsupported ends of false ceiling timbers

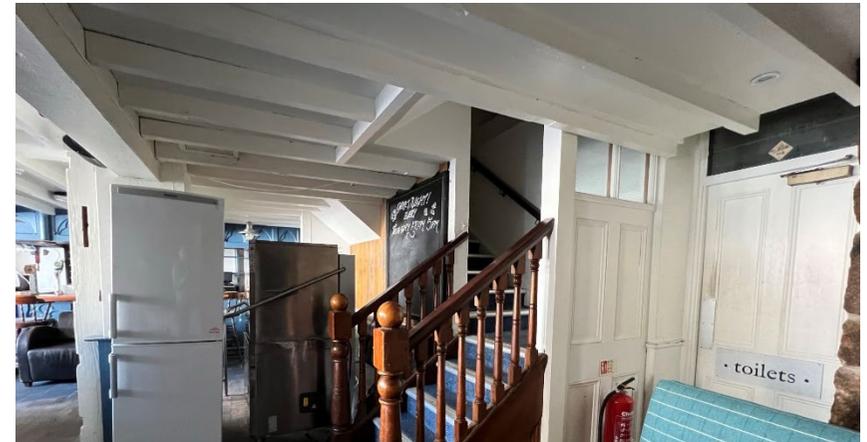
- 4.3.16. The staircase to the first floor was found to be of late C20 construction and set at a right angle to where architectural convention suggests the lower leg of the house's original (c.1744 rebuild) stair would have been positioned.

Fig 27 Main Range, Ground Floor – foot of stair. A clumsy arrangement of faux and reclaimed historic elements creates a confusing narrative. The ceiling is littered with false beams and 'aertex' textured plasterboard panels potentially hiding issues requiring attention.

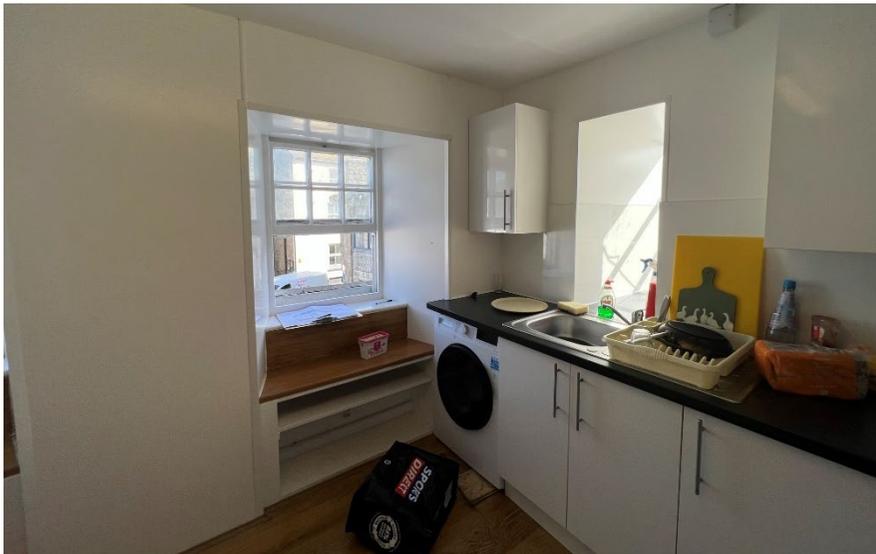
Fig 28 Main Range, First Floor northeast corner – recent kitchen installation in former Manger's Sitting room. Fixtures and fittings, including hygienic wall linings, have been installed over existing wall finishes, left in situ.

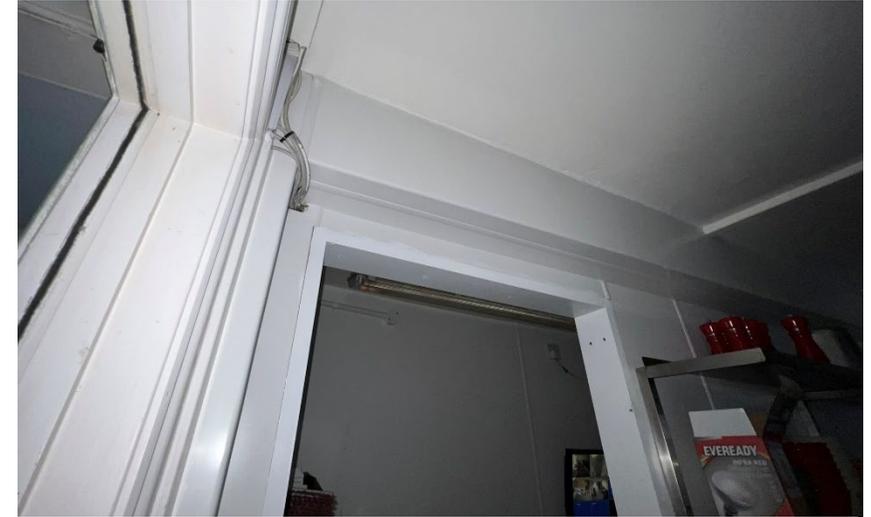
Fig 29 Main Range, First Floor centre, east. Recently added partition to commercial kitchen to create 'office' area.

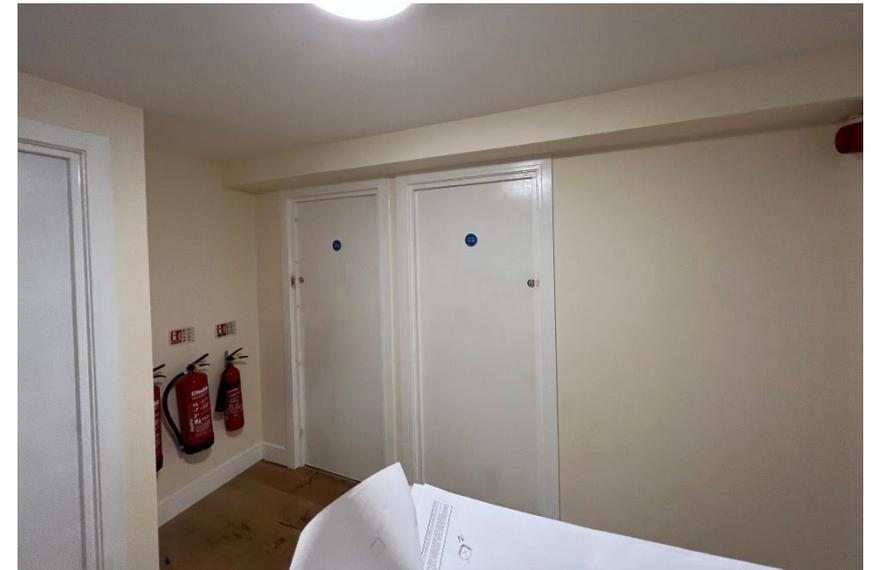
Fig 30 Main Range, First Floor centre, west (view from south) showing recently added partition walls to former Pub Dining Room to create staff bedrooms.

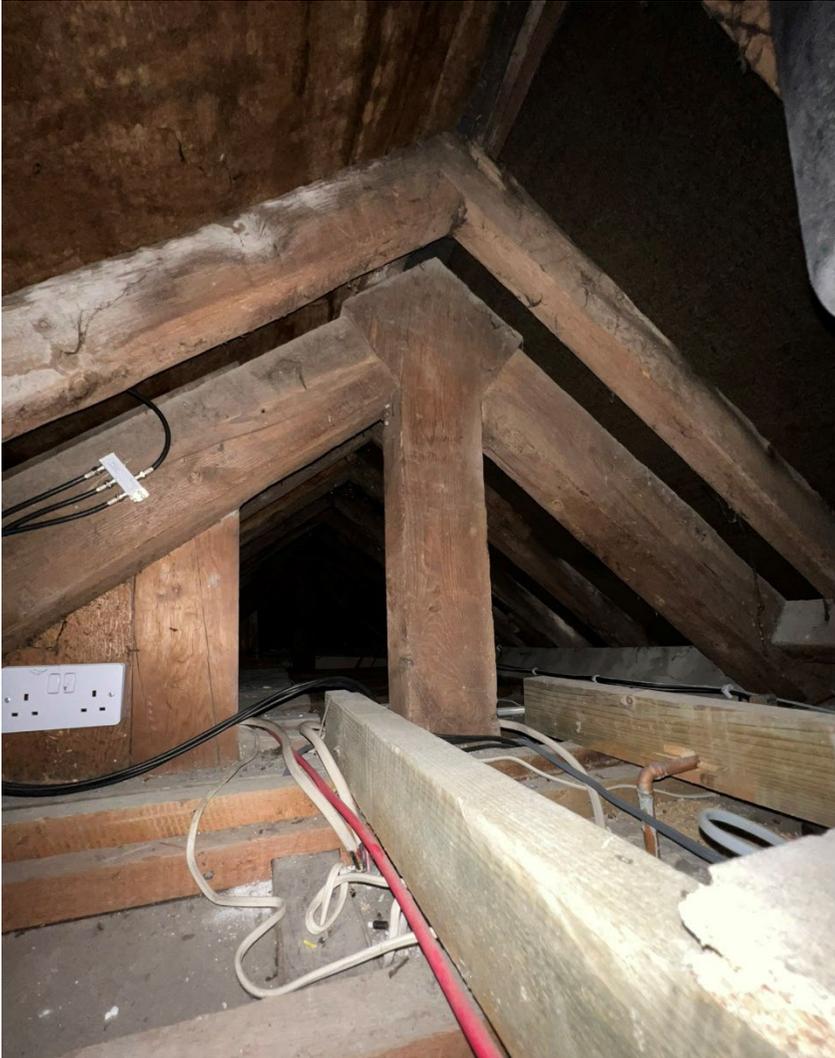
Fig 37 Roof structure within small attic apex void, showing unusual arrangement of structural elements with modern ceilings

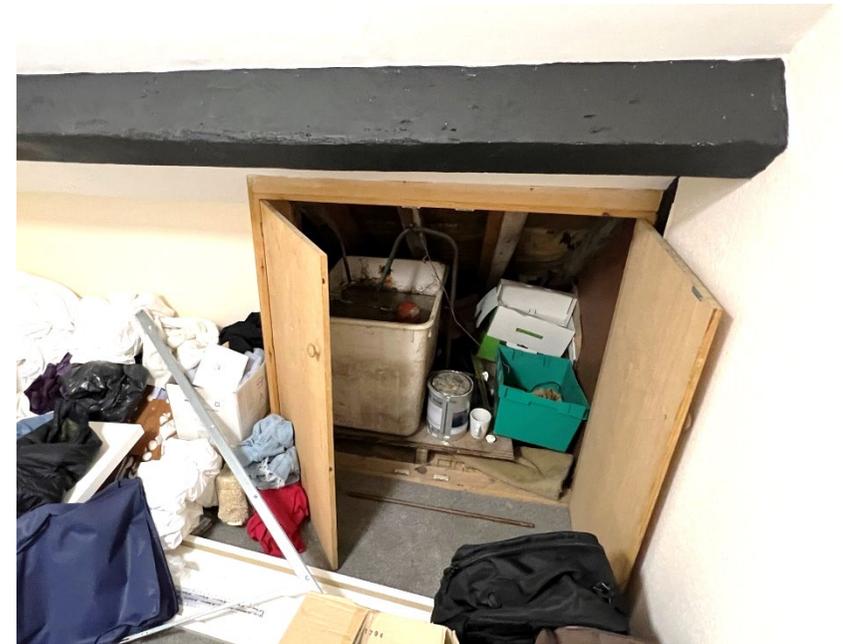
4.3.45. A storage void toward the eaves of the rear roof slope reveals evidence of limewashed rafters, hinting at a layout before the current one was formed.

Fig 38 Second Floor eaves void within landing/bedroom lobby, with purlin exposed and evidence of limewashed rafters

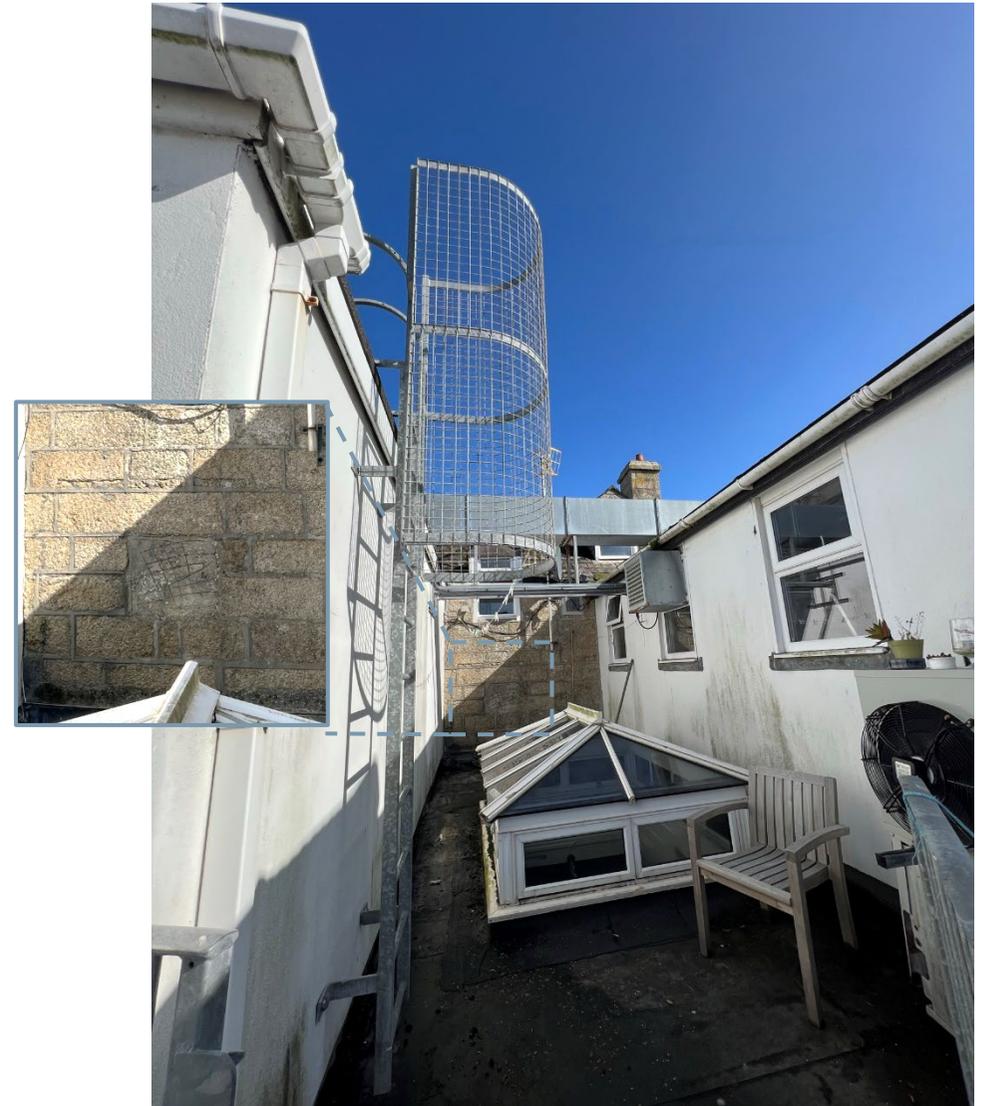
- 4.3.48. Evidence of a former, now infilled, window opening in the rear elevation of the main range, was noted above the ‘single storey ‘Pool Room’ flat roof extension – coinciding with a window captured in historic photography. The infill has been completed with stone presumably salvaged from somewhere else in the building, such is its aesthetic match to the surrounding masonry.

Fig 39 Main Range rear elevation over ‘Pool Room’ extension with evidence of former window opening (and subsequent service duct now infilled) highlighted. Note accumulation of extract and cooling equipment and maintenance/attic fire escape ladder

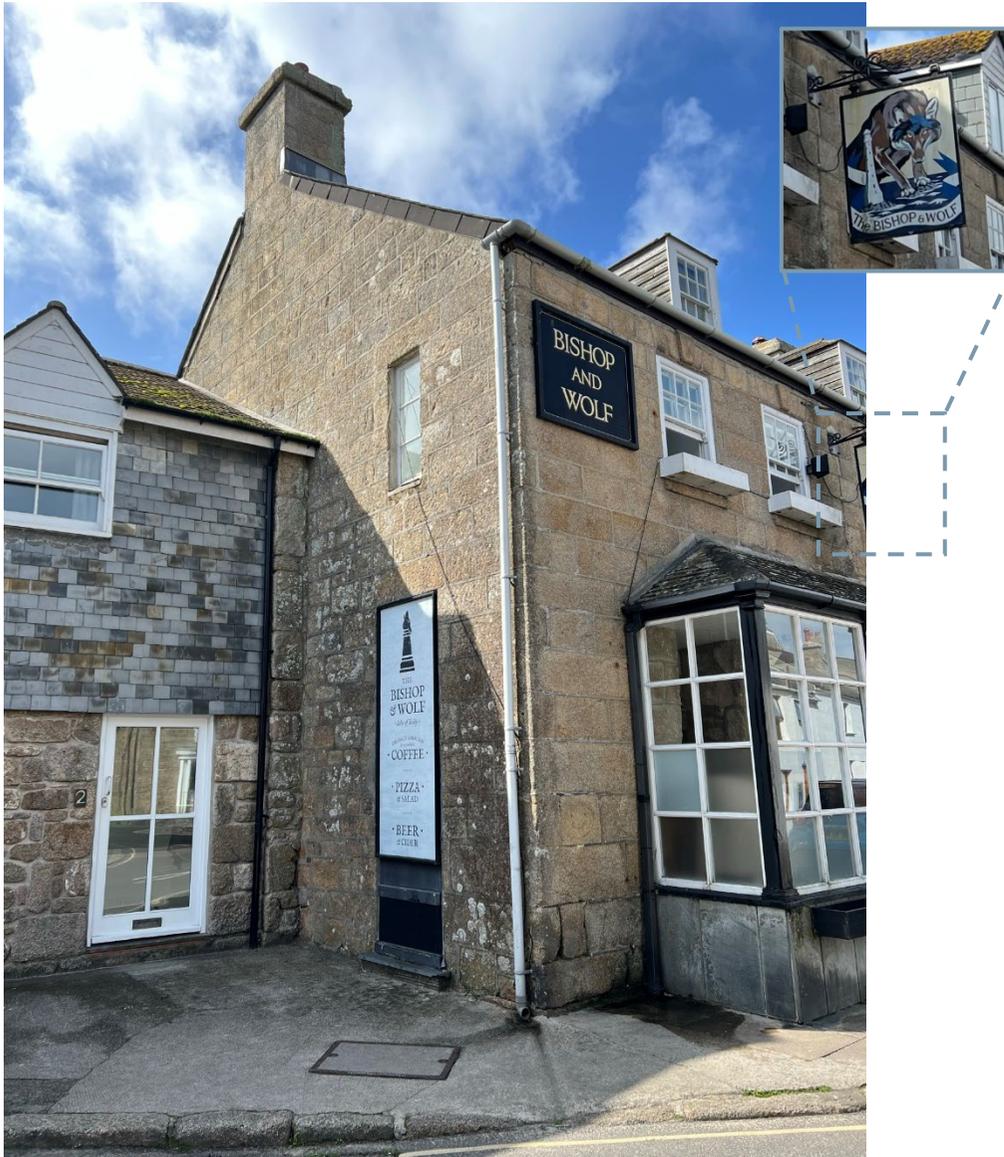
Fig 40 Main Range eastern gable. Note former ground floor window of gable, subsequently converted to door in c.1958 scheme and subsequently re-filled with infill panel and signage finish. Note swing sign of front elevation carries 'Wolf' image on eastern side

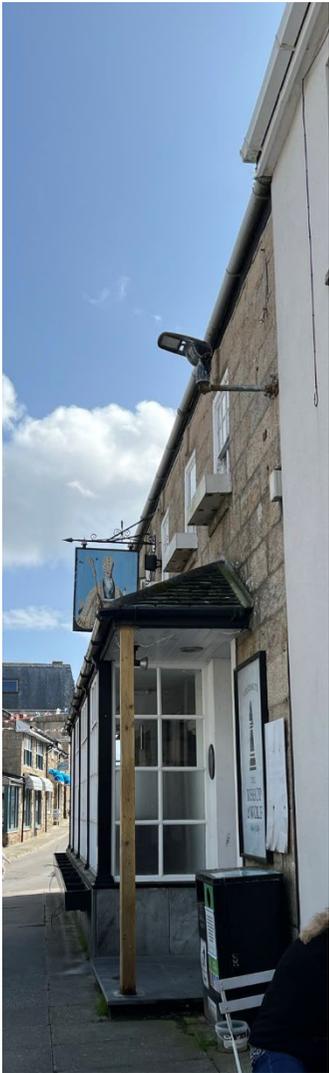
Fig 42 Main Range front elevation from west highlighting temporary repair of canopy over front door. Note swing sign of front elevation carries 'Bishop' image on western side
