PRELIMINARY ROOST ASSESSMENT (PRA)

GUTHERS,
ST MARY'S, ISLES OF SCILLY

Our reference: 24-7-4

Report date: 20th July 2024

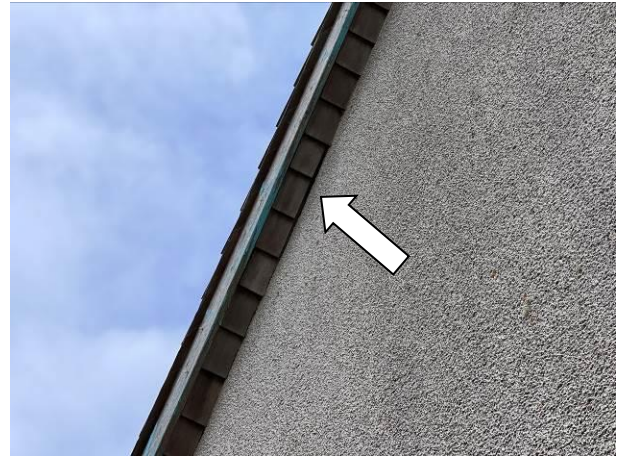
There are cedar shingles on the underside of the gable overhang on both aspects and occasional gaps occur between the shingle and the gable wall which may provide access to roosting opportunities.

Photograph 2: Showing the cedar shingles lining the overhang on the gables – an example of the potential access points between the wall and the shingle is indicated.

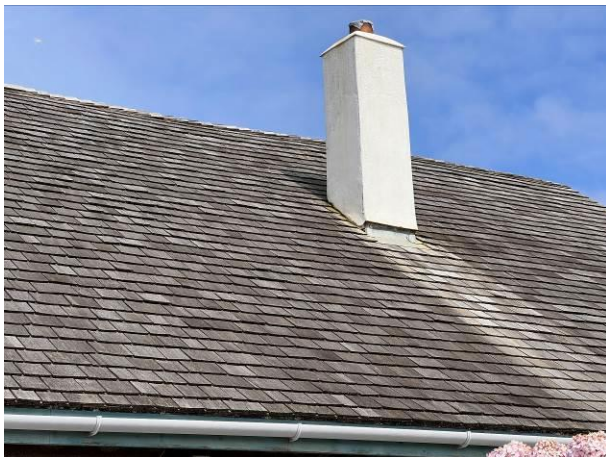
There is a rendered chimney set within the western pitch of the roof – the junction with the cedar shingle roof is sealed with flashing which appears to be in good condition.

Photograph 3: Showing the chimney set within the shingle roof

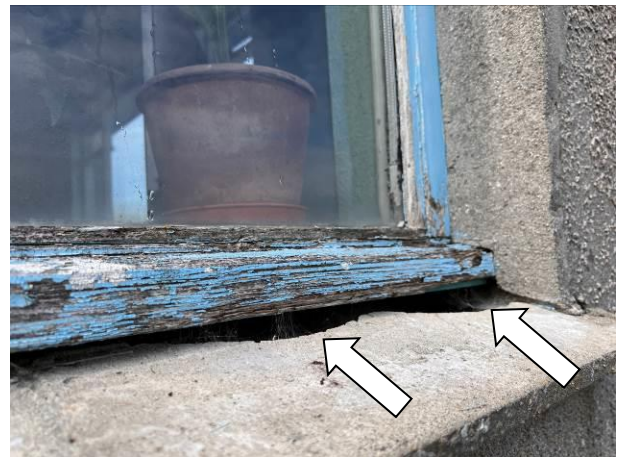
Photograph 4: Showing the potential access to the cavity wall below the window frame on the south-eastern corner of the property

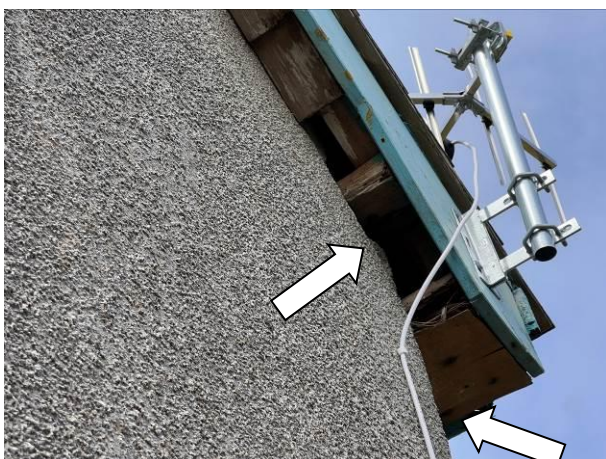
There are soffits running along the eaves and a fascia board on the gable at the roof verge. The soffits are generally well-fitted with the exception of the south-eastern corner where a gap is present allowing potential access for bats or nesting birds to utilise roosting opportunities associated with the void. There is a gap behind the fascia on the gable on this same corner which would similarly provide access to roosting opportunities.

Photograph 5: Showing the damage to the gable fascia and eaves soffit on the south-eastern corner of the property

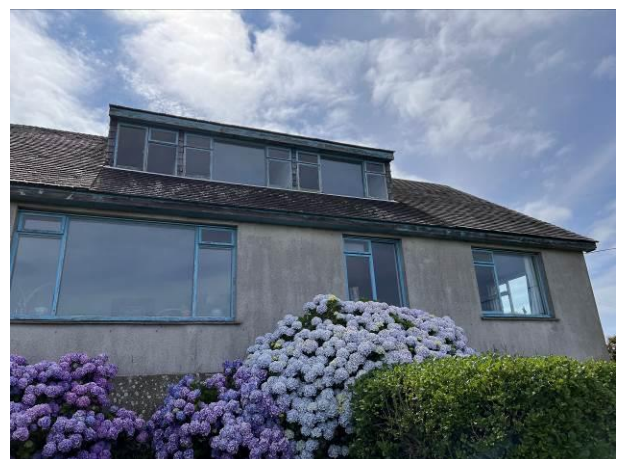
The soffit on the existing dormer on the eastern aspect of the property is well-sealed and the shingle tiling both on the roof and on the sides of the dormer appear to be in a similar condition to the remainder of the roof, offering only minor, superficial gaps. There is flashing at the apex of the valley junction between the dormer and roof which appears to be well-fitted.

Photograph 6: Showing the dormer window set within the eastern roof pitch of the property

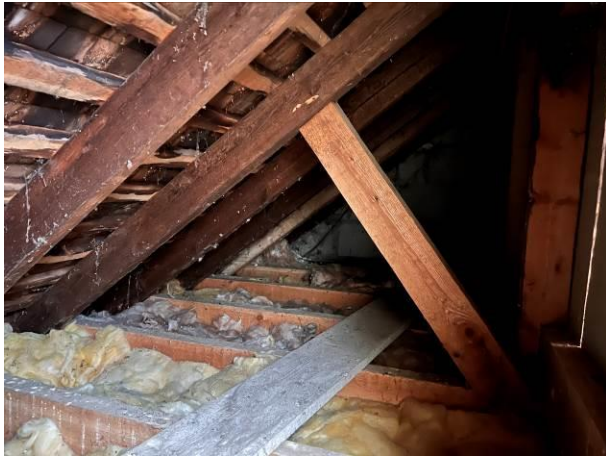
There is no underfelting in the property with tiles attached directly to battens and visible from the internal inspection. There is insulation between the joists in places, and the breeze block gable walls are visible – these appear well-pointed internally. The eaves voids were fully accessed and inspected for evidence of roosting bats – no droppings or other evidence was identified although rodent and bird droppings were identified confirming the scope for access

Photograph 7: Showing an example of the soffit voids within the property – the cedar shingles directly attached to the roof battens are visible

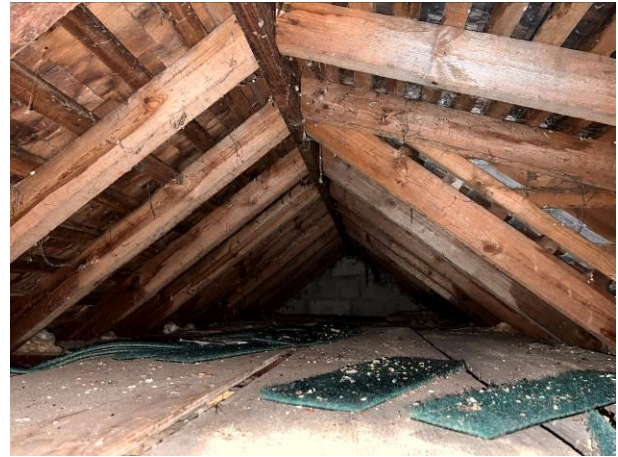
to the voids. Daylight visible between gaps in places further supports this. The apex void was viewed from a hatch but could not be fully accessed for inspection due to constraints on the size of the void – this appears to represent an equivalent roof structure and condition to the eaves voids.

Photograph 8: Showing the apex void as viewed from the access hatch. The structural framework of the contiguous dormer void can be seen on the RHS of the image.
