## PRELIMINARY ROOST ASSESSMENT (PRA)

### PARKSIDE, ST MARY'S, ISLES OF SCILLY

*Report date: 11<sup>th</sup> September 2024*

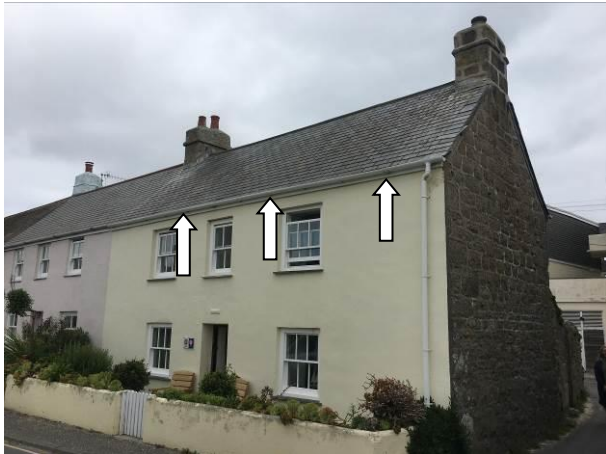
The Cottage has rendered walls on the front and rear with open granite blockwork on the gable. It is attached to the next property in the terrace to the west. All of the render and pointing is in good condition with no gaps or other opportunities for roosting bats noted. The Cottage has a pitched, dry-laid slate tile roof with ridge tiles. There are fascias running along both the eaves which are lifted in places and could provide either roosting opportunities in their own right (in the space between the flat fascia surface and the irregular stone blockwork behind) or provide access to further roosting opportunities associated with the wall plate or internal features. Gaps behind drop-tiles on the eastern gable may provide the same features.

**Photograph 1:** Showing the front aspect of the Cottage facing Lower Strand. There are gaps under the fascia boards where indicated.

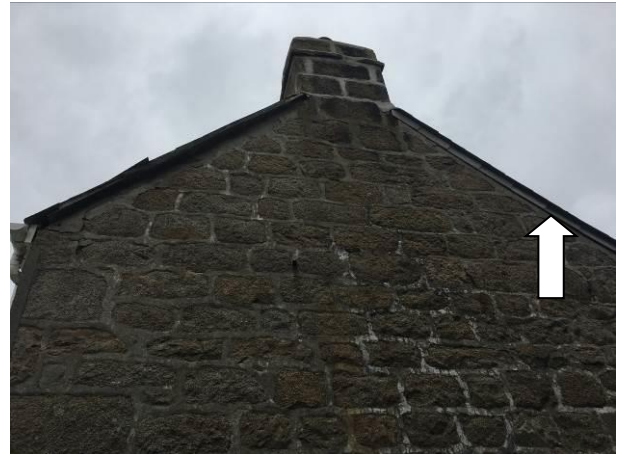
**Photograph 2:** Showing the gable end of the Cottage – there are minor gaps behind drop-tiles in places as indicated.

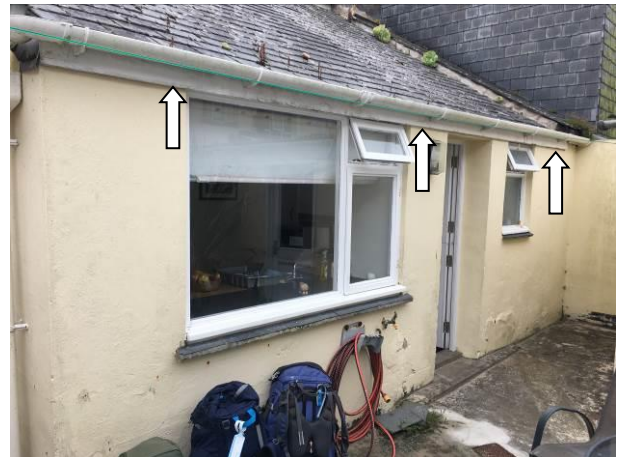
There are gaps behind the fascia board at the eaves of the Extension, as well as behind the drop-tiles on the gable. Both of these could provide either roosting opportunities in their own right or provide access to further roosting opportunities associated with the wall plate or internal features.

**Photograph 4:** Showing the front of the Extension – there are gaps behind the fascia boards on this aspect where indicated.

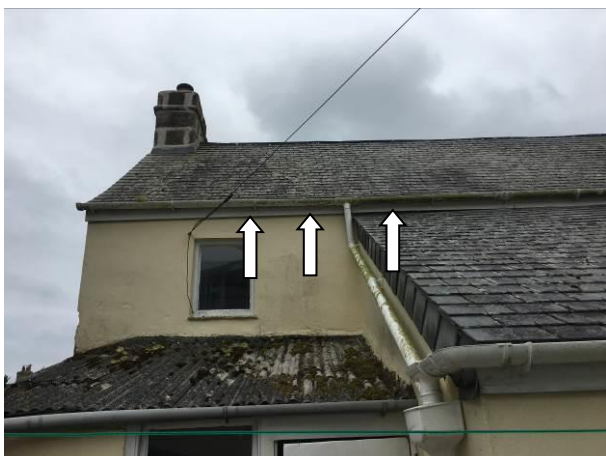
**Photograph 5:** Showing the rear aspect of the Cottage – the corrugated roof of the lean-to Utility can be seen at a lower height than the main Extension roof. There are gaps behind the fascias on the Cottage here as indicated.

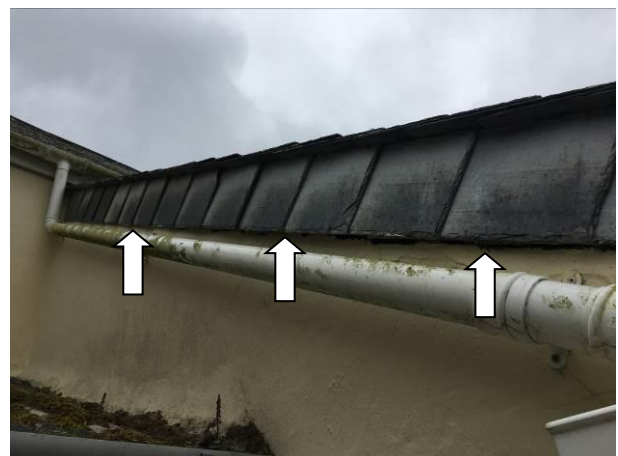
**Photograph 6:** Showing the drop-tiles on the gable of the Extension – gaps occur behind these tiles where indicated.

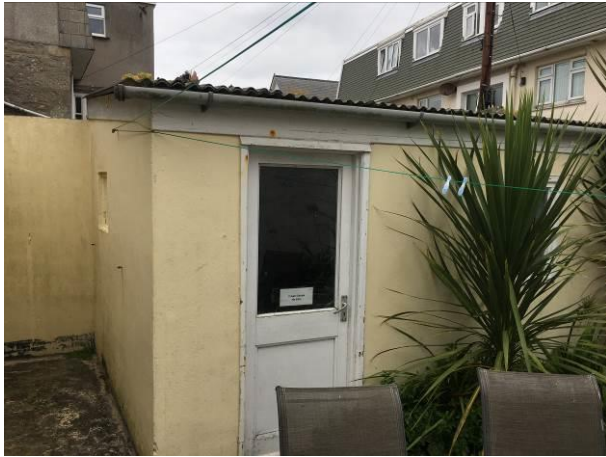
The garage has a single-pitch, gently sloping roof of corrugated sheet – the edges of these could potentially permit internal access for bats but this is considered to be low potential.

**Photograph 7:** Showing the Garage in the courtyard garden of the property.

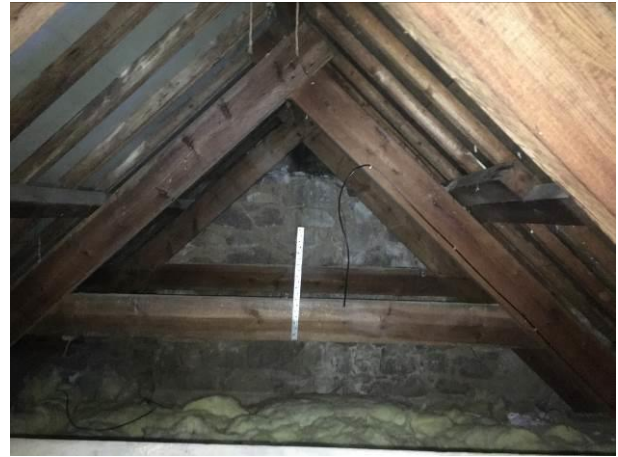
Internally, the roof is under-felted throughout – whilst this is generally in good condition, occasional tears or intentional breaks occur which could permit access to the internal loft space by bats which access beneath tiles or fascia boards. The roof is built around a timber frame –

**Photograph 8:** Showing the interior loft space of the main Cottage

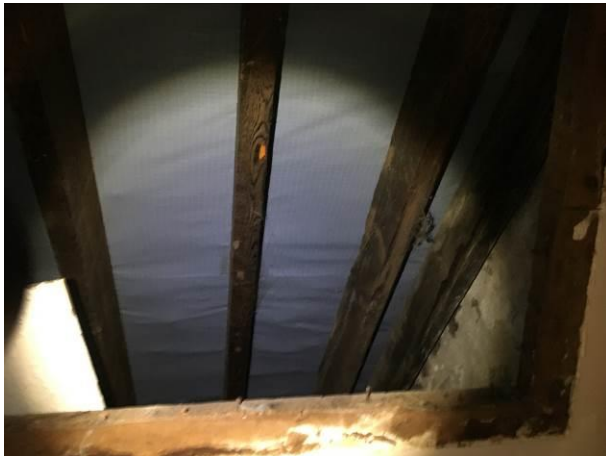
Internally, the loft space is partitioned into a lower void and an upper. The lower void does not offer any roosting opportunities. The upper void, accessed via a second hatch, is relatively shallow and built around a timber frame with well-fitted underfelting throughout. No evidence of bats was noted; however access was restricted by the size of the void which precluded full inspection – please see Survey Limitations for further consideration of the visibility of potential evidence.

**Photograph 9:** Showing the roof structure within the minor loft space of the Extension.

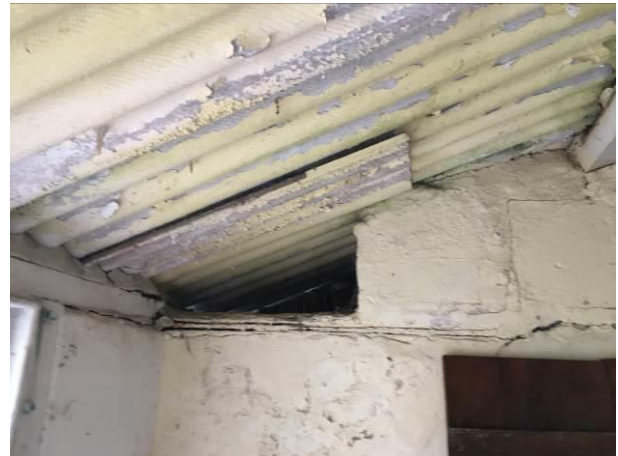
Minor gaps occur internally where the roof timbers abut the walls, and there are very minor gaps between corrugated sheets where these overlap. However the room is light, due to the well-fitted window, and in regular use as a utility space which would reduce the suitability of these features for use by roosting bats.

**Photograph 10:** Showing the interior of the Utility area.

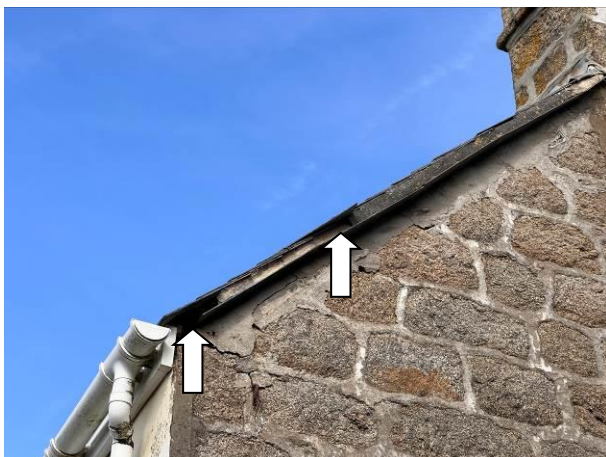
The tiles on the Cottage are largely well-fitted and in good condition, though minor areas of lifted or broken tiles occur which may provide minor gaps which could be accessed by roosting bats. This includes missing pointing and slipped tiles on the southern edge of the western gable.

**Photograph 11:** Showing the slipped tile and missing verge pointing on the southern edge of the western gable.
