PRELIMINARY ROOST ASSESSMENT (PRA)

PARK HOUSE,
HUGH TOWN, ST MARY'S, ISLES OF SCILLY

Report date: 9th February 2025

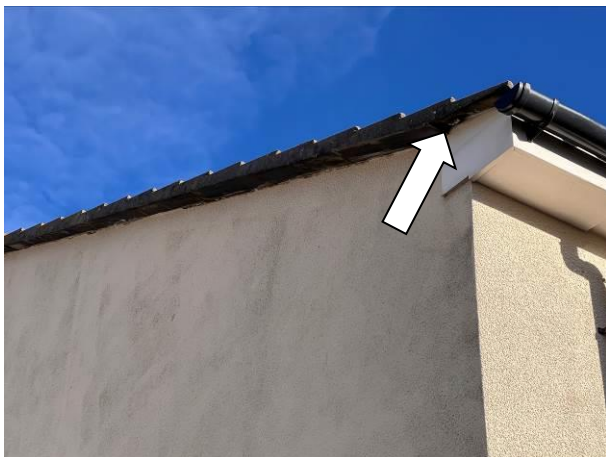
Minor gaps in the verge pointing are present on the southern edge of the western gable.

Photograph 5: Showing the location of the missing pointing on roof verge of the western gable

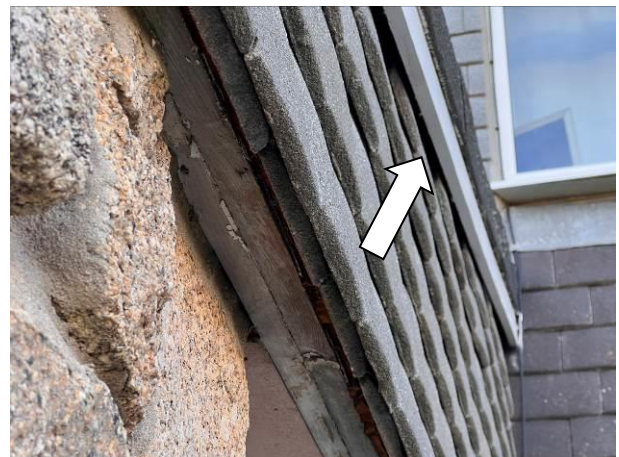
Hanging tiles are present on the gables – these are generally well-fitted but gaps occur at the base in places, and where the fascia overlaps the top of the tiles.

Photograph 6: Showing an example of the minor cavities present on the northern aspect where fascias overtop hanging tiles

Care should be taken during works to ensure that these structures are not disturbed, obstructed, or damaged. This may include a contractor briefing to ensure that those working on the property understand the requirement. Other measures such as a temporary sign, tape or physical barrier should be installed if deemed necessary.

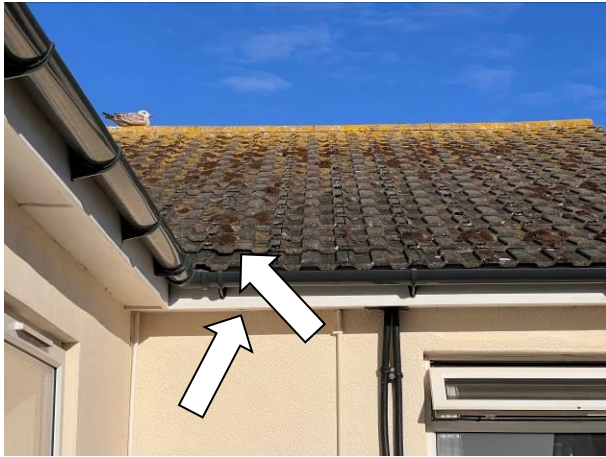
Boxed soffits are generally well-sealed, with a single pipe hole which could potentially provide access to roosting opportunities on the eastern side of the hipped projection. A small gap behind the uPVC fascia is also noted on the south-eastern corner. The uPVC soffit on the northern aspect is generally well-fitted with very minor gaps in places. There is some evidence of gaps being filled with expanding foam visible.

The roof is of interlocking concrete tiles which are occasionally lifted or have minor gaps beneath, especially in the northern pitch and within the hipped projection. The ridge is largely well-pointed with individual minor gaps on the northern aspect only – these may be superficial. Solar panels occupy a portion of the southern pitch to the west of the hipped projection. Guttering runs close to the eaves on all relevant aspects of the property which would preclude the potential for a direct fly-in access.

Photograph 7: Showing the southern aspect of the property – an example of lifted tiles is indicated by the upper arrow - whilst the lower arrow identifies the pipe hole in the soffit on this aspect.

If there are any areas of damage such as lifted tiles or missing pointing within 1m of the location of the Fire Vent installation, then it is recommended that the removal of the tiles is overseen by a Licenced Bat Worker. This is in order to ensure that, in the unlikely event of a bat being identified, they can be captured and moved to a place of safety. As a guideline, any hole or crack which is more than ½” wide should be considered to have potential to support a roosting bat.

Any tiles should be removed carefully, by hand, in such a way that in the unlikely event that a bat is present beneath, they are not crushed or harmed by the action. The underside of the tile should be checked carefully to ensure no bats are clinging to the underside before being set aside.

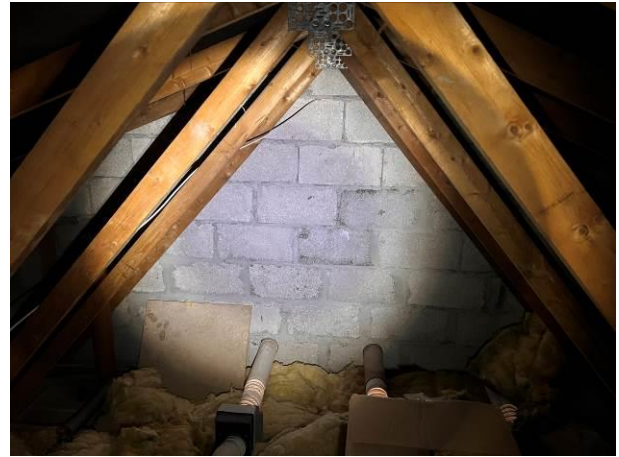
Internally, the roof is built around a modern timber truss structure with nail-plate joints which preclude gaps between the wood. No ridge is present. The loft space has breeze-block gable walls which are generally well-pointed although minor gaps occur. The terminal timbers appear generally tightly fitted against these walls, precluding potential roosting opportunities.

The loft space has insulation between the joists and is largely unfinished though used for long-term storage. A central section is boarded with plasterboard and a panel floor. The well-lapped felt is in good condition throughout the majority of the roof space, though occasional tears were noted. In places, evidence of replacement of the felting was noted.

No internal evidence of bats was recorded, though some evidence of rodents was confirmed.

Photograph 8: Showing the interior of the loft space – the breeze block gable wall can be seen with the timber truss framework in the foreground.
