## PRELIMINARY ROOST ASSESSMENT (PRA)

### ROCK HOUSE & ROCK COTTAGE, HIGHER TOWN, ST MARTIN'S, ISLES OF SCILLY

**Our reference:** 25-2-1

**Report date:** 20<sup>th</sup> February 2025

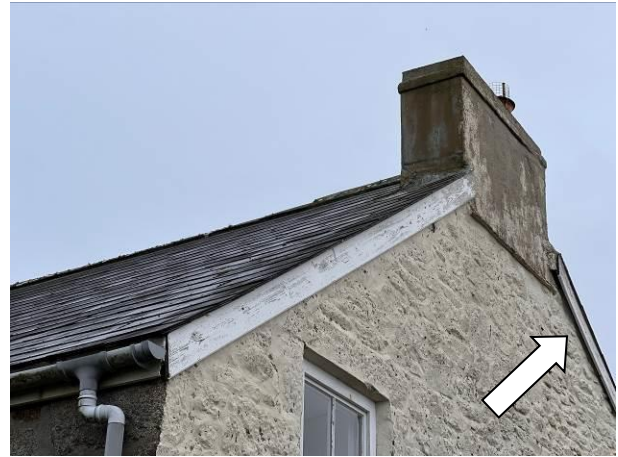
**Photograph 8:** Showing the south-western gable of Rock Cottage with the gaps behind the fascia indicated.

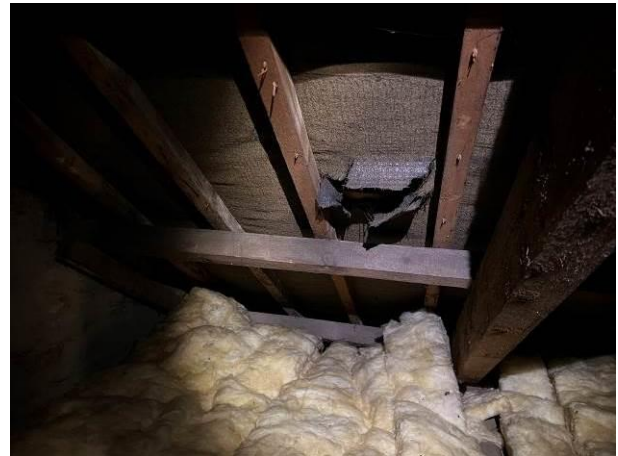
Internally, there is tar paper (Rock House) or underfelted (Rock Cottage) beneath the tiles which is mostly intact but tears in places could permit movement between the internal loft space and the space beneath the tiles.

**Photograph10:** Showing an example of a tear in the tar paper which lies between the rafters and the battens/tiles above.
