PRELIMINARY ROOST ASSESSMENT (PRA)

BELONGING AND INCLUSION HUB, CARN GWAVEL, ST MARY'S, ISLES OF SCILLY

Client: Council of the Isles of Scilly

Report date: 27th November 2025

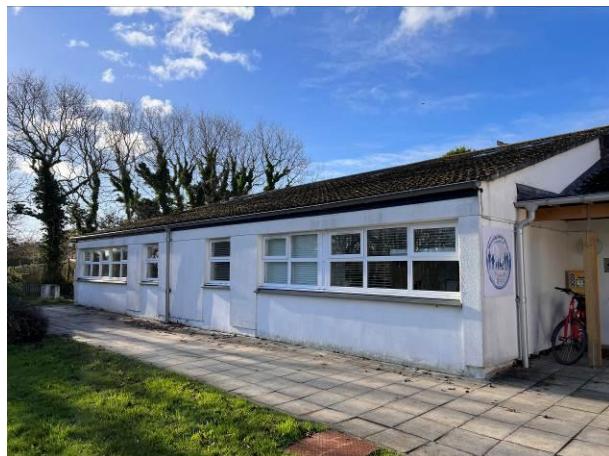
The survey did not identify any suitable roosting opportunities (such as gaps behind fascias or flashing or access beneath roof tiles) on the eastern aspect of the structure which is to be directly impacted. These are therefore considered to offer **Negligible Potential** for use by roosting bats.

Photograph 1: Showing the eastern aspect of the existing structure where the new building would tie in.

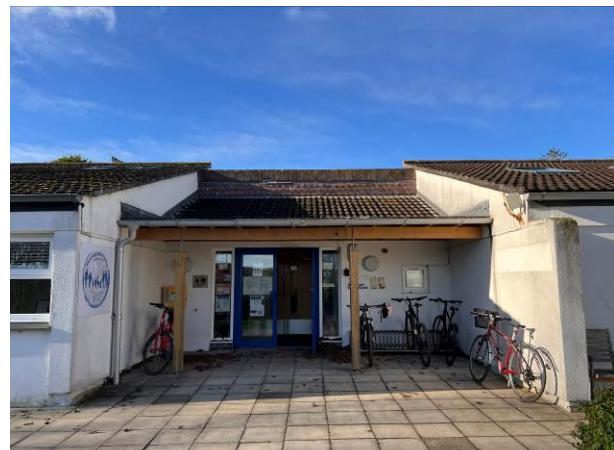
The open-fronted under-boarded entrance porch is well-sealed with no potential roosting features identified on the underside. Guttering is mounted directly to the porch timbers without a fascia.

The lower section of the porch roof is a shallow-sloping flat roof that ties into the gable walls on either side. Lifted flashing occurs at these junctions, presenting potential access features, though this appears superficial and the dimensions only likely to be suitable to support individual bats at best.

Photograph 2: Showing the under-boarded porch which is inset within the main structure – this would not be directly or indirectly affected by the proposals.

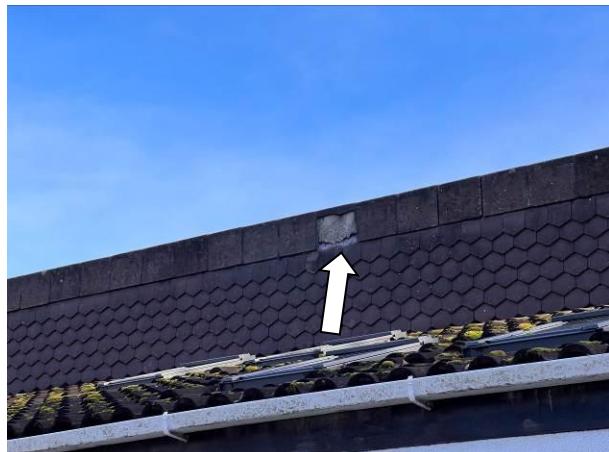
There are both hanging and drop tiles on the vertical pitch which links the irregular roof pitches. Hanging tiles are well-fitted where present on the western aspect, however the drop tiles at the apex here are damaged in a number of locations and these missing tiles would permit access to minor roosting features. Occasional minor gaps also occur where the flashing is slightly lifted in some places between the hanging and drop tiles.

Photograph 3: Showing an example of the damaged drop tiles on the western ridge of the main structure.

- No works affecting the southern gable of the building;
- No works affecting the western aspect of the building;
- No works affecting the porch/entrance.

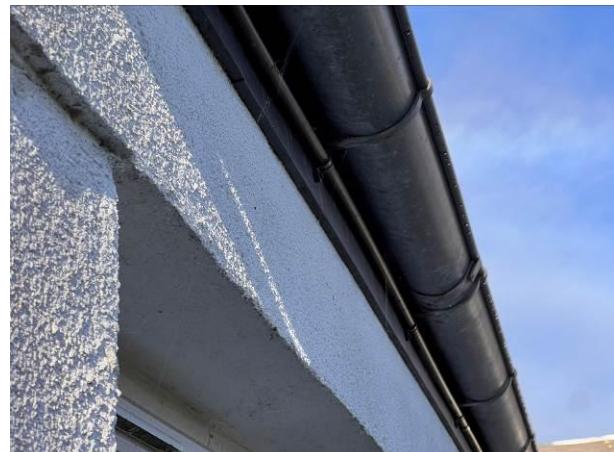
Gaps beneath the terminal tiles at the eaves on both the eastern and western aspects are largely blocked by tight guttering fixed to a well-fitted fascia throughout – no gaps or potential features were noted.

Photograph 4: Showing an example of the tightly-fitted fascia along the eastern aspect of the building.

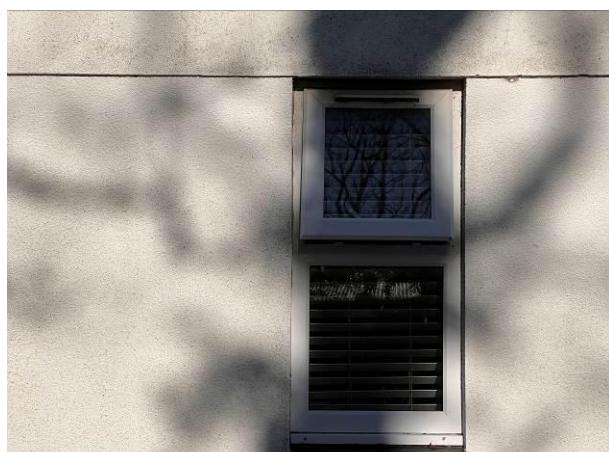
The main structure is a single-storey building which is rendered and painted externally to a good standard. The uPVC windows are well-fitted in their apertures throughout the structure.

Photograph 5: Showing an example of the uPVC windows whose frames are well-fitted within the apertures.

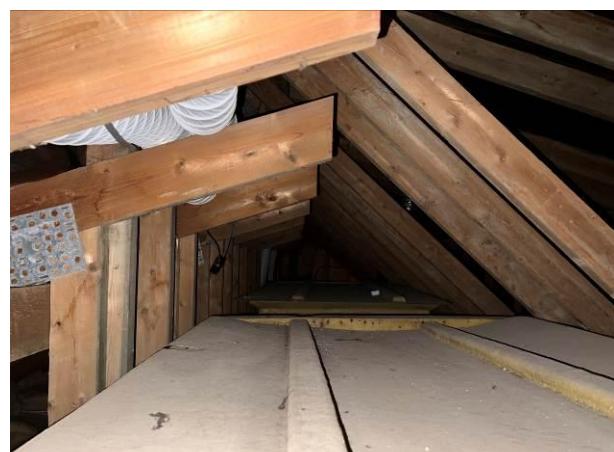
Internally, the loft space is built around a modern timber truss system. The timbers are in good condition. Fibreglass insulation is present between the ceiling joists. A black plastic-lined insulating underfelt/DMP is present throughout; this appears intact with no obvious tears. Gaps occur only where sheets overlap, but overall the membrane is well fitted and the roof structure appears well sealed.

Photograph 6: Showing the interior of the loft space – this image includes the cover of the water tank below, whereas the majority of the loft space has insulation between the joists.
