**Listed Building Information for
PIER HOUSE, THE BANK, HUGH STREET, ST.MARY'S TR21 0HY
24th November 2017**

LISTING INFORMATION

Heritage Assessment

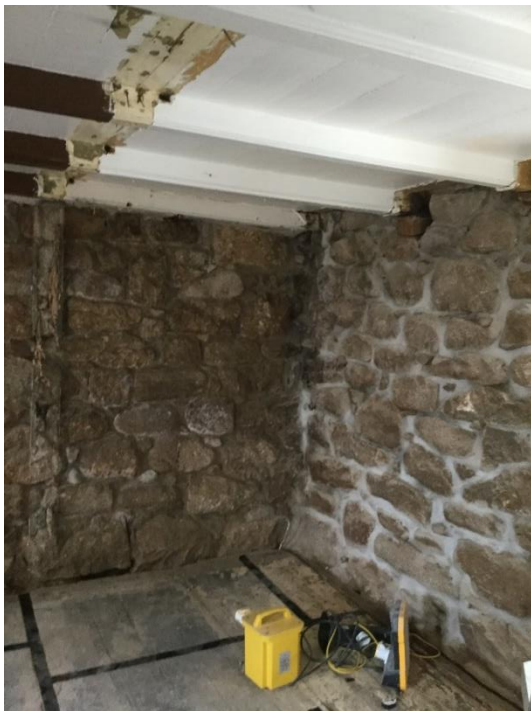
The current internal face of the walls is exposed rough faced granite that was once filled with a local binding material called RAM. This material has over the years dried out and is still falling out of the walls. Previous work has been carried out, some years ago, to the internal faces of these perimeter walls as they have been repointed in cement to ensure the remaining ram within the walls is retained and to bond the stones in the internal face of the wall together.

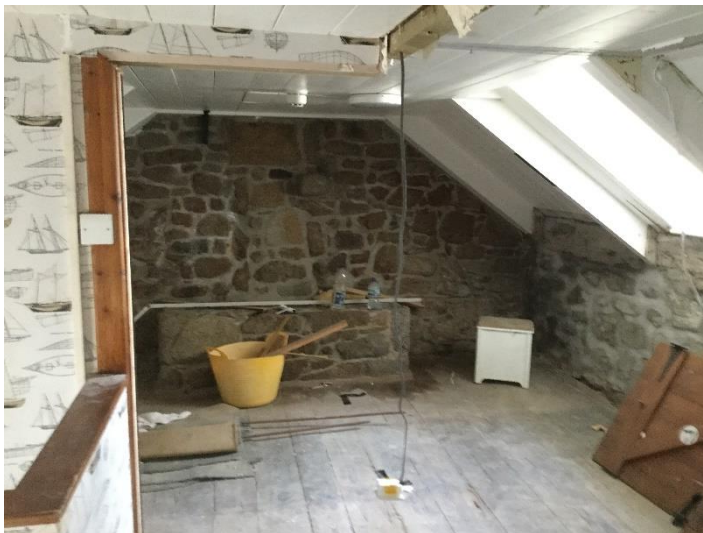
The chimney on the west gable has previously been rendered redundant as it has, many years ago, been reduced to just above the second floor level. Shown in the photo below

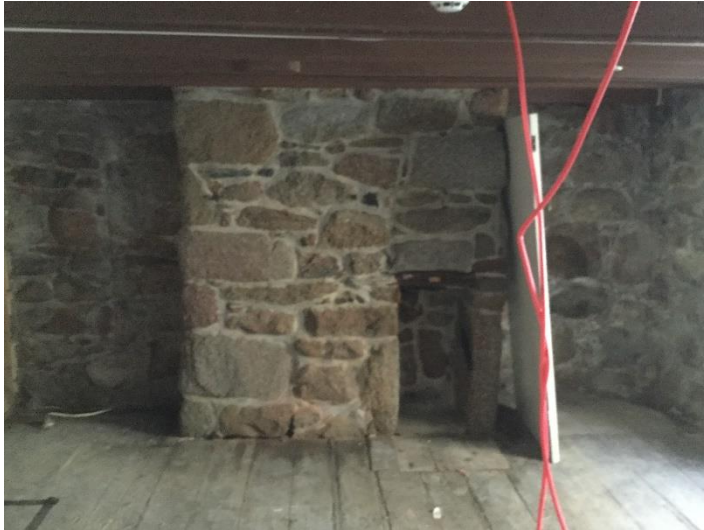
The photo below shows the chimney breast on the first floor of the west gable that has previously been rendered unusable by the previous work to the second floor chimney in the photo above.

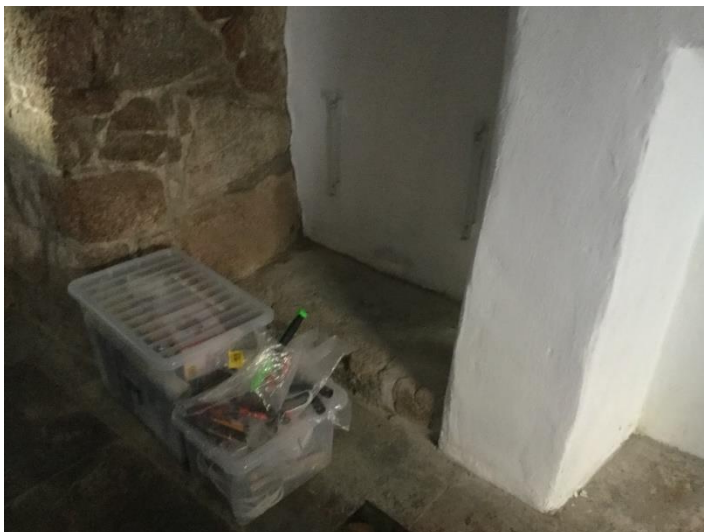
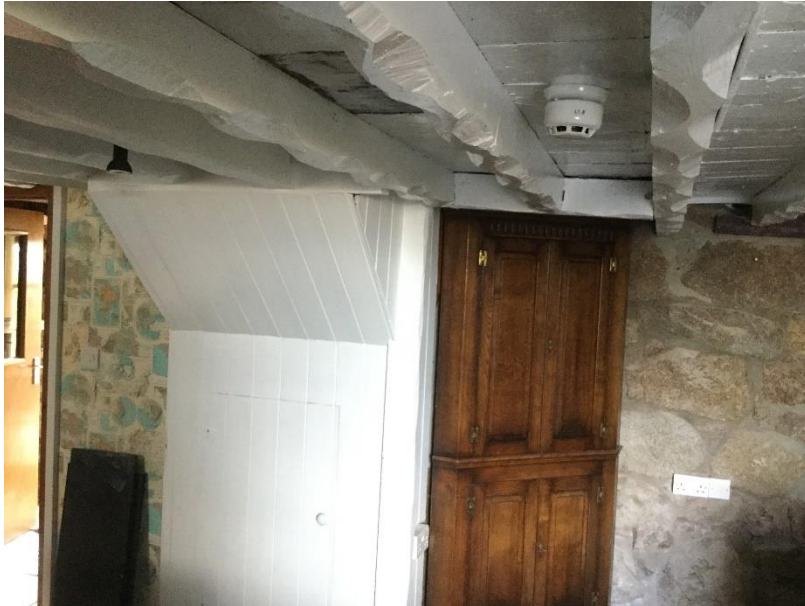
The first floor was constructed in recent times with exposed timber beams to the ground floor with joist size 115mm by 90mm and set at 370mm centres. These joists have been heavily defaced in a poor attempt to age them when they were installed.

The ceiling of this room is sagging to the centre of the building and this is more apparent to the right hand side of the staircase. The ceiling joists have not been installed correctly and there ceiling is not correctly trimmed around the staircase opening resulting in a compromised structure and sagging to the floor above.

The ceiling joists in this room are modern in comparison with the ceiling joists of the floor above. They are 115mm by 90mm and set at 370mm centres. These joists have been heavily defaced in an attempt to age them when they were installed. The effect of this is that the integrity of the joists has been compromised and the visual effect of this is a detriment to the building.

The ends of these newer replacement joists have been inserted into pockets within the granite perimeter walls, as was usual past practice, this has subjected the joist ends to the damp atmosphere of the inside of this structure which has caused them to rot which is a typical result of this form of construction. The ends of a number of joists have been compromised and as such the ground floor ceiling flexes when weight is applied to the first floor.

For these reasons there is a requirement for these joists to be replaced.

It is proposed that we replace these joists with C24 timbers of a similar dimension to that of the original joists 120mm by 63mm @ 400mm centres that will have the same bead details on the bottom edges of the joists as the original joists and that detail will stop 100mm from the finished face of the wall. Although these joist sizes do not comply with current Building Regulations for the span of 3.6m (170mm by 63mm are required now) they are an improvement to the current situation as they will be installed correctly. It is proposed to fix a 100mm by 50mm C24 timber wall plate to the face of the rendered and tanked perimeter wall to both of the long sides of the building. This wall plate will be fixed at approximately 400mm centres between each joist position with a 12mm diameter 200mm long stainless steel chemical anchor bolt. The bolts will be set into the timbers at alternating positions of 50mm from the top of the wall plate to 50mm above the bottom of the wall plate. The joists will be hung from this wall plate by utilising a solid galvanised joist hanger that is fixed to the front face and the top of the wall plate with 3mm diameter 50mm long stainless steel ring shank nails. The staircase will be correctly trimmed with double joists either side of the staircase opening and with double joists between these trimmers to form the staircase well. These trimmers will be glued clamped and nailed together every 300mm as per the joist hangers with 3mm diameter 85mm long ring shank stainless steel lost head nails.

Both the wall plates and the replacement joists will be painted before they are installed with two coats of intumescent paint to protect these timbers from fire.

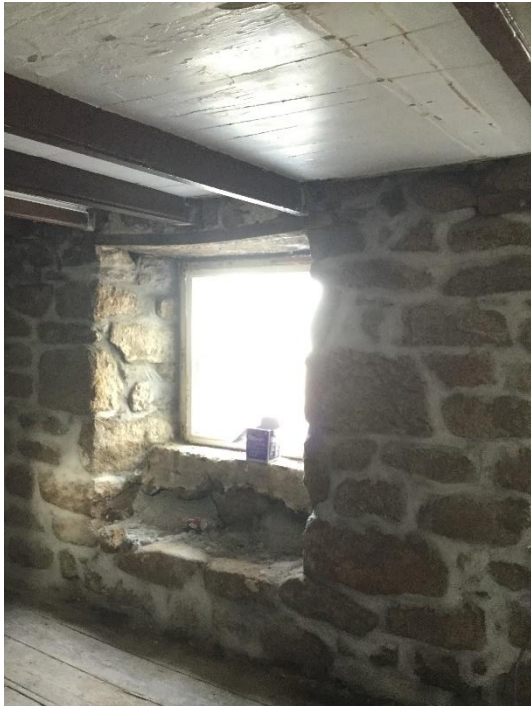
This photograph shows the joist spacing under the second floor

The second floor joists are older than that of the first floor below and are 100mm by 70mm and are spaced at between 590mm to 1050mm which is significantly less of a structure than would comply with today's Building Regulations (170mm by 47mm @400 centres for this **3.6m span**). These joists have detailed beaded bottom edges. Most of these joists have been damaged by wet rot as they are pocketed into the perimeter walls and have been either re-supported by large section angle irons or by bolting new sections of joists to the original.

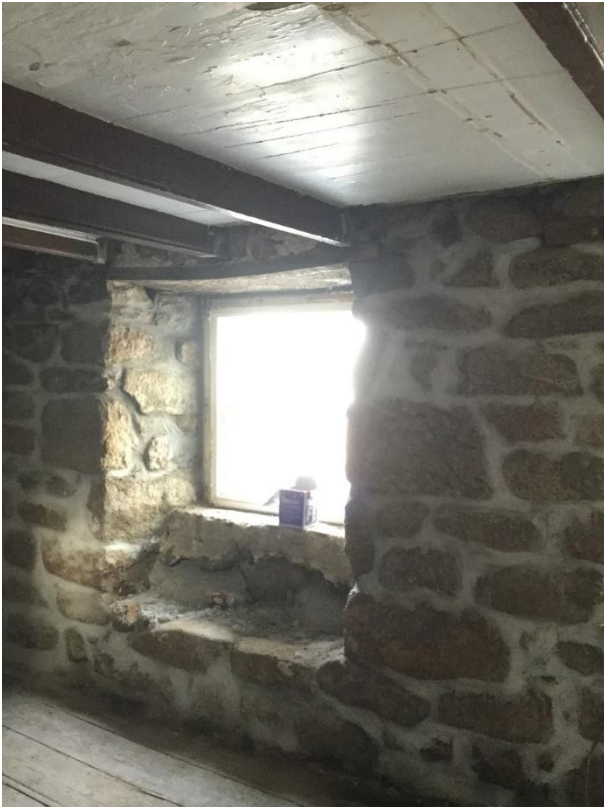
The ceiling in this area is structurally compromised. The joists in this ceiling are older than that of the floor/ceiling below and are 100mm by 70mm and are spaced at between 590mm to 1050mm centres. They have degraded where they are imbedded in the walls. It is proposed that this ceiling is removed and replaced to match that of the work described for the ground floor ceiling.

The photo above shows the existing wide joist spacings

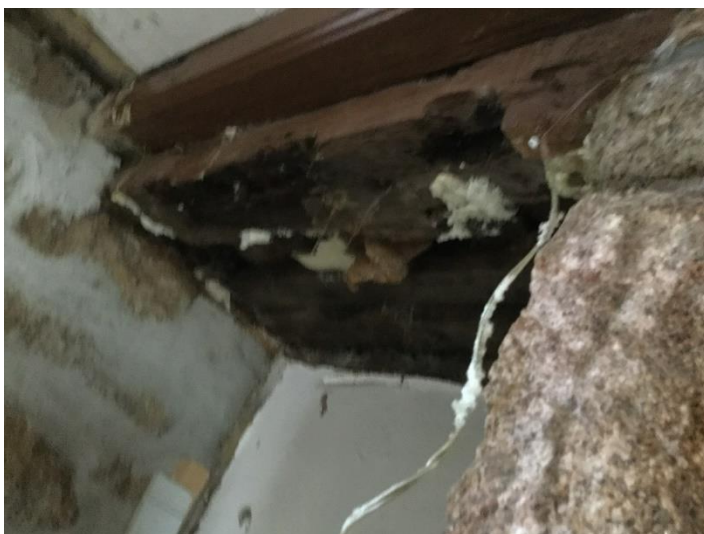
Carrying out the above work will negate the requirement to replace the rotten timber lintels under this same opening, as shown in the photograph below, on the ground floor which can then simply be removed.
