Stage 4: Network planning for Walking

Stage 3 / 4: Walking and Cycling Network assessment tables

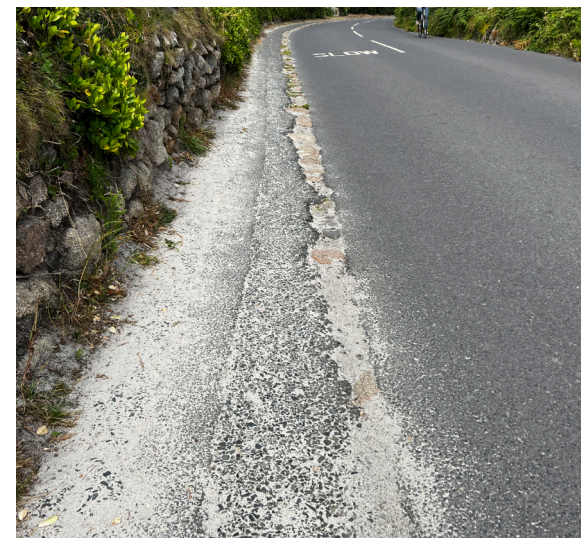
Poor quality narrow footway on route where traffic exceeds 20mph

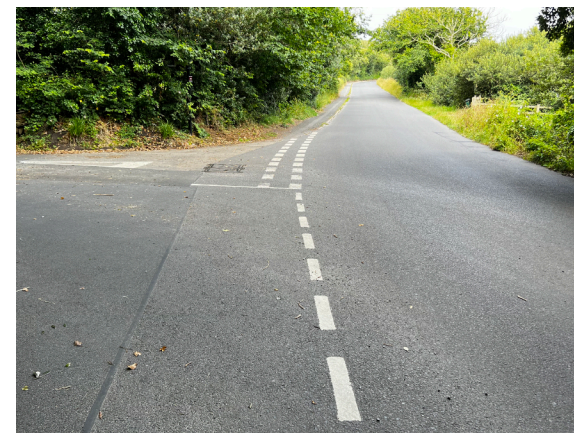
Intervisibility is poor at this junction

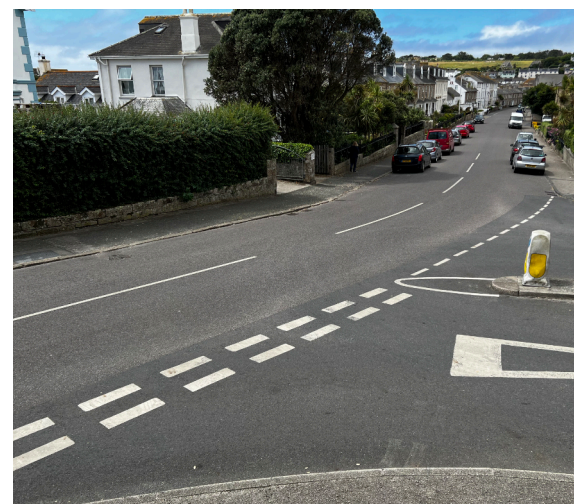
Very wide junction mouth combines with poor visibility from opposite footway and high approach speeds to create a hazardous environment.

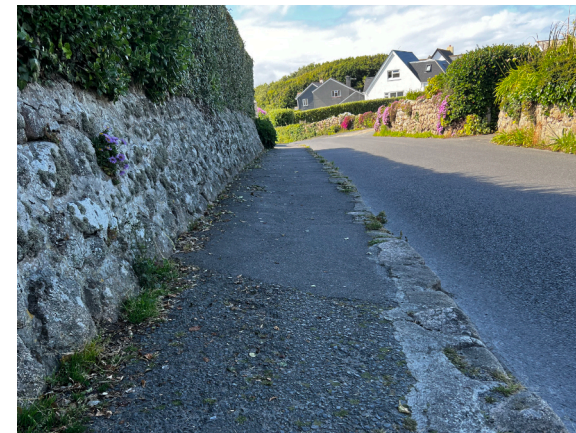
Footways are in poor repair and their kerbs are a fall hazard

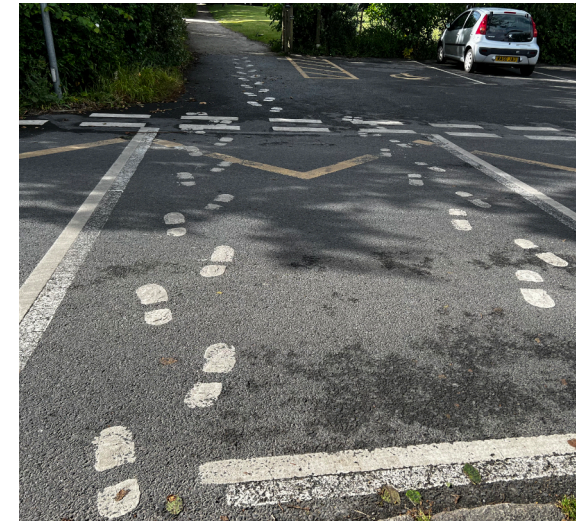
Non-prescribed and indistinct crossing by the Five Islands Academy.

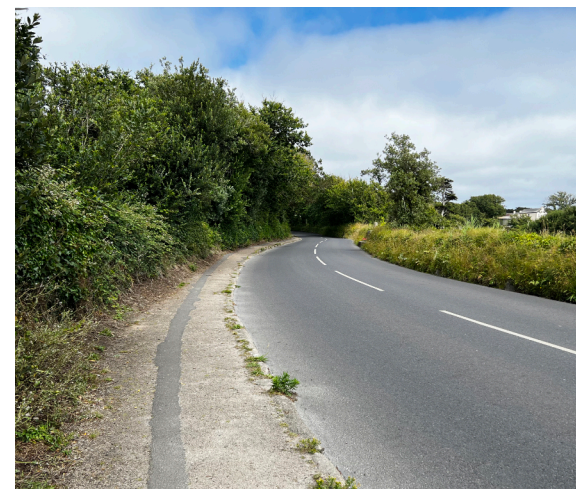
Rural footway.

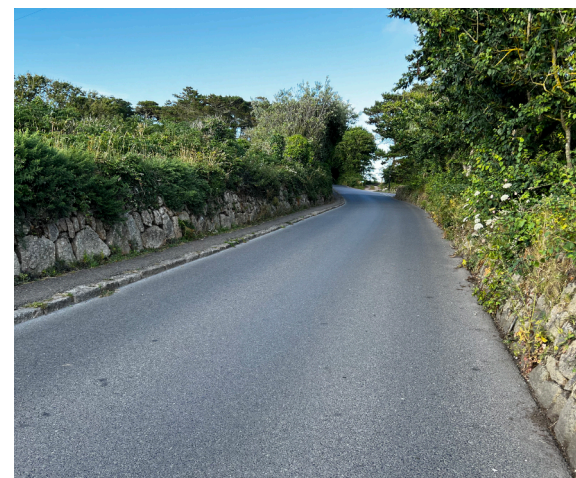
Narrow footways and poor sight lines

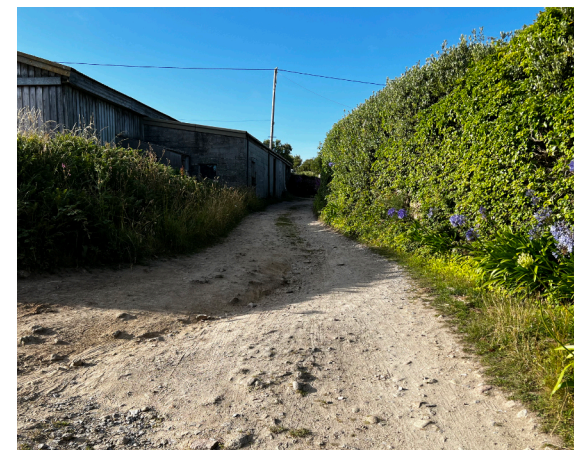
MP-07	W	F	
PL-02 (part)	W	F	Unsurfaced, undulating route with ponding in some areas and protruding rocks. Inaccessible for Disabled pedestrians and cyclists.
MP-06		F	
General	C,W	F	Speed limit on all Island Roads is 60mph, making safe shared use with pedestrians and cyclists inconsistent with LTNI/20.

MP-02 to MP-09: typical surface quality

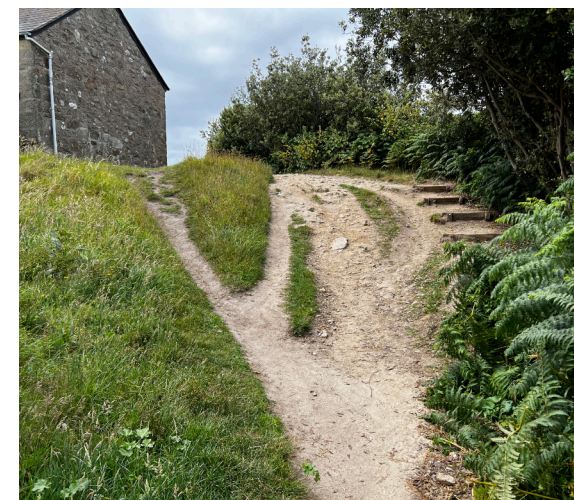
CP-02-04: Coast path is inaccessible for Disabled people.
