#### Isles of Scilly Water Interests Survey

### Report on Flood Defences

11/8185 Issue 1 | August 2011

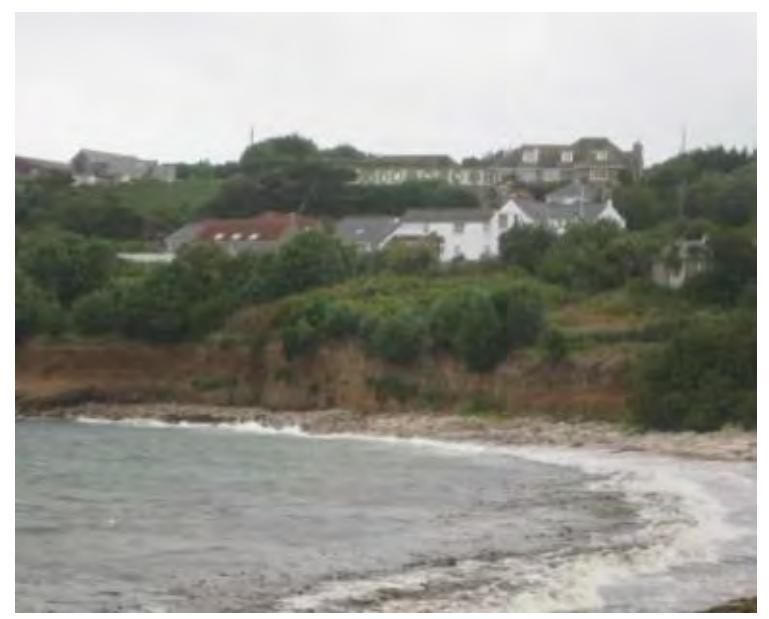
Figure 1: Ram cliff at Porthloo threatening property above (July 2011)

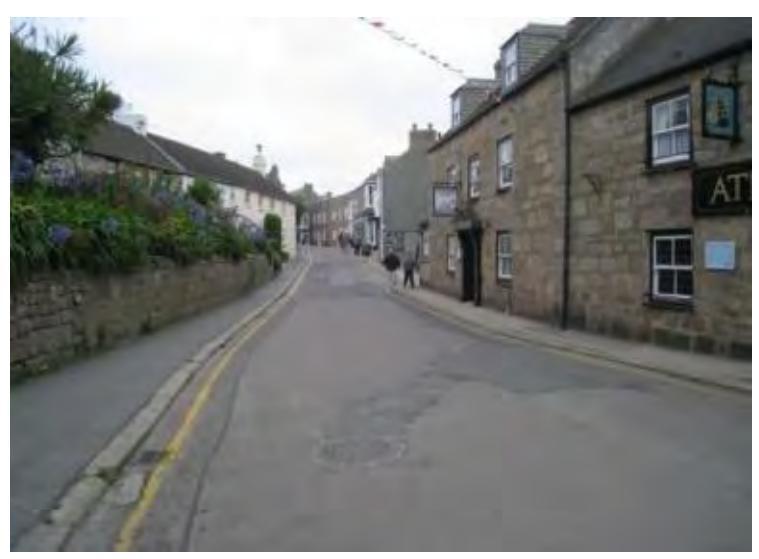
Flooding of Hugh Street via the surface water system is not that uncommon either during particularly high tides, with seawater coming up through the road gullies near the Atlantic Hotel. However, no property flooding has been reported as a result. It was noted that the flap valve on the Town Beach surface water outfall was detached from the end of the pipe and the pipe was cracked a short distance back from the end.

Figure 20: Hugh Street, adjacent to the Atlantic Hotel.

A further issue occurs in this location. It is possible for foul effluent to back up and flow into the surface water system at the slipway by the Atlantic Hotel, as part of an informal Combined Sewer Overflow arrangement, and discharge onto Town Beach via the existing but fractured surface water outfall.

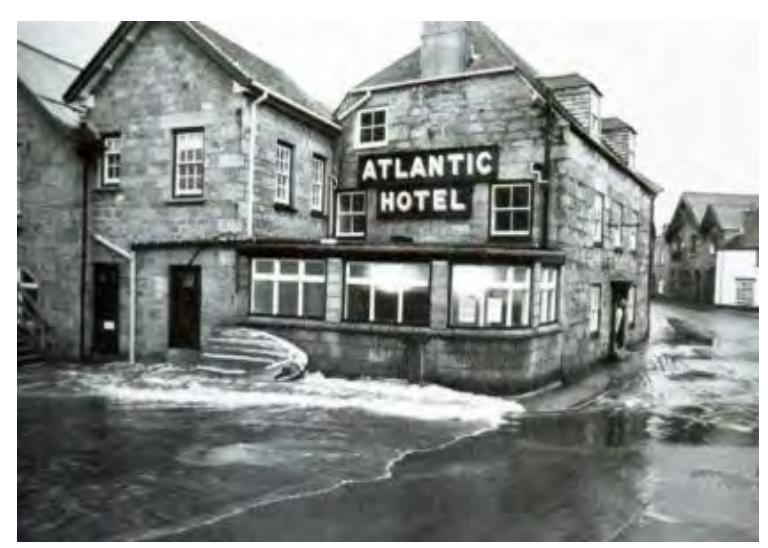
High tides sometimes inundate Hugh Street, via the slipway and surface water drainage system at the Atlantic Hotel, formerly the Custom House. Both these inundation routes have since been fitted with stop logs to help prevent serious inundation but the surface water drainage system remains a flood route, until the flap valve and discharge pipe are repaired.

Figure 37: Inundation of Hugh Street via the Atlantic Hotel slipway and surface water drainage system during a high tide

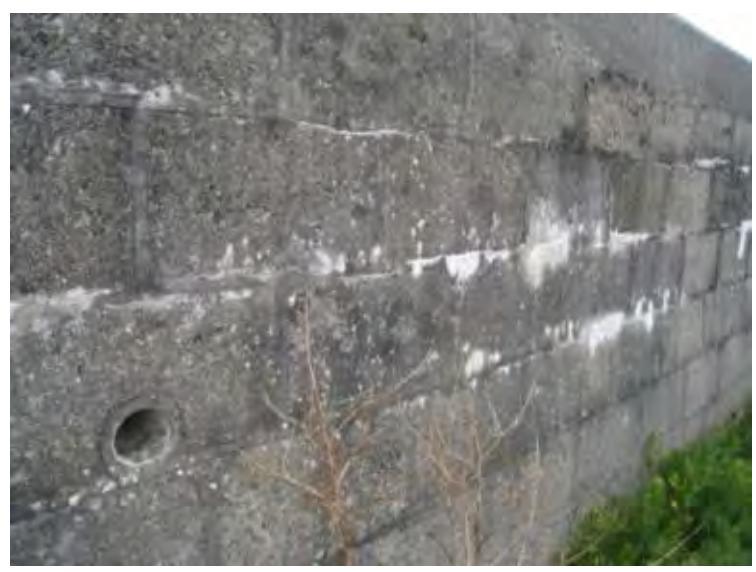
Figure 43: Limited spalling on the face of the stone blocks

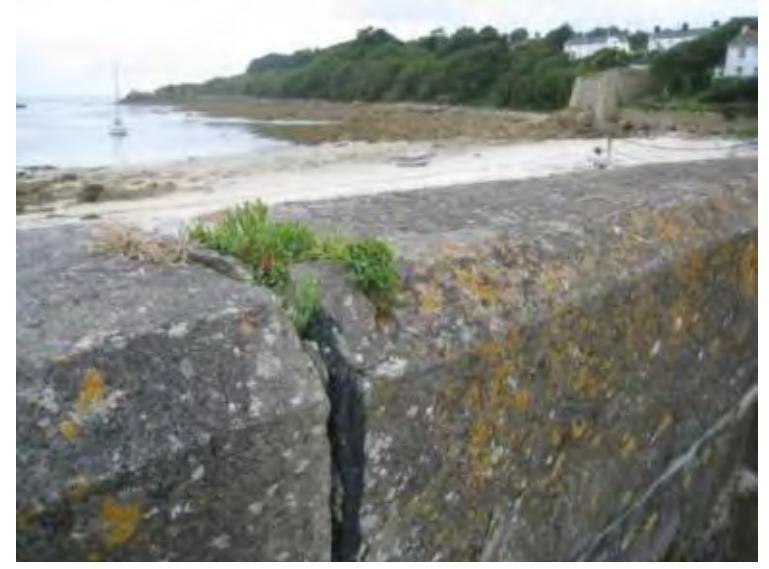
Figure 44: Joints sealed with mastic filler. Where the mastic filler is missing, vegetation is starting to become established

Vegetation is becoming established in small voids where either the mortar or mastic filler is missing.

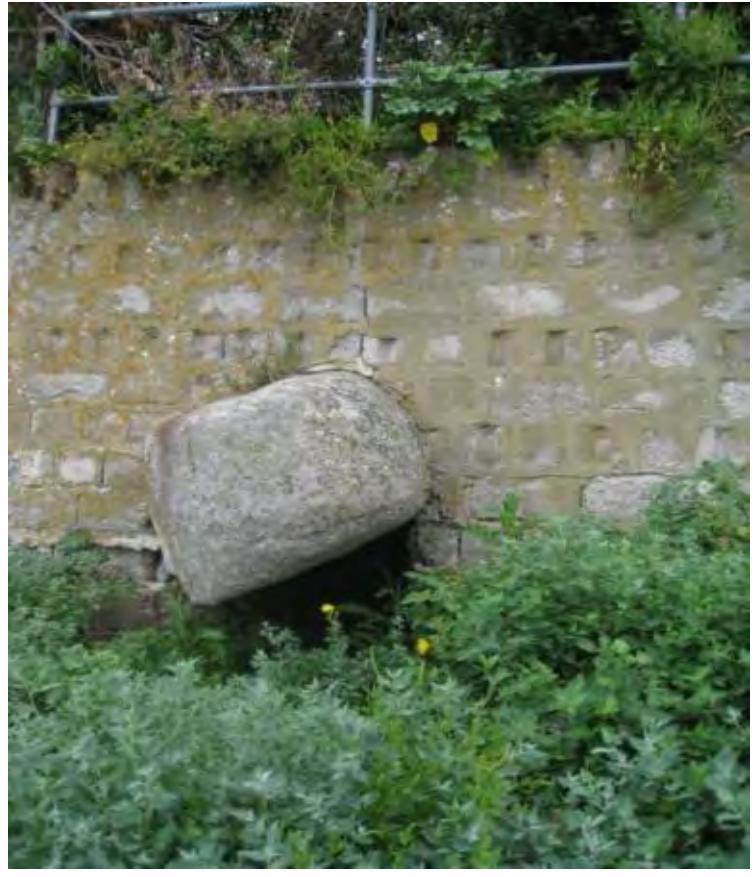
There is some loss of mortar and spalling at the face. Again vegetation is developing where there are small voids. There is evidence of re-pointing of the mortar joints. Very close to where the wall ties into the Garrison wall, the concrete block wall has been built around a rock intrusion and a void has formed beneath it.

Judging by the vegetation at the toe of this section of wall, it would appear that it is outside of the mean high tide level. However, there is potential for this void to open up during storm conditions which could impact on the integrity of the rest of the wall.

Figure 48: Wall built around rock intrusion with void below

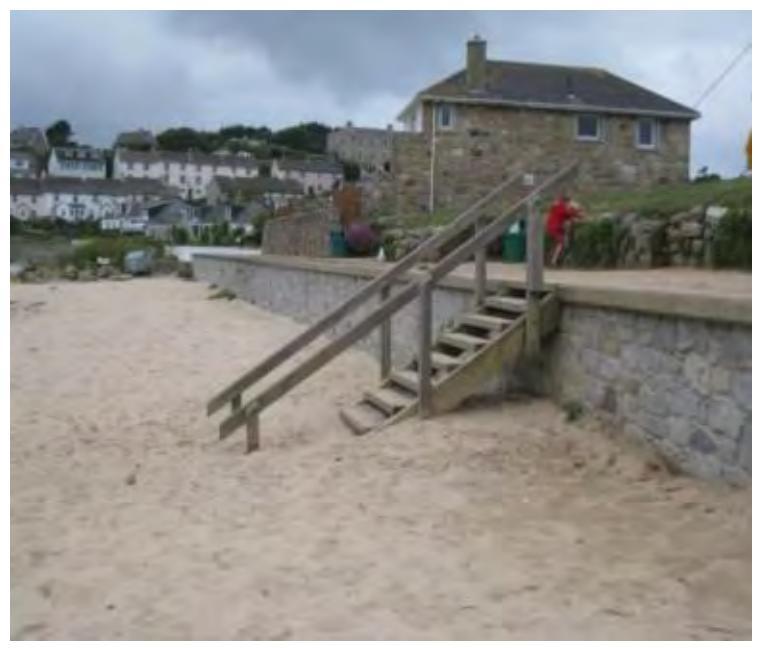
Sand transportation along the beach was visible, with significant accumulations noted at the western end.

Figure 51: Bottom end of wooden steps buried in sand transported along the beach

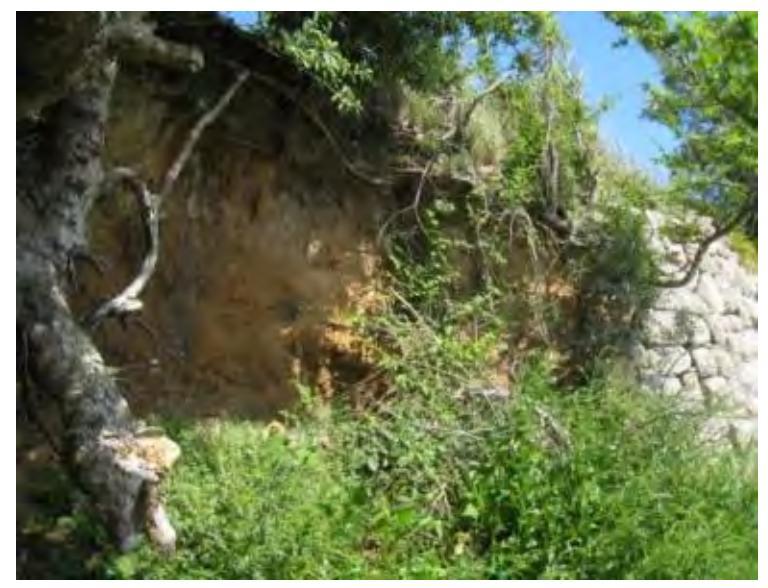
Figure 68: Erosion of the loose head deposits at far western end of dry stone wall, beneath Church

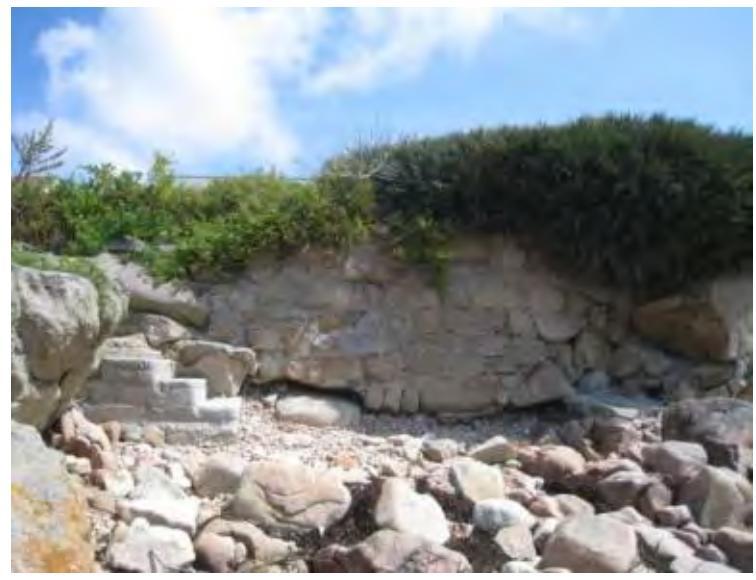
It would appear that the wall is toed into the rock outcrop at the far eastern end of the bay. Adjacent to the slip, a void is developing at the toe, where the stone wall supports the road down to Tolman Head. It is assumed that the mass concrete wall is sufficiently keyed in at foundation level, to ensure the integrity of the wall. However, it would be beneficial to seal the void to help ensure that the stone facing remains intact in this location.

Figure 69: Void forming at toe of stone work

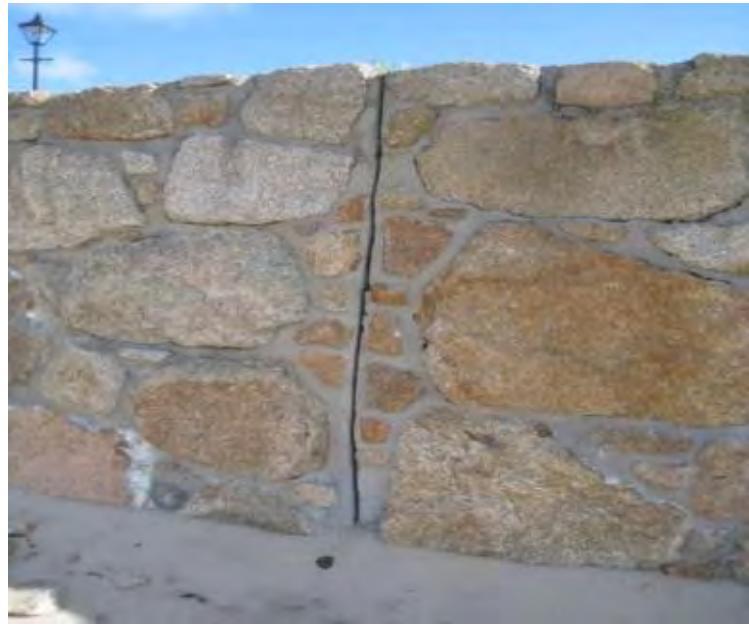
Figure 71: Mastic filler missing completely from joint

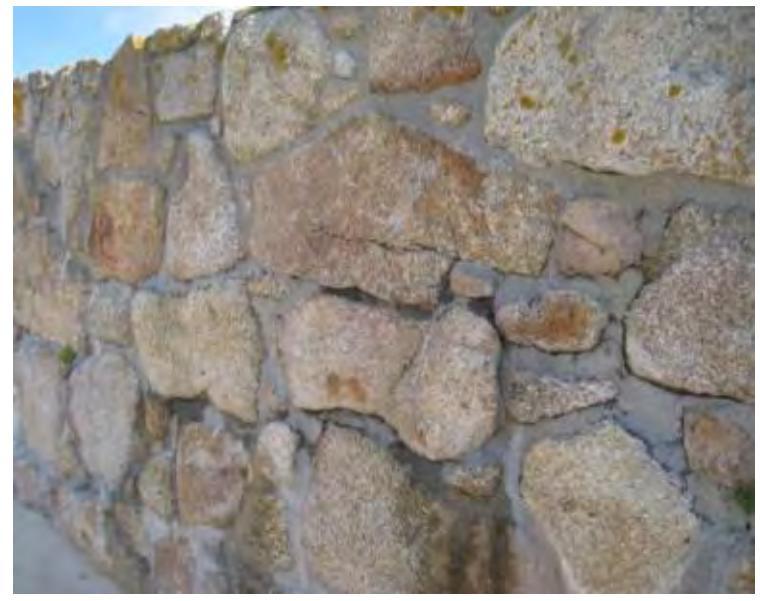
Figure 72: Fracture lines appearing on stone cladding and re-pointing repairs notable

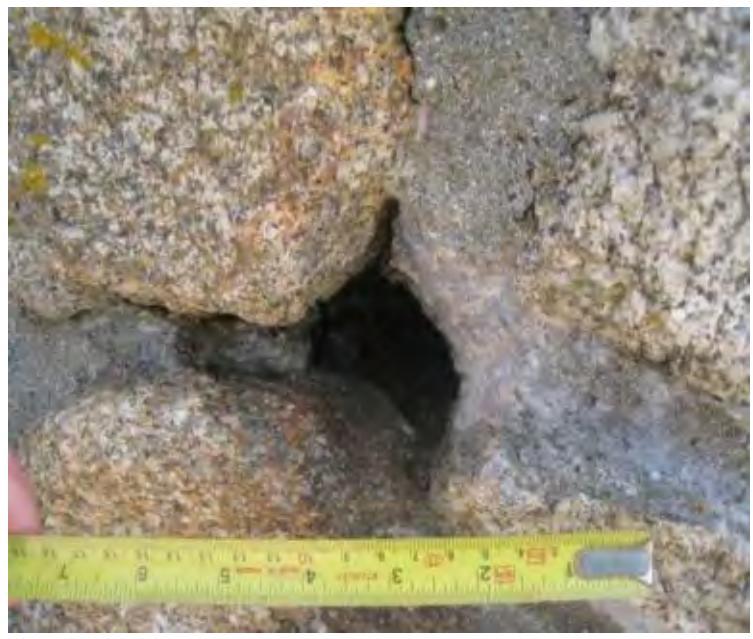
Figure 73: Some loss of mortar

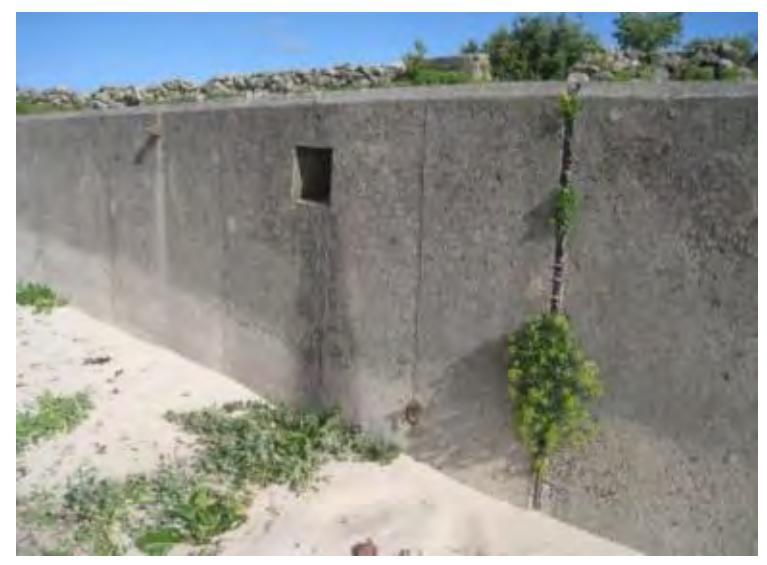
Figure 75: Drainage outlet onto beach. Mastic filler missing from joints

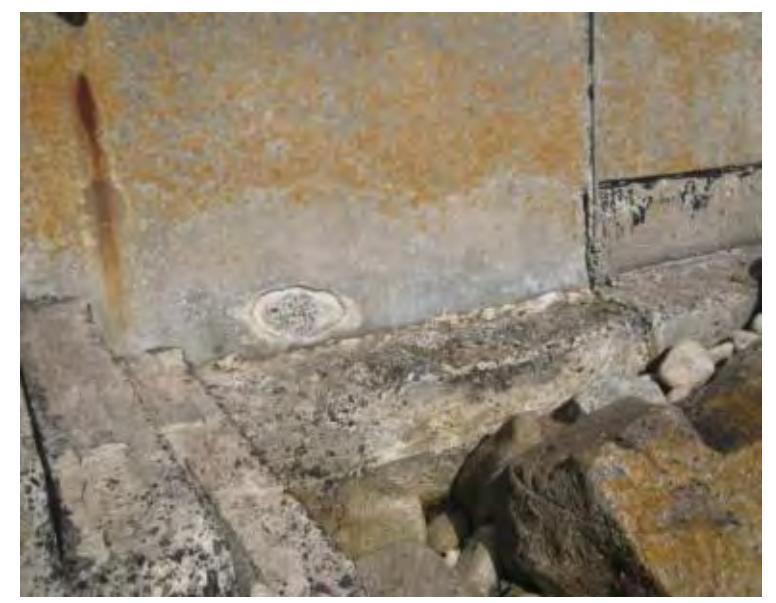
Figure 84: Only one location of spalling was noted, at the western end

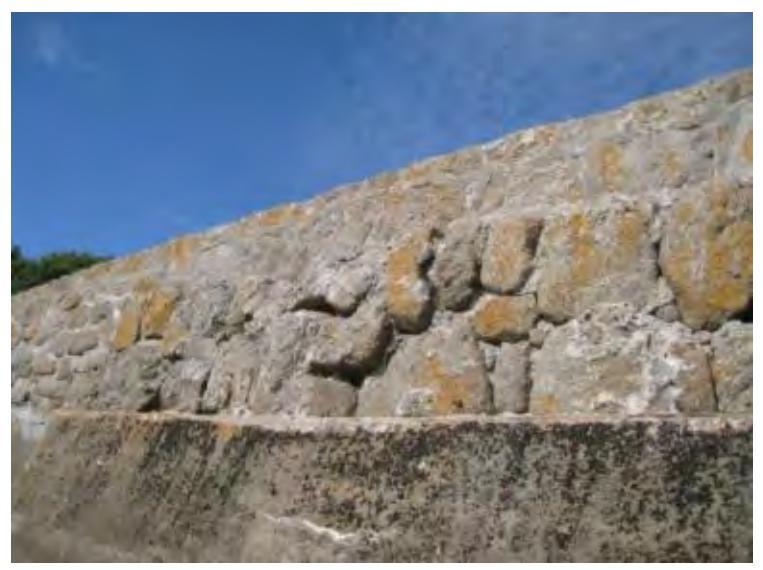
Figure 89: Voids beginning to open up where shape of stone makes mortar joints difficult to install

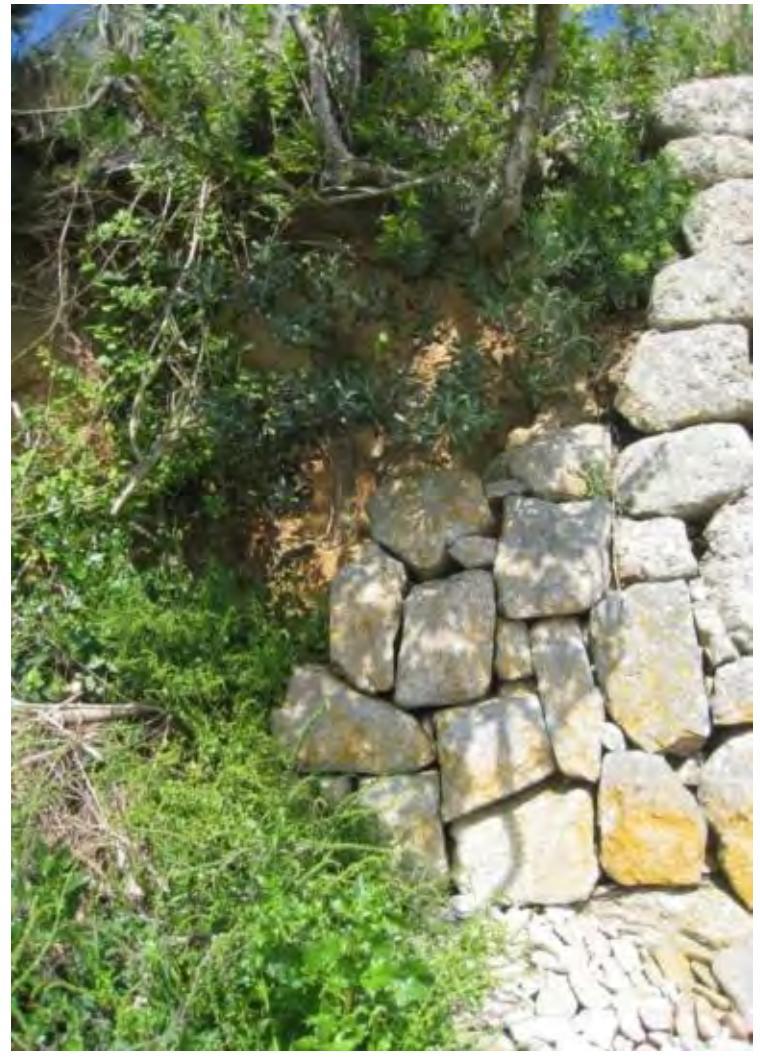
Although not subject to daily high tides, erosion is threatening this end of the wall and the coastal path above.

Figure 91: Erosion of cliff to rear of and adjacent to stone wall

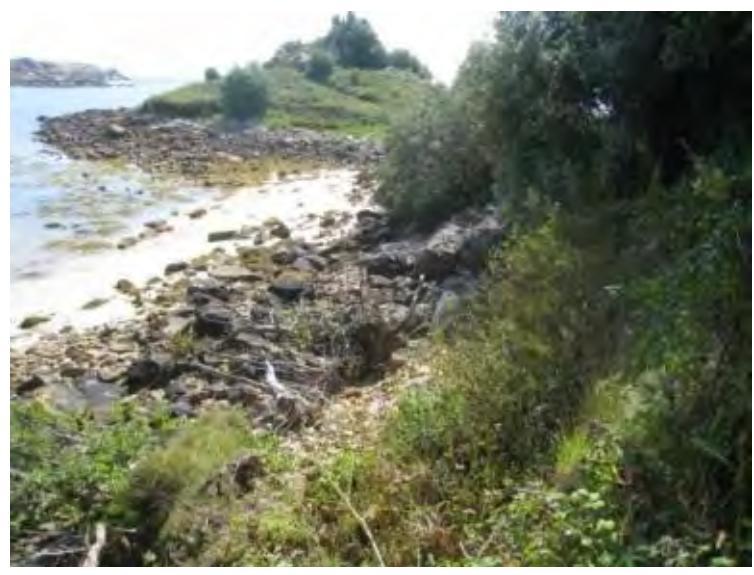
Figure 92: Retreating coastline, Old Town Bay

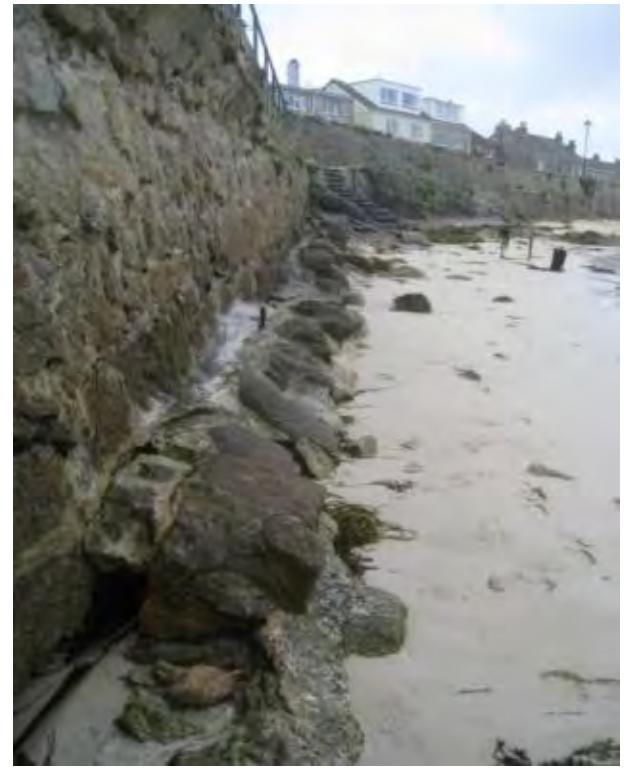
It was noted that the wall has no proper toe to it, so undermining is likely to be a long term problem.

Figure 97: Toe of wall has failed in places

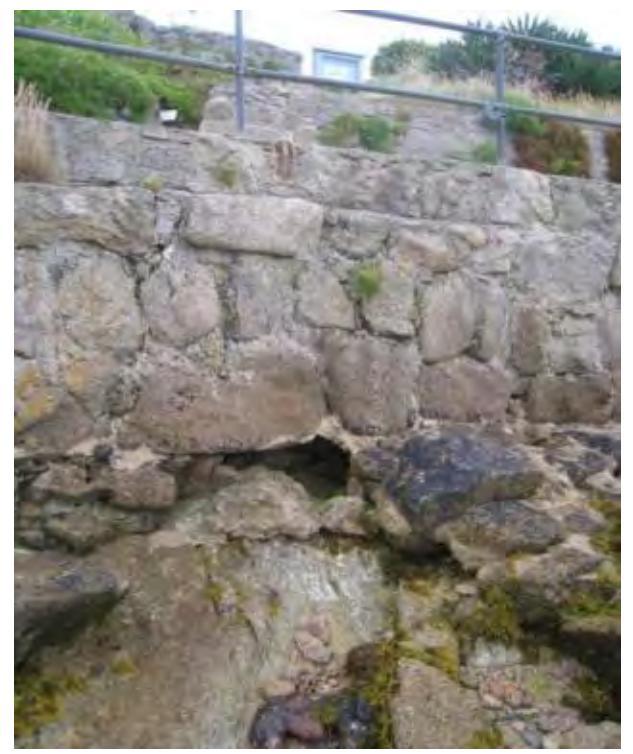
Figure 98: Voids are common along this length, from toe level up to 1.6m above toe level

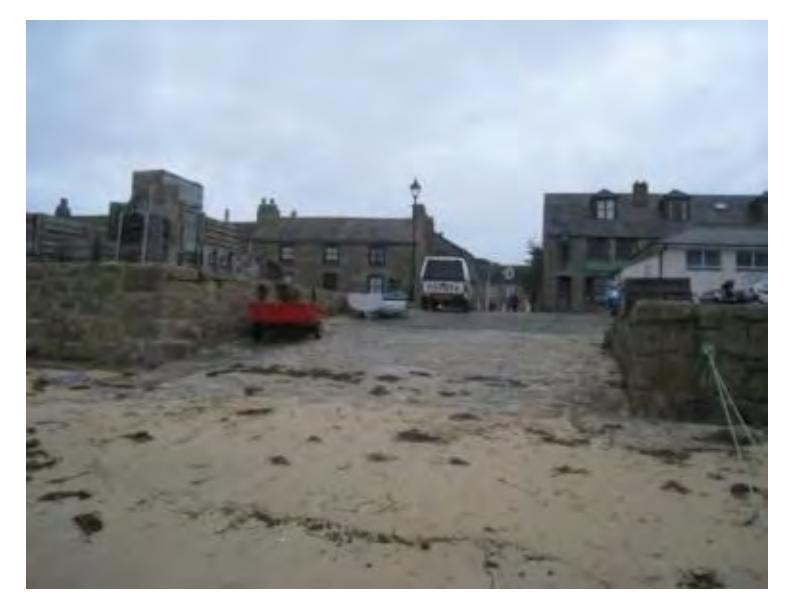
Figure 104: Rechabite Slip. There are no stop log grooves provided at this slip for flood boards.

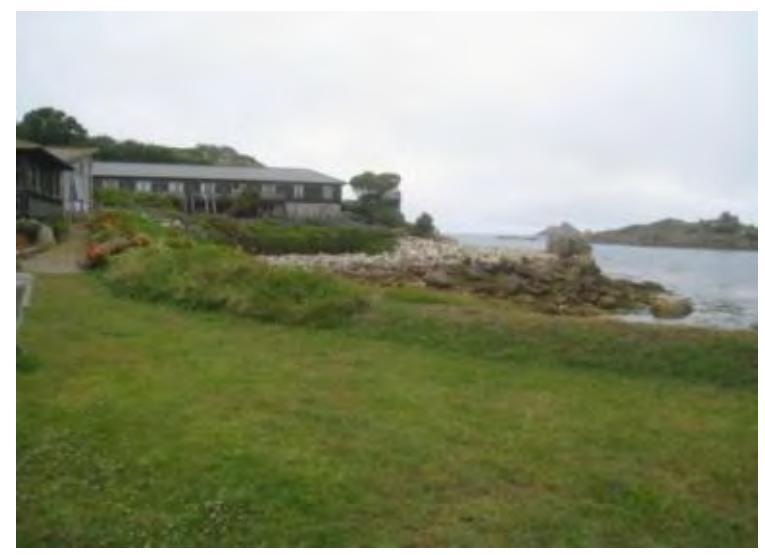
Figure 146: Erosion and poor vegetation noted on embankment

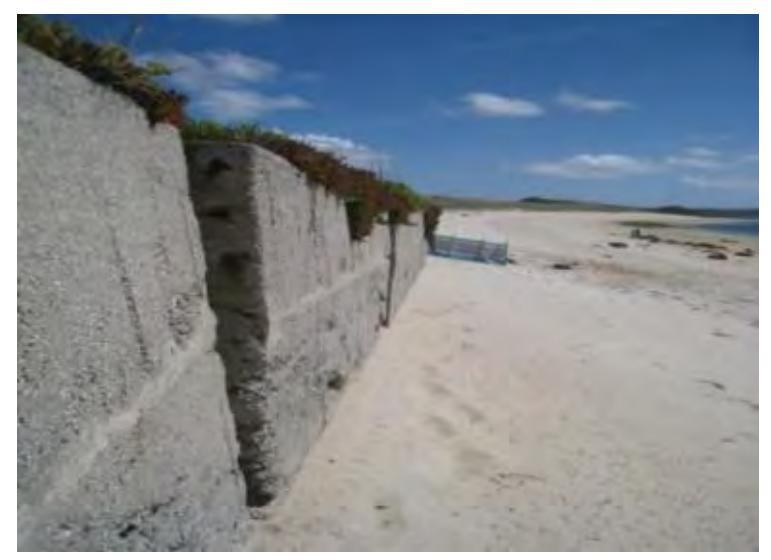
Figure 150: Section of wall displaced from adjacent section, potentially due to corrosion of steel ties

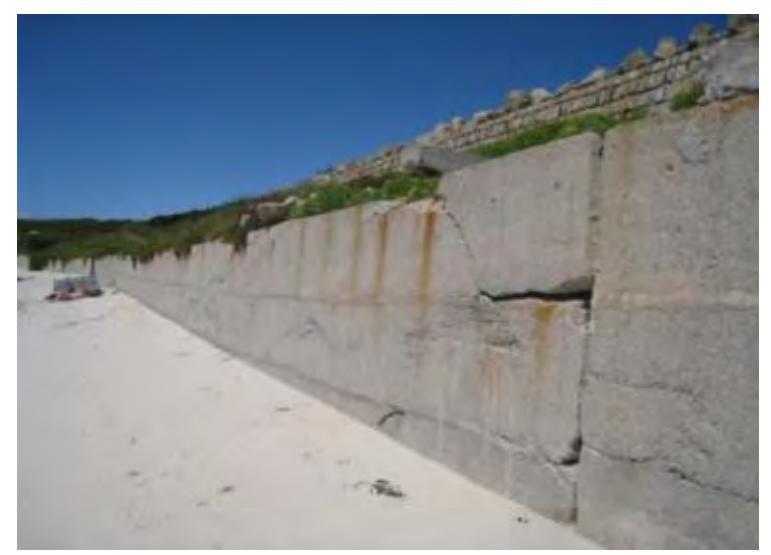
Figure 151: Fracture has occurred, in places coinciding with the original concrete pour lines

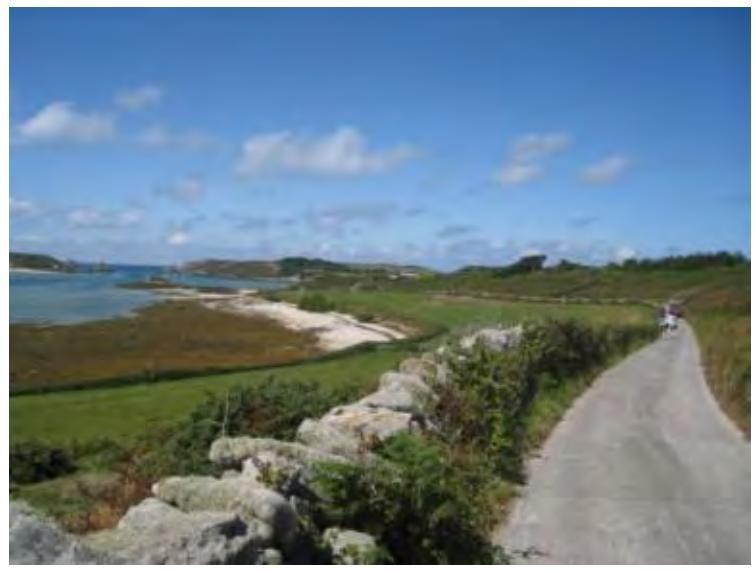
Figure 154: The ram cliffs between Appletree Bay and New Grimsby continue to erode, threatening the grazing land and local road

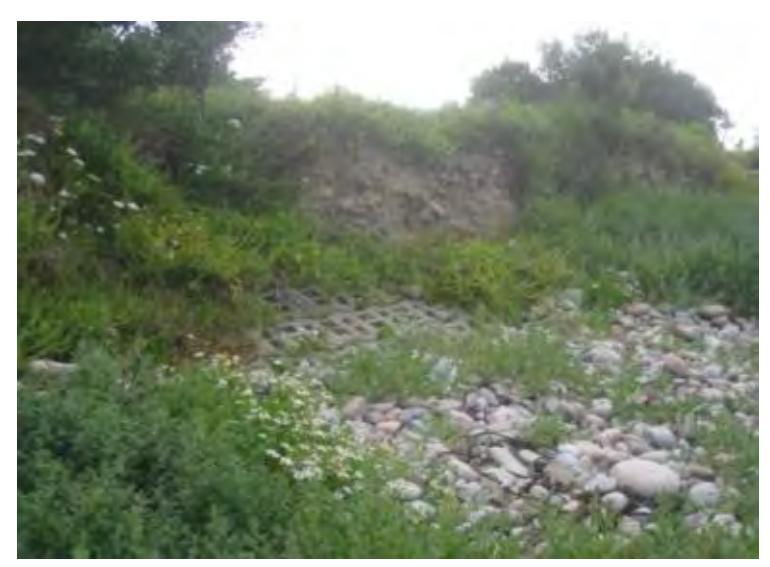
Figure 162: The concrete block revetment is clearly visible on the front face of the embankment. Erosion of the crest has taken place leading to an unstable face

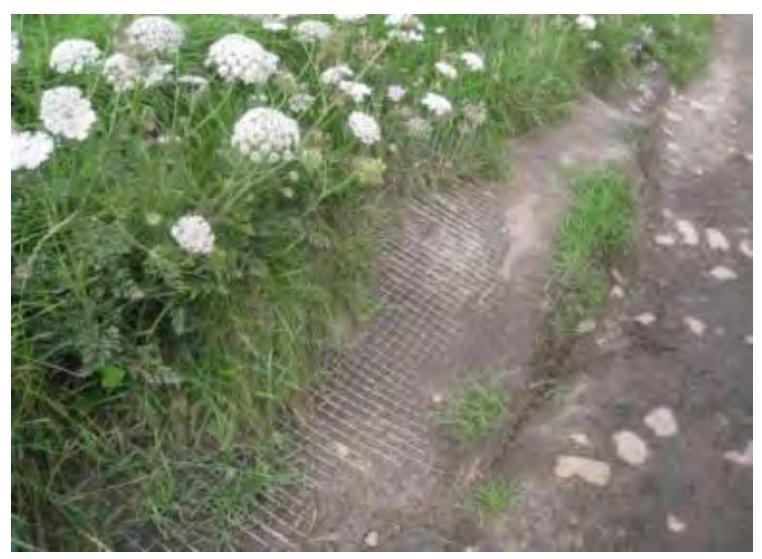
Figure 166: Reinforcement matting is visible at the toe on the back face. This has probably been exposed by rutting caused by farm vehicles, wider than the track provided

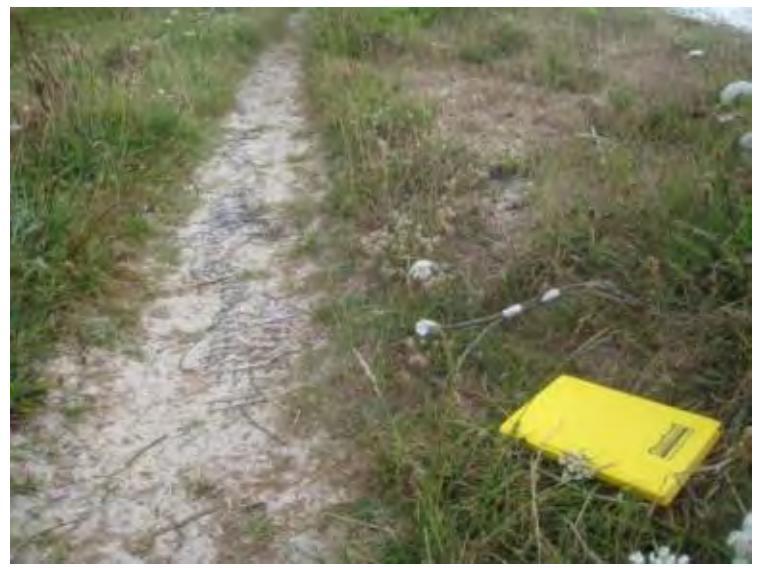
Figure 170: Erosion matting damaged from foot traffic and cable tie exposed

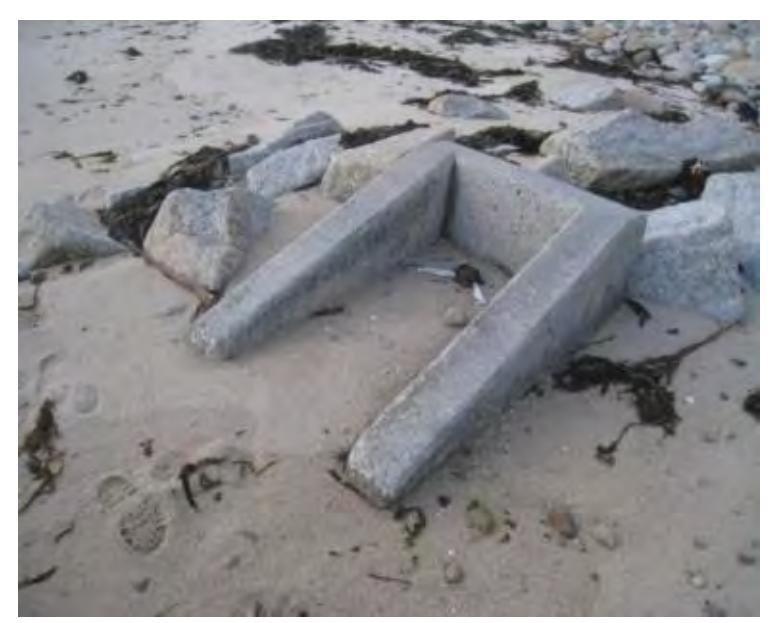
Figure 175: The headwall and flap valve on the front face is buried with sand

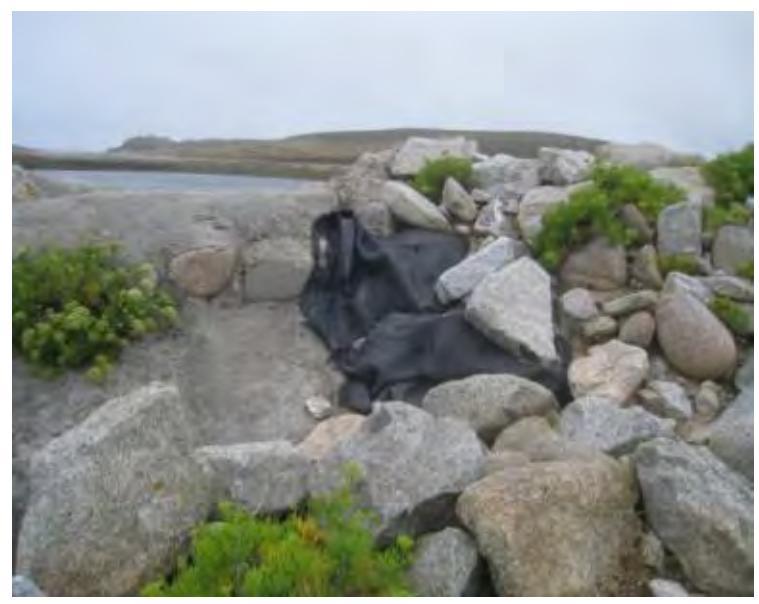
Figure 183: There has been a fracture at the centre of the wall

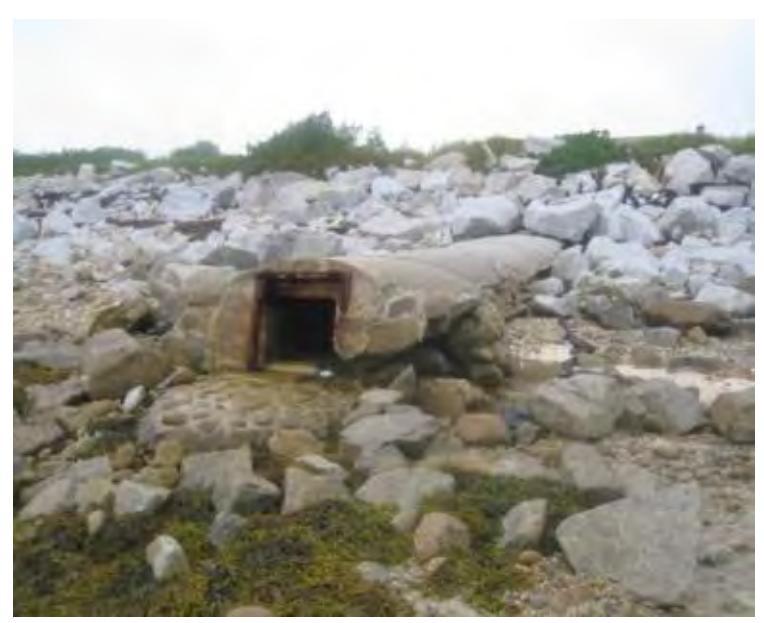
Figure 186: Outlet from Great Pool lies high up the beach at Great Par. The concrete surround has been fractured and there is an absence of a flap valve.
