## **Cornwall and Isles of Scilly Shoreline Management Plan 2**

Isles of Scilly Mid Term Review Appendix A

Client: Council of the Isles of Scilly

Date: 12 August 2016

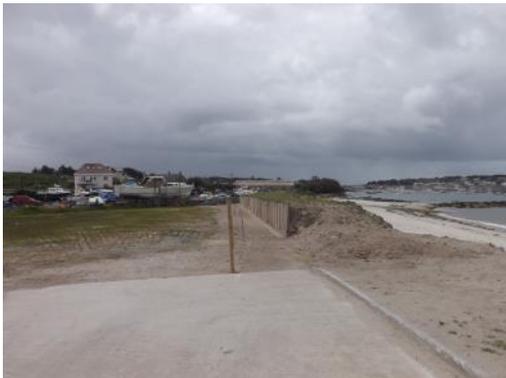
the Lower Moor, the frontage has suffered continuing erosion and pressure on defences and it is reported that overtopping due to wave action has contributed to flooding of the wider hinterland. This bay is more exposed to wave action than areas further to the south. The area immediately behind the recently constructed defences is used as a boat park providing an important storage and service area to boats moored within Town Beach. To the northern end of the bay is the main northern coastal road and this has been lost and reinstated in the past and is now defended.

The nature of the new defences along the central section of the beach is unlikely to be sufficiently robust to resist future pressure. Although constructed in an appropriate manner to minimise the visual impacts, the defence allows no width for change in the beach for development of the backshore with sea level rise. Whilst accepting the importance of the boat yard and the services this provides to the wider area, it has to be recognised that over the longer term development along this line of defence will require significantly more investment and will tend to result in lowering of the beach.

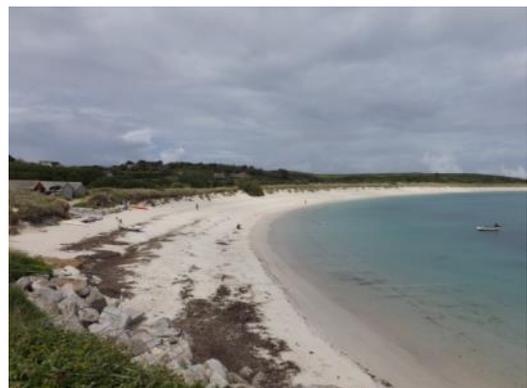
The natural beach plan runs into the protected cliff line running out in the lee of Higher Town Quay. This rock rip rap revetment behind the Quay acts to protect the access road to

the Quay as well as protecting some limited number of properties. The crest of the bank behind the rock has suffered minor erosion, presumably due to overtopping.

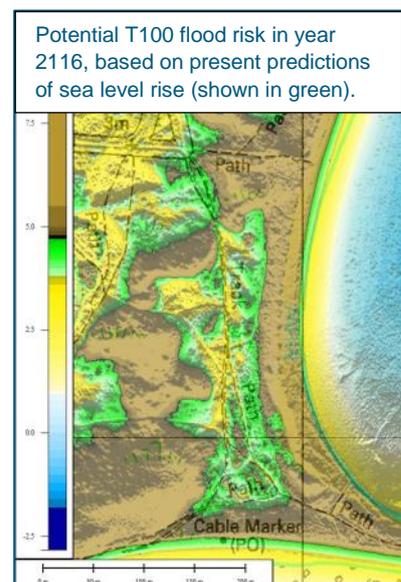
- Following the storms in 2014 the area, around the cable marker at the eastern end of Bathinghouse Porth, was subject to erosion; as was much of the cliffed dune frontage. While it is understood that the cable being marked is well beneath the surface there is concern that erosion in this area might open up flooding to the valley behind. Some minor works were undertaken to locally defend the marker. During the inspection, it was noted that some recovery of the dunes has occurred, with evidence of embryo dune development at the toe. Hardening the shoreline, even over a short distance in this area, is likely to impose a significant disruption to the naturally developing line of the dunes and cliffs, always with the risk that further works would be undertaken in the future, extending the need for defences to prevent outflanking.

Clearly there is a need to examine further the risk to the cable and to review the use and vulnerability of the wood storage and maintenance yard behind. However, in terms of more extensive flood risk it appears based on the Lidar data that, even in the future there is limited connectivity through to low lying areas

further to the north, as shown in the relevant image. Future risk could be managed by locally raising land levels at the critical point in the valley.

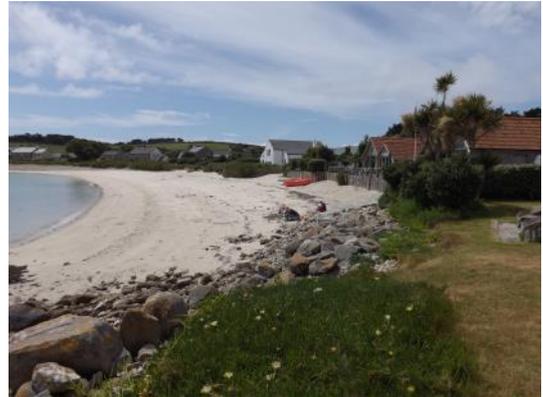
In relation to the hotel, further development of the facilities has to a degree imposed further constraint on the natural development of the foreshore. The nature of the area suggests that there is adequate supply of sediment generally but the issue relates to the potential limited width of the upper beach and back shore to maintain beach levels.

Even at present, as seen from the photograph of the hotel frontage, an upper beach is only allowed to develop where the defence is slightly set back. Over the next fifty years this situation will deteriorate and it would only be where defences are no longer held or where the shoreline is allowed to erode back that an upper beach will be maintained. This needs to be considered within the long term planning and future development of the resort.

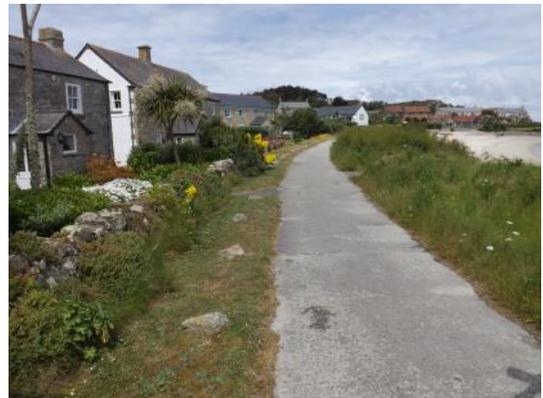
Further south within the bay, the situation is becoming more critical with limited width for adaptation. While properties in this area are above the T100 extreme water level at present, they are increasingly at risk due to wave overtopping.

At present there may be sufficient width over the crest of the defence to address such risk. In the future, with reduced beach levels and increased water levels overtopping will become increasingly frequent and more severe. Over the 100 year period still water level could exceed the level of defence over part of the frontage and overtopping is likely to affect significant areas around Dolphin Town.
