DESIGN & ACCESS STATEMENT – PORTHCRESSA FLATS, ST MARYS.

Introduction

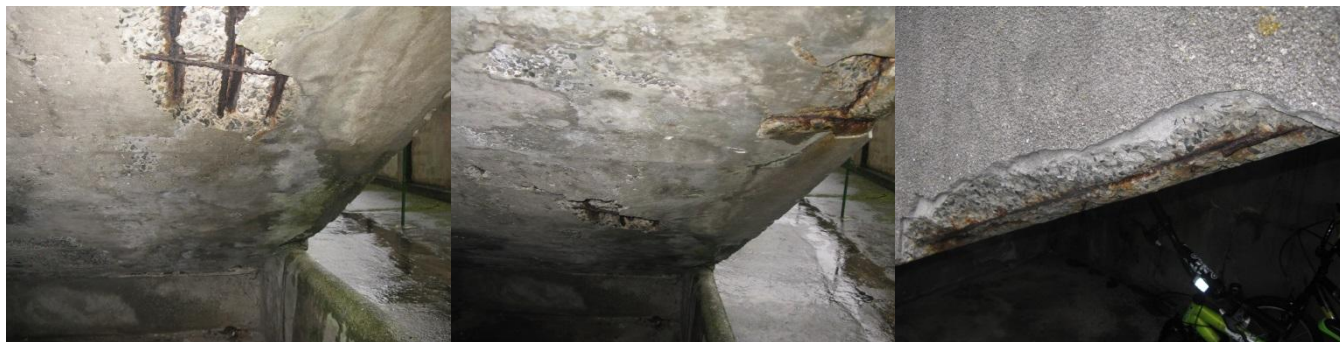
Corroded Reinforcement and spalled concrete to stairs

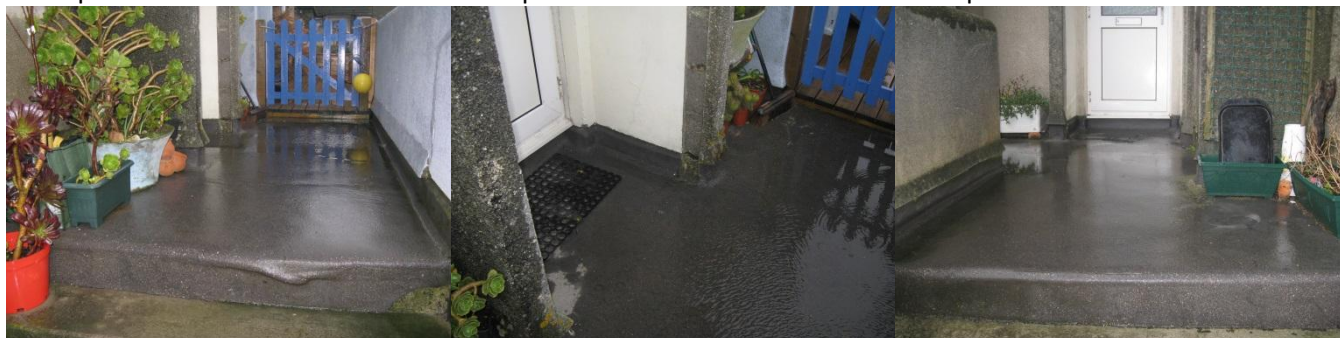
Failure of surface finish to walkways

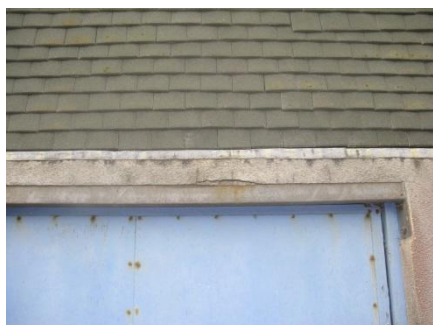
Failure of vertical tile hanging

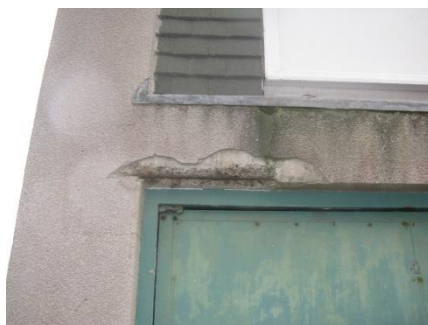
Corroded Reinforcement and spalled concrete to opening reveal

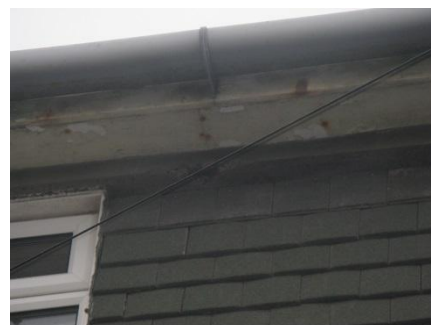
Poor condition of fascias and soffits.
