Heritage Impact Statement

The Galley Takeaway

The Parade, St. Mary's, Isles of Scilly.

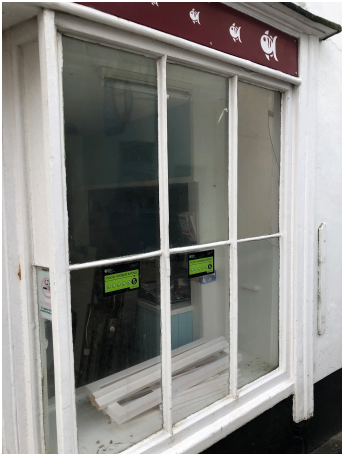
Existing Windows/Door

The existing windows and door are beyond repair; the windows have become unstable and unsafe, the glazing moves within its frame, and the frames are weak and suffering from rot.

The main door has been made good year on year and is now at a stage that it has been repaired so many times it now requires replacement.

On inspection of the large 6 pane glass windows it has been established that these windows were not made by a qualified carpenter and most likely constructed using cheap materials that would have been handy at the time. This can be easily noted as the windows are fitted with window putty on both inside and out; this should be a wooden transom with a bead or putty fixing to the outside only.

The proposed alteration to The Galley are to replace the front 6 pane windows and front door with window above.

The proposed replacement windows have been made to copy the existing listed windows to as close as they can be made whilst incorporating modern standards of build quality as possible.

The replacement windows are identical in size to the existing windows, the original windows posts and door frame to remain. The only difference is the beading which will be made in the "Ovolo Moulding" traditional style, formed inside and out.
