Replacement Windows and Door

The Galley

Lower Parade, St. Mary's, Isles of Scilly.

Record of Existing Windows

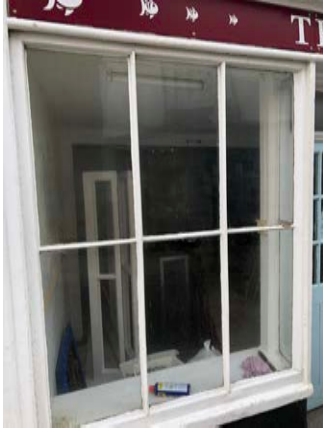
Left Front Window (Seen from the Street)

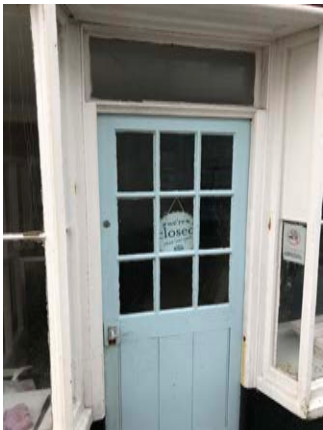
Front Door (Seen from the Street)

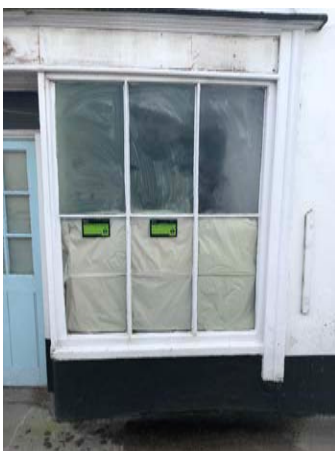
Right Front Window (Seen from Street)

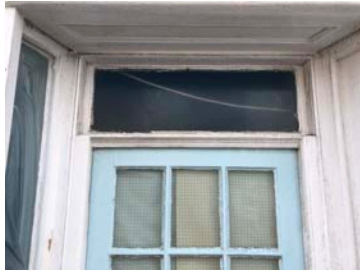
Over Door Glazing and Door Frame (From Street)

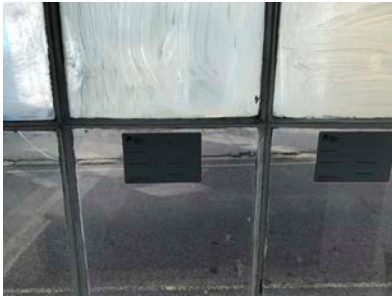
Window Moulding (Inside View) Showing internal Putty to Glazing

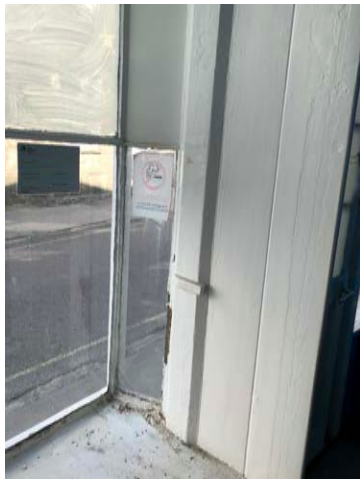
Internal View of Right Window with Window Post (to remain)

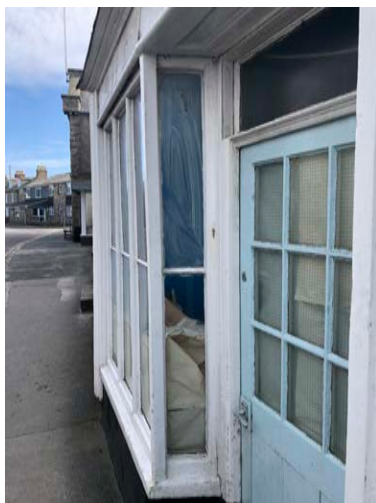
Window and Door Frame mouldings, Corner of Window Frame shown is a later addition to reinforce window structure (As shown in Carpenters diagram)

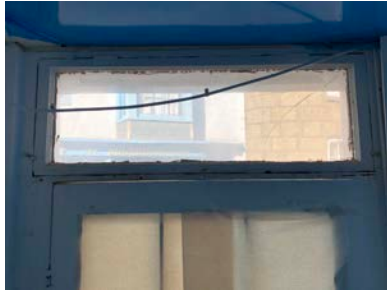
Above Window Glazing (Originally an opening Window that was later sealed over with moulding strip on the exterior.

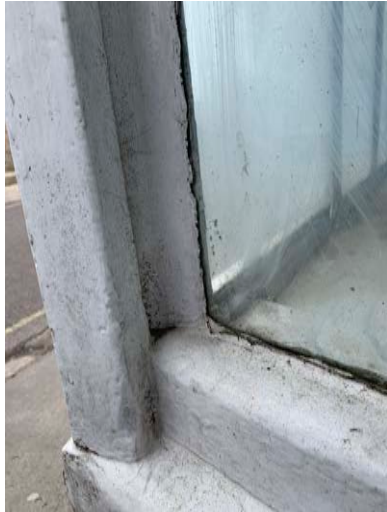
The left of the frame shows the additional timber to the window frame as shown in the carpenter's diagram.

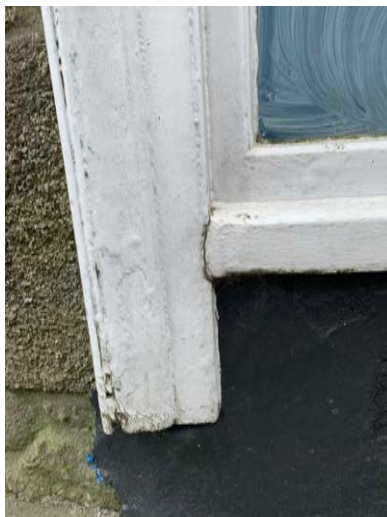
Wood Moulding to the outside of the window- This is to remain.
