# PRELIMINARY ROOST ASSESSMENT (PRA)

## OUTBUILDING AT GREEN PASTURES, MCFARLAND'S DOWN, ST MARY'S, ISLES OF SCILLY

*Report date: 27<sup>th</sup> August 2021*

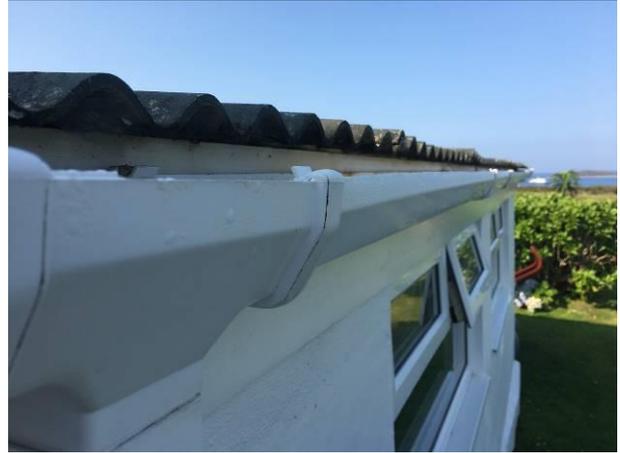
utilise such features due to their size and position within the roof. Any minor gaps present were observed to be well-cobwebbed at the time of survey which supports this assessment. There is guttering affixed on the northern aspect – this effectively blocks direct fly-in access to gaps under the ridges of the corrugated sheets from this side. The sheets are well-pointed on their junction with the walls on all other aspects with no cavities noted externally. The fascia board to which the guttering is attached is generally tightly fitted, though above the windows there is a gap offering direct access up and into the building interior. This is the only location where potential internal access was identified but the feature is not considered to represent a roosting opportunity in its own right.

**Photograph 2:** Showing the guttering attached to the fascia board on the northern aspect – this fitting effectively blocks direct fly-in access to the gaps in the corrugated roof sheets.

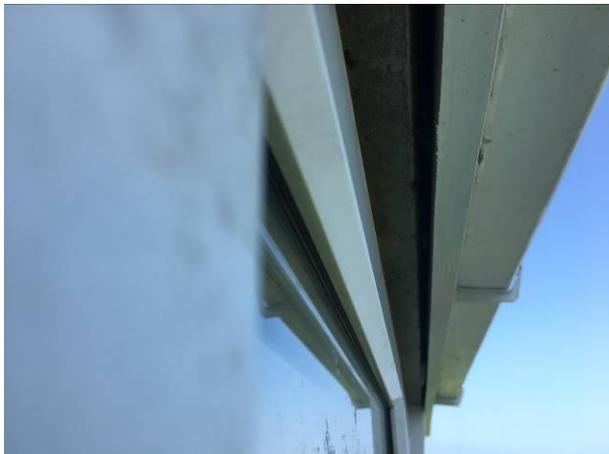
**Photograph 3:** Showing the gap beneath the fascia board on the northern aspect where it passes above the window, potentially allowing internal access to the outbuilding.

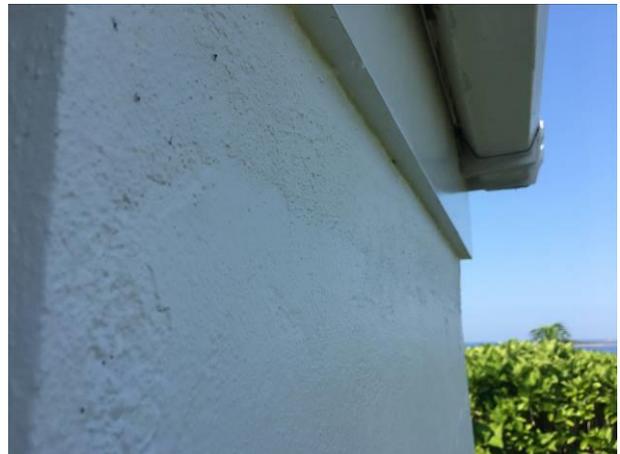
**Photograph 4:** Showing the tight fit between the fascia and the wall at all locations except above the windows.

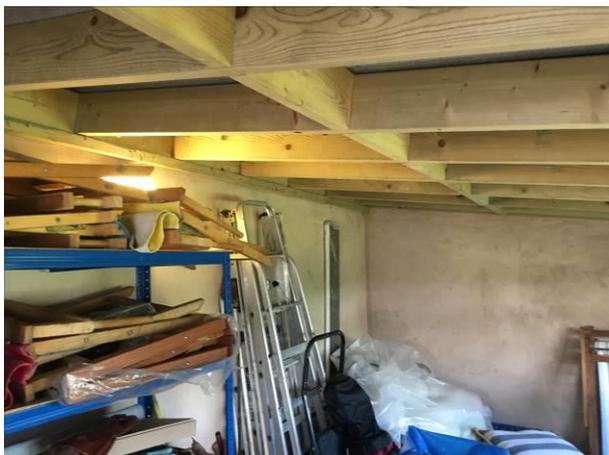
Internally the outbuilding is used for storage and appeared to be in routine use being clean and tidy. A careful inspection did not identify any droppings or other evidence of use by bats, and the internal conditions indicated that such a search could be considered comprehensive. There is no loft or roof void and the corrugated sheets were affixed directly to the timber roof structure. Occasional minor gaps were observed where the roof timbers meet the adjacent walls, though these gaps were sporadic and well-cobwebbed indicating no recent use by mammals including bats.

**Photograph 5:** Showing the interior of the building with the timber roof structure visible.

There is a negligible risk of bats being present internally in crevices between the timber roof structure and the adjacent walls. Where possible, the roof timbers around the edges of the structure should be removed by hand and with care.
