Design & Access Statement

Hilldrop – Store

Lower Town, St Martins

03 SEPTEMBER 2021

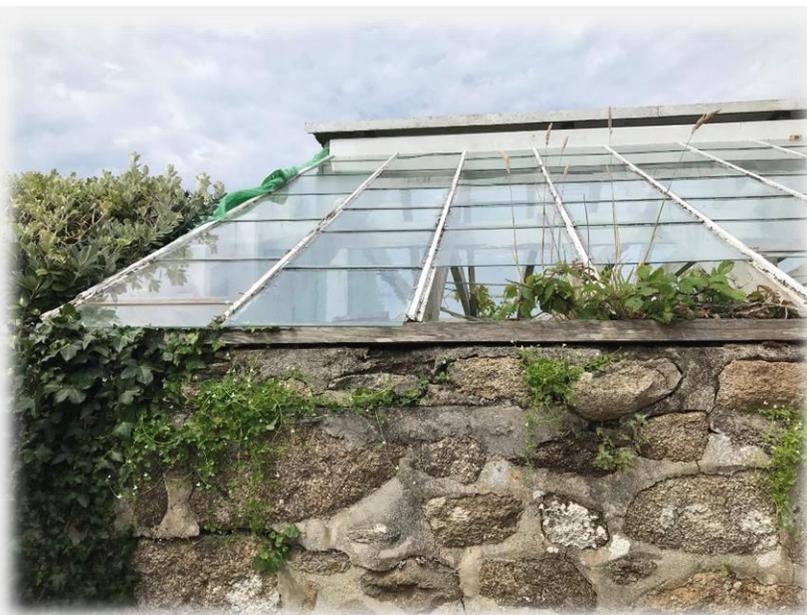
The out building is due for decoration works and during an inspection several maintenance and repair items were detected. Carrying out maintenance on buildings with sheet glass roofs is difficult and hazardous to operatives and regular maintenance is required to keep them in good repair.

The glass currently used is not safety glass and is between 2mm and 4mm in thickness. The tops of the rafters need painting on a regular basis and to do this in a safety conscious way it is necessary to remove the glass panes to give access, which in itself is a hazardous process.

“...maintenance is difficult and hazardous...”

The proposal is to remove the hazardous glass roof and replace with cement profile sheets to match existing.
