# PRELIMINARY ROOST ASSESSMENT (PRA)

## CHIMNEY REMOVAL AT FREESIA GUESTHOUSE HUGH TOWN, ST MARY'S, ISLES OF SCILLY

*Report date: 28<sup>th</sup> October 2021*

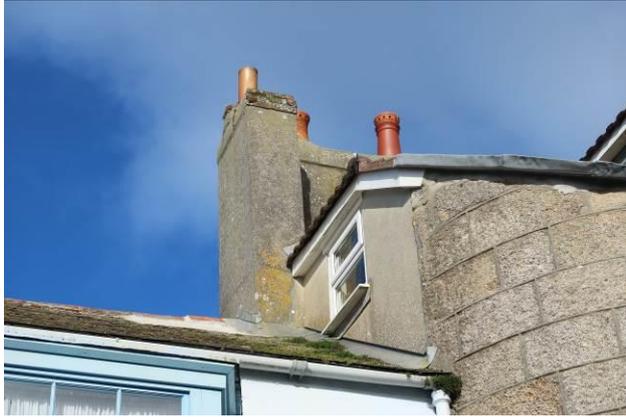
The chimney itself is of brick-built construction with concrete render – this render covers all external aspects and is in good condition throughout. There are three chimney pots – two of which were capped whilst the western-most appeared to be uncapped. The chimney structure itself did not appear to provide any potential roosting opportunities for bats.

**Photograph 1:** Showing the chimney with the higher structure of Freesia Guesthouse to the right and the lower roof of Bordeaux to the left.

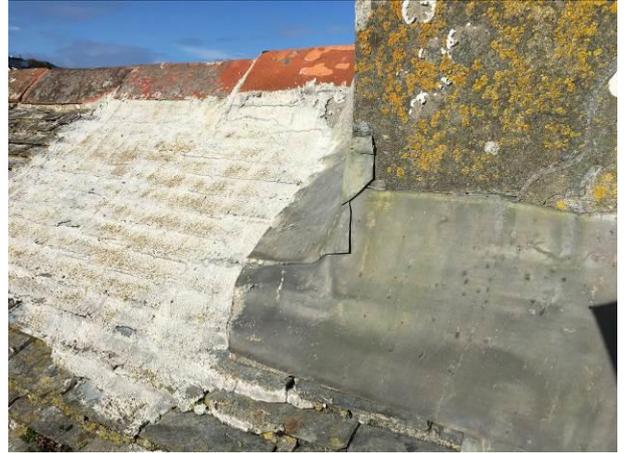
The points at which the chimney intersects the roof of both Freesia and the adjacent property Bordeaux were lined with flashing. This was well fitted and in good condition although this has the potential to change in time and could potentially offer a low-potential roosting opportunity for individual common pipistrelle bats if the lead were to lift with winter storms for example.

**Photograph 2:** An example of the tightly fitted flashing where the concrete-rendered chimney meets to the roof of Bordeaux.

The flashing around the chimney should be lifted carefully in such a way that in the highly unlikely event of a bat being present beneath, they are not crushed. Once inspected, the flashing can be removed.

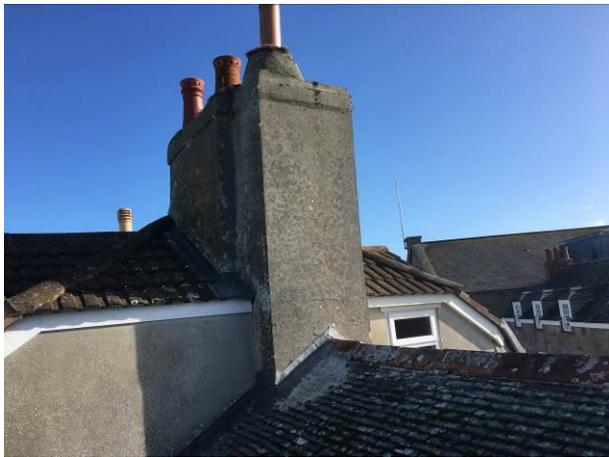
**Photograph 3:** Showing the hipped roof on the gable end of Freesia with the chimney meeting the lower roof of Bordeaux.

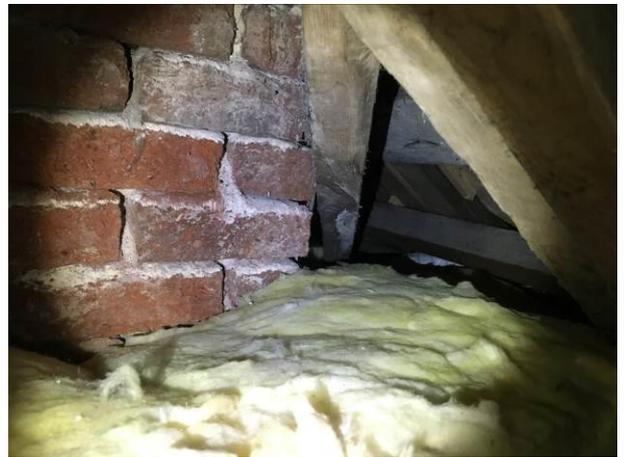
It was not possible to fully access and inspect the roof space of Freesia Guesthouse due to the restricted size and obstacles such as the chimney under consideration. However the conditions internally and the lack of any evidence from a torchlit inspection conducted from inside the loft hatch allows inferences to be made regarding the overall negligible likelihood of bats being present within the interior of the void.

**Photograph 4:** Showing the chimney from within the roof space of Freesia guesthouse – the brickwork is well pointed and no cavities were noted.

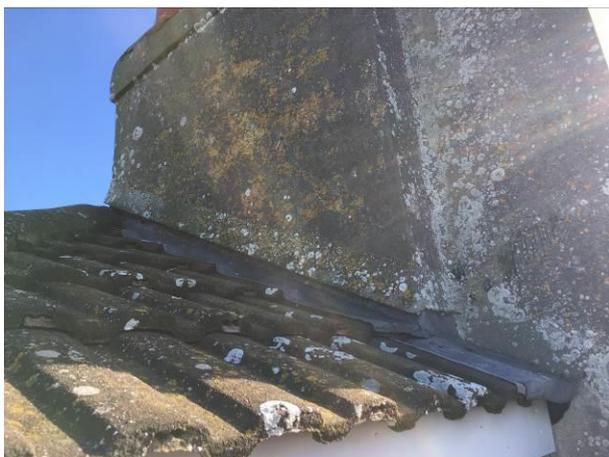
The roof of Freesia Guesthouse is pitched with dormer windows. The roof covering comprises concrete tiles which appear well-fitted, as are the well-pointed ridge tiles. The gable where the chimney is situated is partially hipped. The eaves are well-sealed with a soffit to one side of the chimney and a fascia on the other – both of these features are also well-sealed. Apparent gaps under the tiles adjacent to the chimney were inspected with an endoscope and found to be well sealed. An internal inspection of the roof void above the residential rooms found no evidence of bats or other species – internally this void is well sealed with clean insulation which facilitated the inspection. There appeared to be negligible potential that the area of roof around the chimney, or the internal loft space, provide suitable roosting opportunities for bats at the time of survey.

**Photograph 5:** Showing the well-fitted concrete roof tiles of Freesia abutting the chimney.

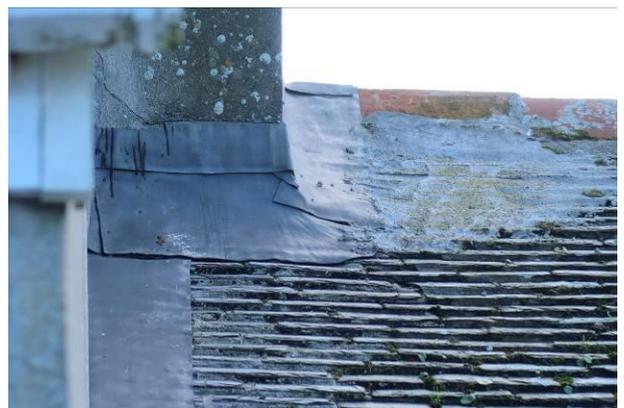
The roof of Bordeaux could not be accessed internally as this is a neighboring property under different ownership; however it was carefully inspected at height from a flat roof adjacent. The scantle slate tiles are well fitted and well pointed with no appreciable gaps or crevices. The ridge tiles are well-fitted and pointed. There is guttering running along the eaves preventing direct fly-in access at this location. There appeared to be negligible potential that the area of roof around the chimney, or the loft space, provide suitable roosting opportunities for bats at the time of survey.

**Photograph 6:** Showing the well-fitted scantle slate tiled roof of Bordeaux.
