PRELIMINARY ROOST ASSESSMENT (PRA)

REAR ROOF PITCH OF SAMSON HOUSE, PORTHLOO, ST MARY'S, ISLES OF SCILLY

Report date: 18th January 2022

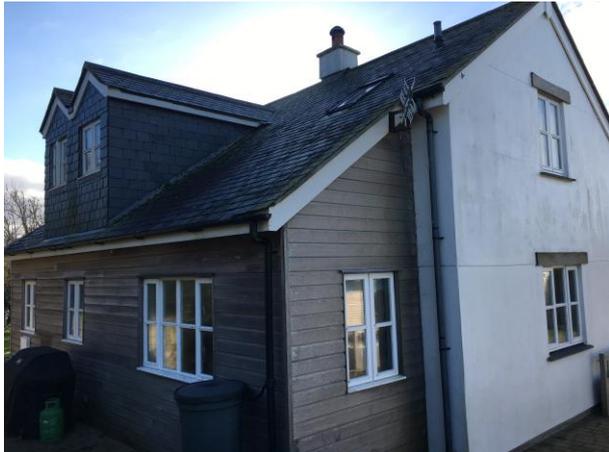
Photograph 1: Showing the proposed location for the new dormer window approximately 1m to the right of the existing dormer. Image is taken from the north-western corner of the property.

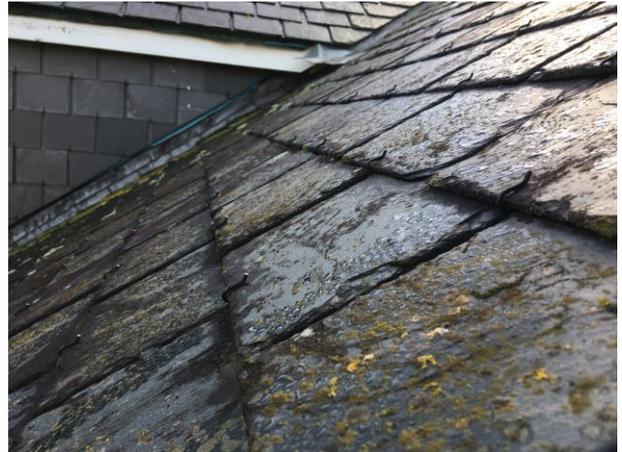
The roof section in question has a sloping pitch which finishes above a single storey element of the property to the rear. The slate tiles are well fitted and in excellent condition – no gaps were noted which would potentially provide roosting crevices for bats. Set within the section of roof under consideration is a Velux window – this is well fitted with no suitable roosting opportunities for bats identified around the fitting. Internally, the plasterboard has been stripped back and the timber structure supporting the roof can be directly inspected from the room. There is no internal roof void or other space to which bats could access – potential features would be restricted to gaps between the tiles and the underfelting and, as discussed above, the quality of the fitting excludes this possibility.

Photograph 2: Showing the roof structure from the existing Velux window – the scandle tiles are well fitted and in good condition. The adjacent dormer can be seen in the background.

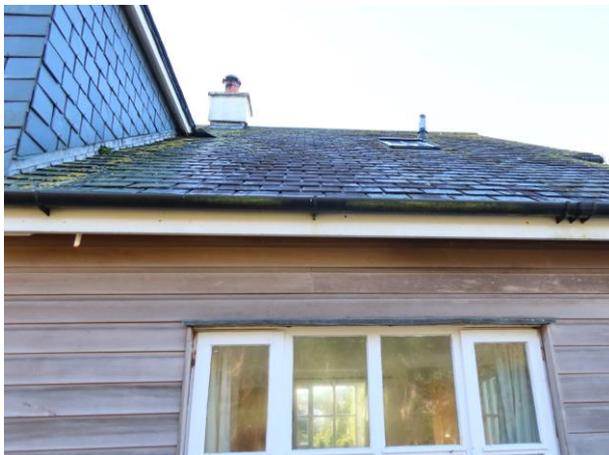
Photograph 3: Showing the roof section taken from the rear of the property – the tightly-fitted wood cladding of the exterior can be seen.

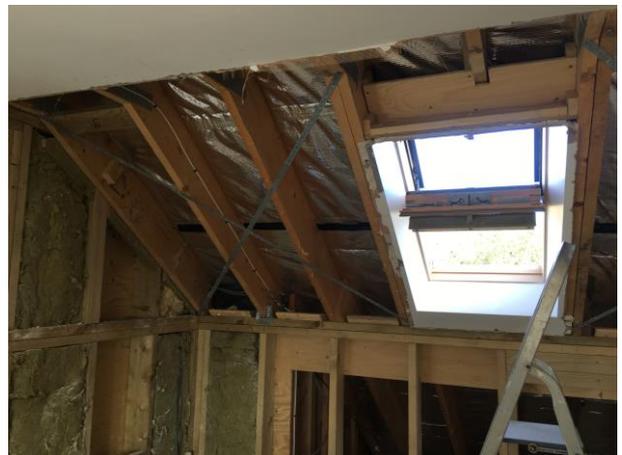
Photograph 4: Showing the view from inside the property – the underfelting is in excellent condition and offers no potential internal access to voids or roosting opportunities.

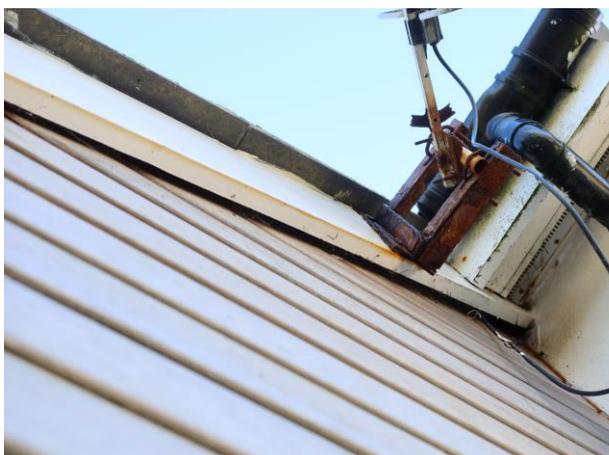
The fascia board running along the verge of the north-western gable of the roof is lifted in places – this could potentially provide roosting opportunities for individual bats.

Photograph 5: Showing the fascia board on the north-western gable with gaps beneath. This area would not be directly impacted by proposals.

The roof replacement works can approach, but must not impact upon or obstruct, these features in order for the assessment and working methodology outlined in this report to be valid.

Care should be taken during works to ensure that these structures are not disturbed, obstructed, or damaged. This involves careful design of scaffolding installation and may include a contractor briefing to ensure that those working on the roof understand the requirement. Other measures such as a temporary sign, tape or physical barrier should be installed if deemed necessary.

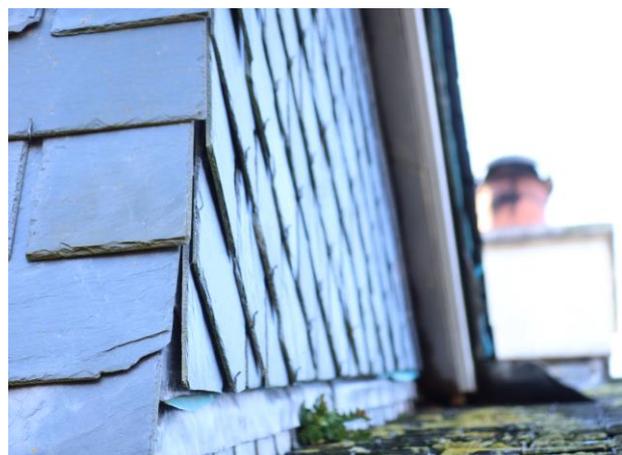
There are two dormer windows situated to the south-east of the proposed new dormer. There would be a separation of >1m between the new and existing dormers, and the existing dormers would not be directly impacted by the proposals. There are low-potential roosting opportunities which may be suitable for individual bats associated with these existing features – the primarily location is beneath the lead flashing at the apex where the window ties in with the roof, however small cavities beneath hanging tiles also occur.

Photograph 6: Showing the slightly lifted tiles on the adjacent dormer with the lifted flashing where it meets the main roof visible to the right.
