# Design and Heritage Statement

**Ashvale  
Lower Town  
St Martins**

02 FEBRUARY 2022

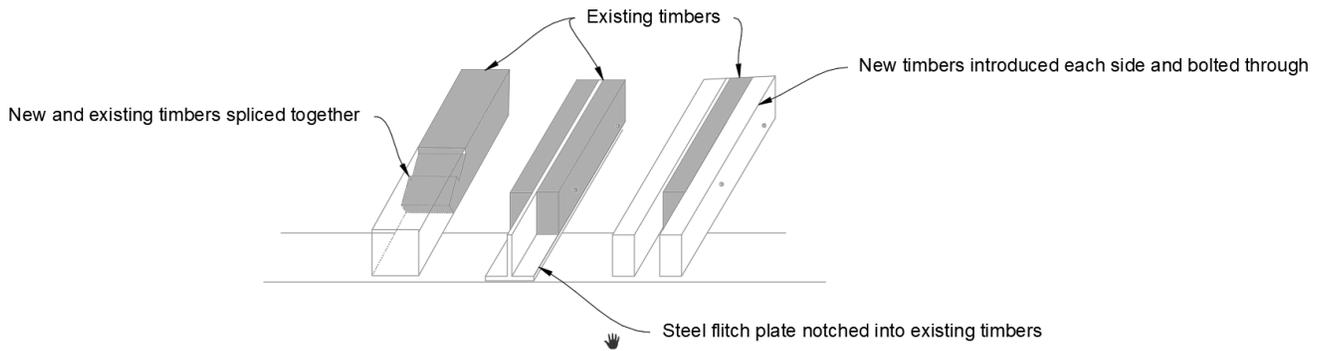
Timber repairs are inevitable and it is proposed to replace the wall plate in a like for like basis, whilst the feet of the trusses and rafters are likely to require repairs. An example of potential techniques used is shown on the diagram below, however the exact details of the repair can only be finalised at the point that the timbers are fully exposed during the process of re-roofing. Principles which will be adhered to include:

- Retain as much of the original elements as possible.
- Ensure process is reversible.
- Where replacing material do so with like for like materials.
- Honest exposure of repair work – where modern intervention used, make it an obvious repair.
- Document the process through photographic records.
