PRELIMINARY ROOST ASSESSMENT (PRA)

FORMER GLASSHOUSE AT CARRON FARM HIGHER TOWN, ST MARTIN'S, ISLES OF SCILLY

Our reference: 22-3-3

Report date: 23rd March 2022

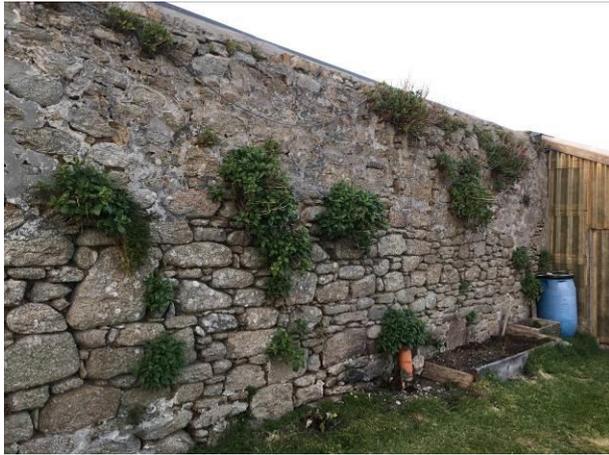
The main northern wall is approximately 3m high and constructed from granite blocks. The wall is predominantly well-pointed but occasional gaps do occur – whilst largely superficial, there are individual gaps which extend back into minor niches. These were comprehensively inspected with a video endoscope and no evidence of bats was identified. The level of exposure of potential roosting opportunities to the elements, especially prevailing wind and rain from the south-west, is significant and this was evident in the formation of these features which were largely clean of debris through wind-scouring.

Photograph 1: Showing the northern wall with occasional minor niches in the rock.

Both walls should be subject to an **inspection using a video endoscope** immediately prior to repointing in the case of the northern wall and demolition in the case of the southern wall. This must be undertaken by a **licenced bat worker**.

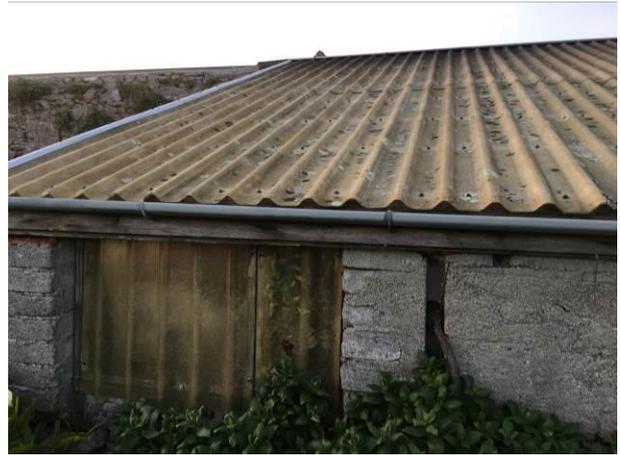
The southern wall is only intact along the boundary of the glasshouse – here there are very occasional minor gaps in the concrete which are similar in character and aspect to those associated with the exposed elements of the northern wall and subject to the same environmental exposure. They were fully inspected with a video endoscope and no evidence of bats was identified. The southern wall remains in reduced fragments along the remainder of the southern boundary of the footprint – here it offers no roosting opportunities.

Photograph 2: Showing the southern wall supporting the existing glasshouse roof. The fascia and guttering are visible.

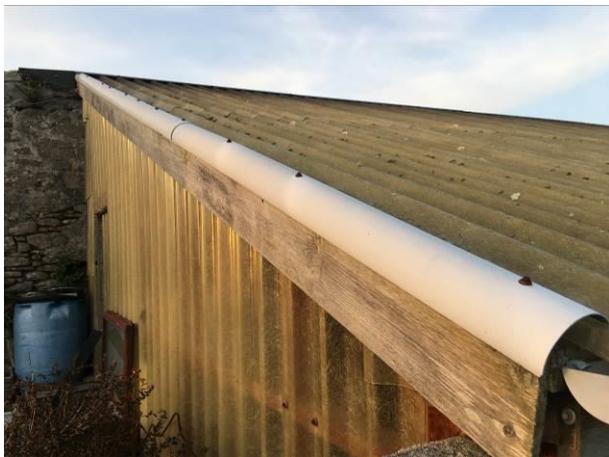
Photograph 3: Showing the western gable of the existing glasshouse with the fascia board.

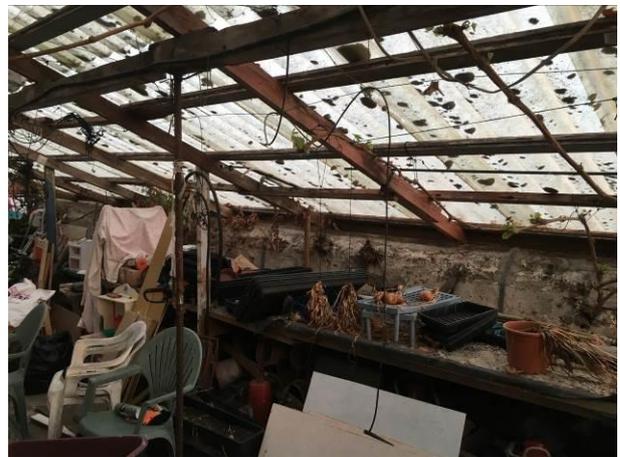
The northern wall extends within the existing modern glasshouse which comprises the eastern portion of the footprint – here the northern wall is internal to the glasshouse structure and well-pointed throughout. The glasshouse is constructed around wooden timbers which lie between the northern wall and a lower southern wall which is approximately 1m high at the eaves. This creates a single-slope pitched roof. Internally the glasshouse is used for growing fruit and vegetable plants as well as for general storage. The roof and gables are covered with a translucent plastic material creating a light, airy interior. The nature of these panels would make any niches between the sheets and associated timbers too light to be suitable for use by roosting bats. At the apex of the single-pitched roof, there is flashing where it meets the northern wall. As with the timbers, the intersection between the flashing and the roof material would be too light to provide suitable roosting niches. There is a fascia board supporting guttering on the southern aspect of the glasshouse as well as along the roof verge on the gable – these are well-fitted but where gaps occur at the base of the boards, there is no terminal apex as they open directly into the interior of the glasshouse.

Photograph 4: Showing the interior of the existing glasshouse.

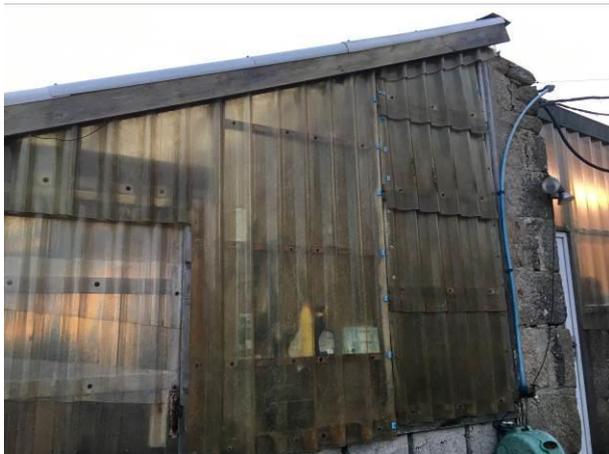
Photograph 5: Showing the eastern gable of the existing glasshouse with the translucent corrugated panels forming the majority of the structure.

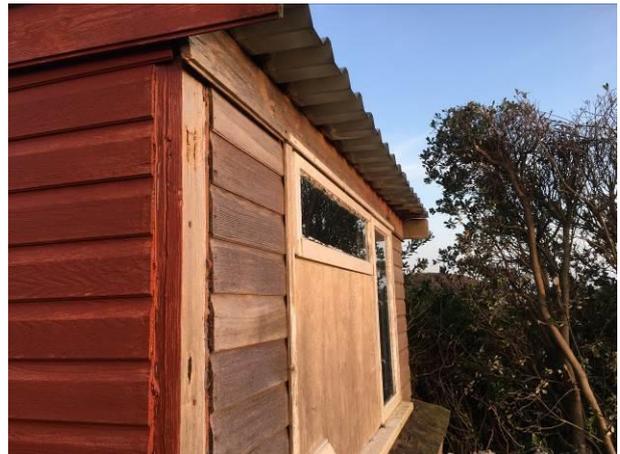
window on the western aspect. These doors and windows were well-fitted, as were their frames. It is used for typical storage of garden equipment and is light internally due to the windows on two aspects – no internal voids were present. The timber cladding was tight and well-fitted throughout. The roof is a gently-sloping single-pitched structure which is formed from tin sheets with wide corrugations open on the western aspect only. The gaps created by the corrugations would be too large to provide suitable safe roosting niches for bats. In addition, the spaces beneath the corrugations are likely to be subject to significant daytime temperature variations due to the thin sheet material and lack of shading. The corrugations were fully inspected with a torch and, whilst clear of debris, this was due to the level of exposure to prevailing western winds against which there is no protection. This roof structure was therefore considered to offer negligible roosting potential for bats. The fascia boards on the northern and southern aspects were well-fitted and minor niches were too superficial to be suitable for use by roosting bats.

Photograph 6: Showing western aspect of the shed with the wide-spaced corrugated roof visible where it is open.
