PRELIMINARY ROOST ASSESSMENT (PRA)

TOWN HALL, ST MARY'S, ISLES OF SCILLY

Our reference: 22-1-3

Report date: 4th March 2022

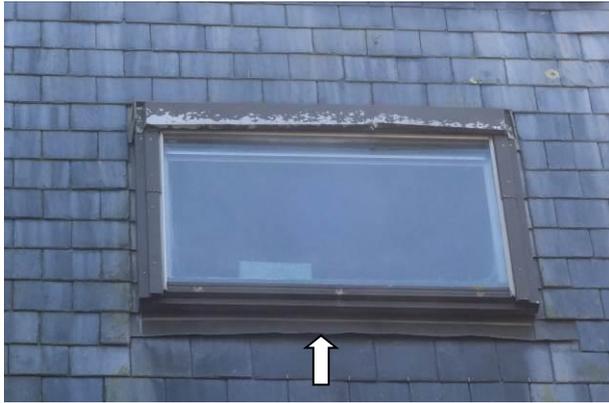
The windows are built into both the walls and mansard roof of the extension – these are generally well-fitted by the metal lining though this is lifted on one window on the northern aspect potentially providing access beneath. Further flashing is lifted at the top of the slate-tiled element of the construction.

Photograph 1: Showing the lifted flashing around the window on the 1970's extension on the northern aspect.

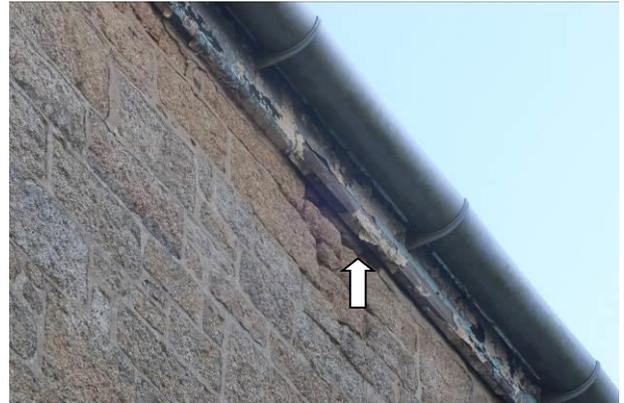
The slate roof was inspected at height on the western aspect but from ground level only on the eastern aspect. Slate tiles are generally well fitted but occasional minor gaps occur where tiles have slipped or lifted. The ridge tiles are similarly well fitted in the main, though occasional gaps occur. Where the roof meets with the adjacent 1970's extension, the valley is lead-lined and this appears to be in good condition. A fascia board supporting guttering runs along the eaves on the eastern and part of the western aspect above the front porch. There are gaps behind this in places, due to minor lifting but also reflecting the irregular nature of the granite blockwork which lies behind it. Minor gaps behind roof and ridge tiles, and behind the fascia board, could potentially support roosting bats.

Photograph 2: An example of the gaps behind the fascia board on the western aspect of the hall as well as gaps in the pointing beneath.

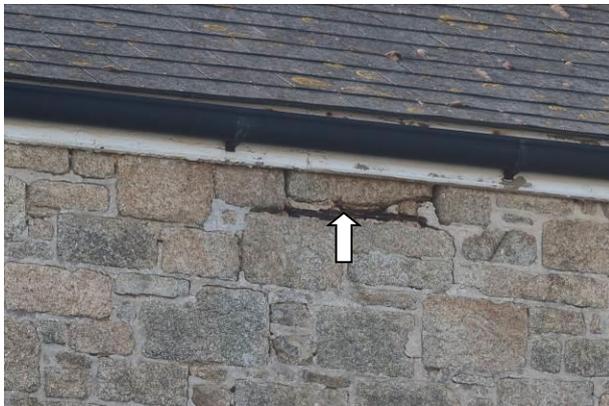
The pointing throughout generally appears in good condition though some gaps and cracks were noted on the eastern aspect which could potentially offer roosting opportunities. The external wall on the western aspect is largely internalized by the attached 1970’s extension except at the front of the building where only the single-storey front porch is present. There is a cottage attached to the hall on the eastern aspect and external wall on the western aspect forms the interior wall to the 1970’s extension which runs along its length. Air vents occur on the north-facing face with a louvered vent opening to internal plant close to the apex. These may

Photograph 3: Showing one of the cracks in the blockwork on the eastern aspect of the hall.

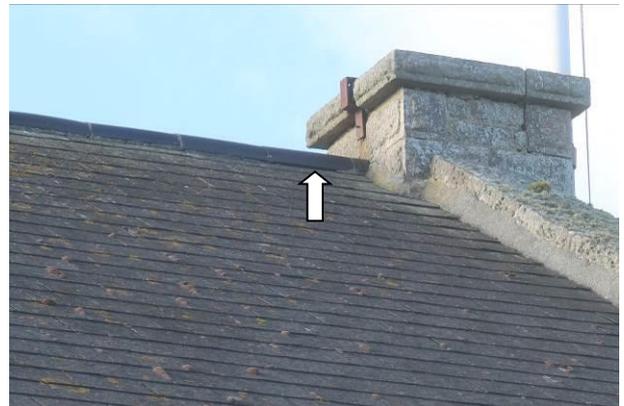
Photograph 4: Showing one of the minor gaps beneath the ridge tiles on the hall.

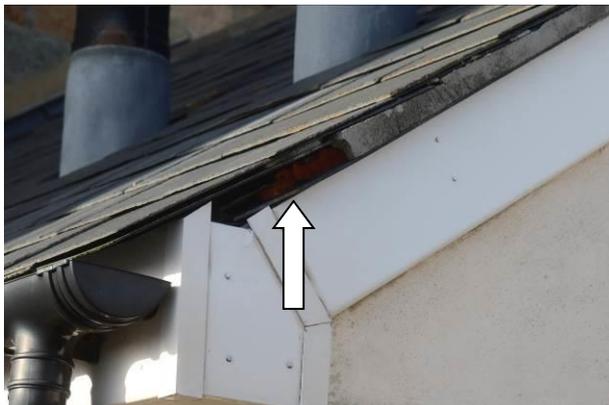
The pitched roof is generally well fitted though gaps occur beneath tiles at the eaves. There is lead flashing at the union between the roof and the adjacent hall which is lifted at the base providing minor gaps. Soffits run beneath the eaves with guttering attached; these are generally well-fitted but with gaps allowing potential access around the wall adjacent to the hall.

Photograph 5: Showing an example of the gaps allowing potential access beneath slate tiles in the plant room; similar features exist on the rear porch.

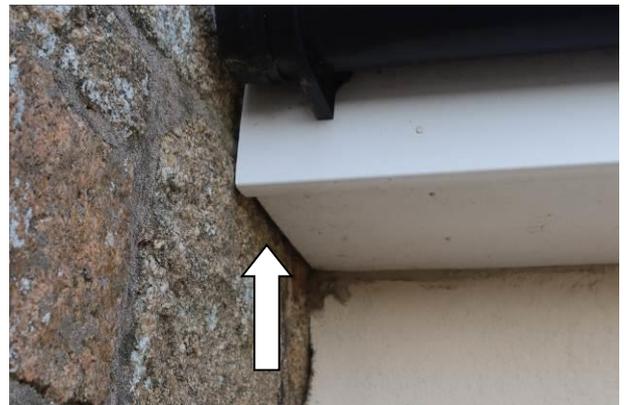
Photograph 6: Showing an example of the gaps allowing potential access beneath soffit box in the plant room; similar features exist on the rear porch.

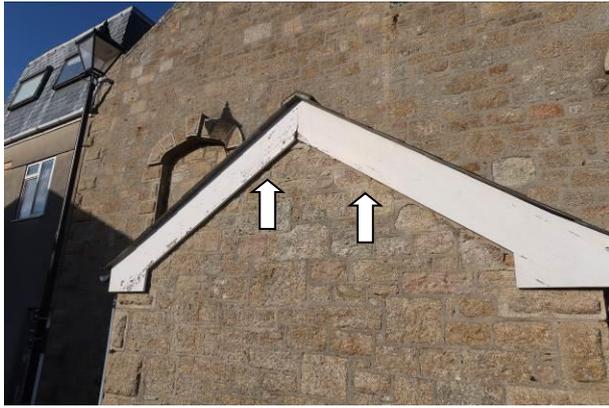
A single-storey porch is present on the southern aspect of the main hall. This has a well-fitted slate-tiled roof with minor gaps at the eaves but these are largely blocked by the guttering. There is a soffit below the eaves which is largely well-fitted though very minor gaps occur close to the wall of the hall. There are minor gaps beneath a fascia running along the gable apex which would provide suitable minor roosting opportunities. Further opportunities are associated with minor gaps behind lifted flashing where the roof meets the adjacent wall. Internally, the porch is under-boarded and well-sealed meaning there is no potential access to the interior of the structure; all roosting opportunities are associated with the external elements.

Photograph 7: Showing gaps behind the fascia board on the gable of the rear porch

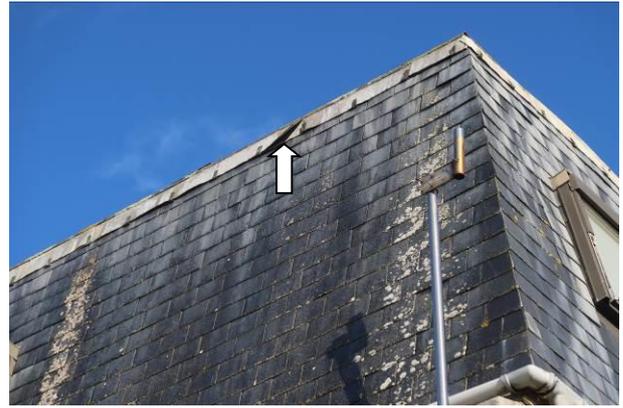
Photograph 8: Showing an example of lifted flashing at the top of the hanging tiles on the 1970's extension.

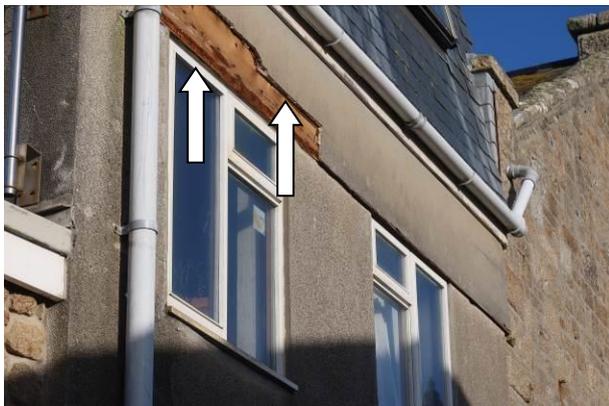
The southern aspect of this extension has uPVC windows which are well-fitted. However there is felted chipboard between the pebble-dash and the slate-lined Mansard roof which is damaged and lifted in places. Potential gaps occur here as well as beneath the flashing which overlaps the top of the slates and is lifted in places. These could provide potential roosting opportunities for individual bats.

Photograph 9: Gaps behind the boarding on the southern aspect of the 1970's extension; similar features are present on the western aspect.

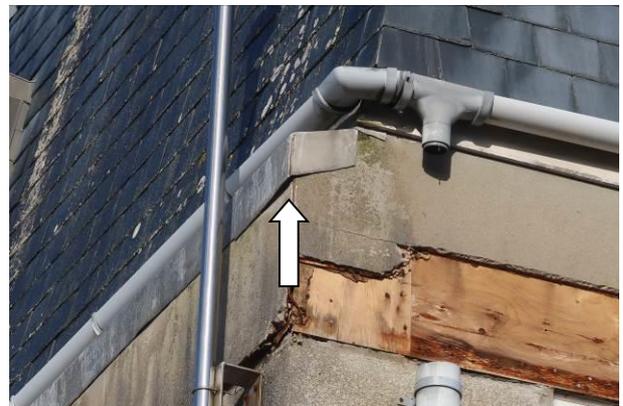
Photograph 10: Showing an example of lifted flashing between the slate tiles of the Mansard roof and the boarding beneath on the 1970's extension

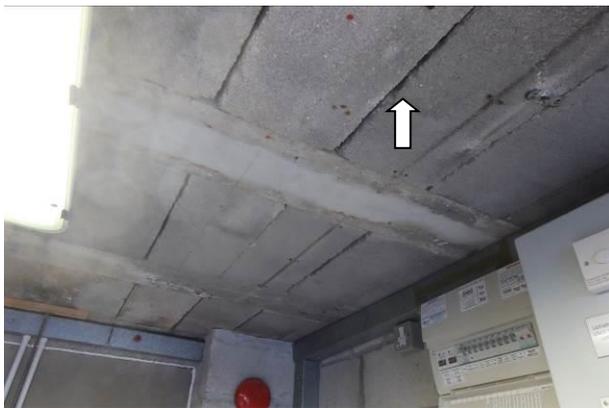
On the eastern aspect of the main hall is a plant room supporting a boiler. This is single-storey with a pitched, slate-tiled roof. Internally, the ceiling is breeze block with gaps between the blocks offering suitable roosting niches for bats. Internal access for bats would be possible through the louvered door.

Photograph 11: Showing gaps between breeze blocks in the ceiling of the plant room.

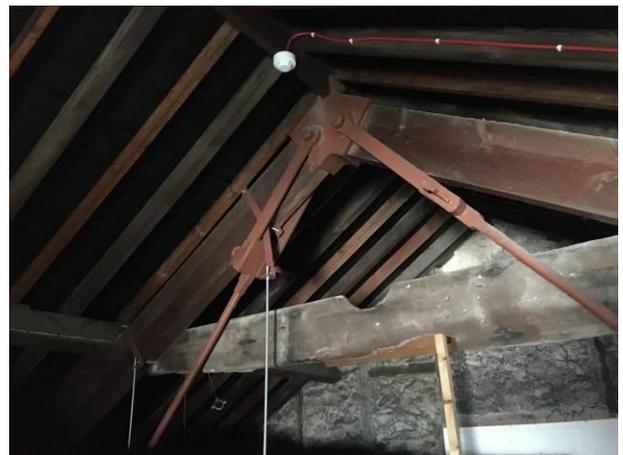
There is attic space above the office/stores to the north of the building. This is under-felted throughout – the felting appears to be in good condition but there is potential internal access for bats at the eaves and also in the wall around the vent where plant exits the attic space. The attic appears rarely used and there is dust and debris present; however this permitted a full inspection and no evidence of roosting bats was noted. There are limited internal roosting opportunities, restricted largely to free-hanging from timbers or discreet opportunities between wooden elements of the construction or fittings. The window in the attic space means that this area is light during the daytime. Internal walls were well-pointed and no suitable crevices for bats were noted.

Photograph 12: The attic space within the main hall showing the timber roof structure and underfelted above. Lighting is from the window set into the north wall.
