PRELIMINARY ROOST ASSESSMENT (PRA)

TREBOETH. HUGH TOWN, ST MARY'S, ISLES OF SCILLY

Our reference: 22-5-1

Report date: 4th June 2022

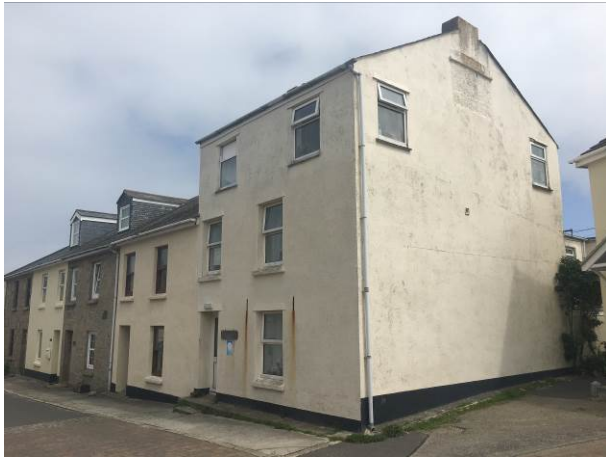
Photograph 1: Showing the western (front) and southern (side) aspects of the main three-storey building.

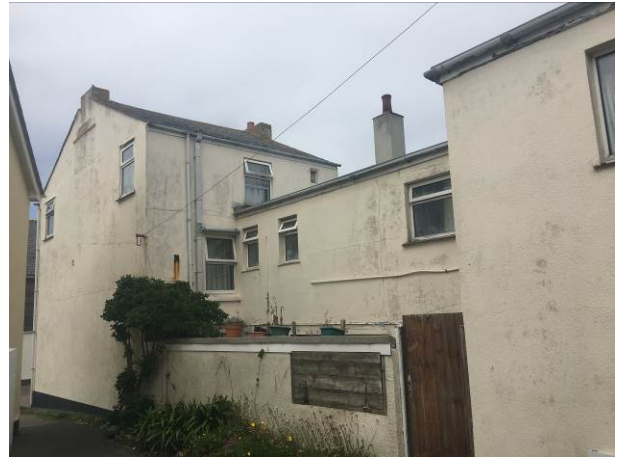
The outbuildings are single-storey and rendered with single-pitch sloping roofs of corrugated sheet or fiberglass construction. There were open doors/windows facing the enclosed alleyway/courtyard allowing internal access and inspection of each; however these appeared to offer no internal or external niches suitable for use by roosting bats.

Photograph 2: Showing the southern aspect of the building complex including the single-storey outbuildings and the 2-storey flat-roof extension behind the main 3-storey house.

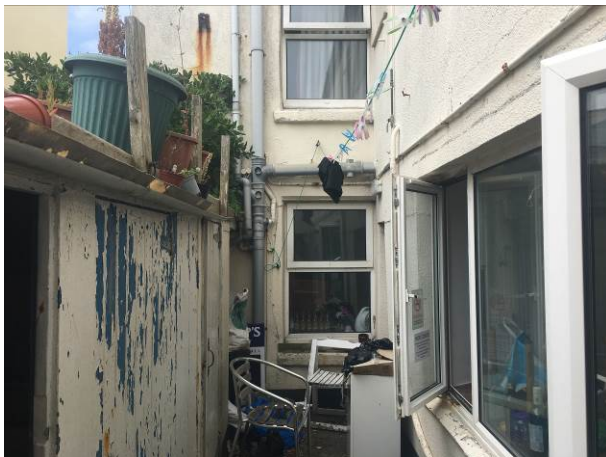
Photograph 3: Showing the alleyway on the southern aspect with the outbuildings to the left; the main 3-storey house ahead and centre; and the 2-storey flat-roof extension on the right.

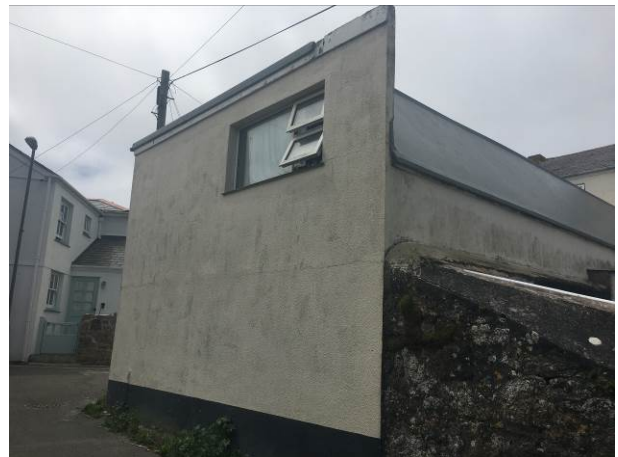
Photograph 4: Showing the eastern façade of the 2-storey extension with the steep single-pitch element which terminates the otherwise flat roof on the northern aspect.

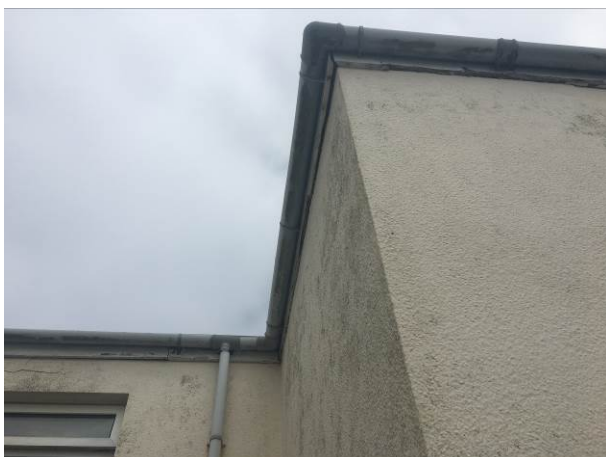
It is considered that the gaps beneath the ridge tiles on the three-storey building; and the gaps behind fascia boards on the two-storey building offer **negligible potential** for use by roosting bats. No other suitable features for use by roosting bats were identified.

Photograph 5: Showing the fascia boards behind which gaps occur in several locations around the two-storey extension.

If these elements of the building are affected by works, they should be removed carefully and by hand in such a manner that, in the unlikely event of a bat being present, they are exposed and identified without risk of crushing or otherwise harming the bat in the process.

Once these areas have been fully exposed, a careful inspection should be undertaken after which works can proceed without further constraint provided that no bats or evidence of bats are identified.

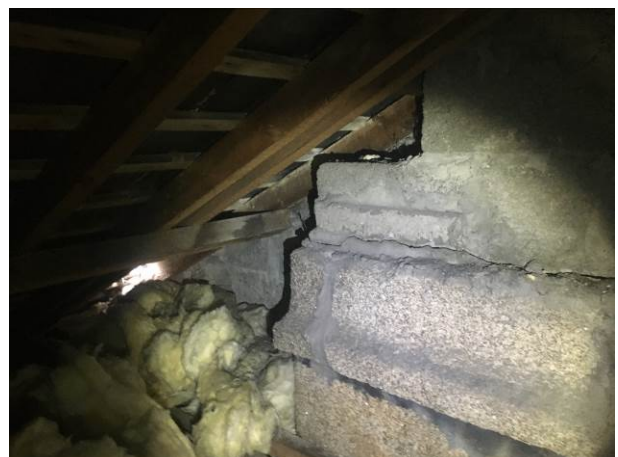
The main roof structure of the three-storey house comprises slate-tiles directly attached to battens with no underfelted. This is generally well-sealed though some gaps at the eaves would allow internal access to the loft space for bats. The A-frame timbers are tightly fitted and offer no gaps between them and adjoining timbers. There is a ridge beam which is predominantly well cemented into position though minor gaps do occur. The loft space contains a water tank, a television aerial and other pipework and electric cabling with insulation covering the floor throughout. The void was fully inspected and no droppings of bats or other species such as rodents were identified; nor was there any evidence of birds accessing the loft space. There are chimney stacks at either end of the roof – one of granite and one of brick construction. These were in good condition and did not appear to offer any roosting opportunities for bats. The terminal rafters are set far enough from the gable walls that they do not offer roosting crevices. Overall, the loft and roof structure offer free-hanging roosting opportunities internally; or potentially beneath minor gaps in the ridge tiles at the western edge of the roof – these tiles are otherwise well-fitted. Both of these potential features are considered to be of negligible potential.

Photograph 6: Showing the granite chimney within the loft with slate tiles directly onto battens and light visible at the eaves indicating potential for internal access.
