# PRELIMINARY ROOST ASSESSMENT (PRA)

## SELECTED STRUCTURES AT KAVORNA HUGH TOWN, ST MARY'S, ISLES OF SCILLY

**Report date:** 10<sup>th</sup> November 2021

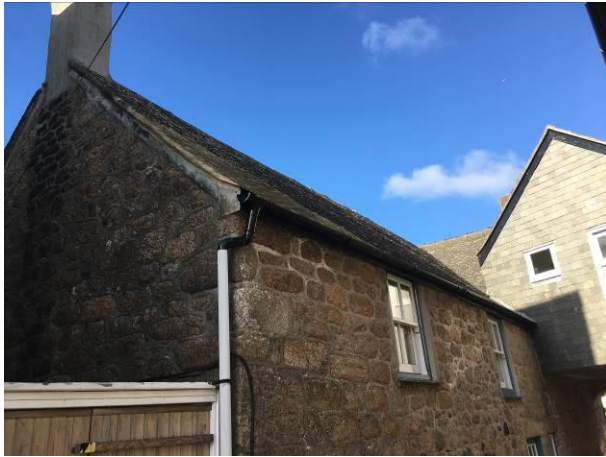
**Photograph 1:** Showing eastern aspect of the pitched roof to be replaced at Kavorna.

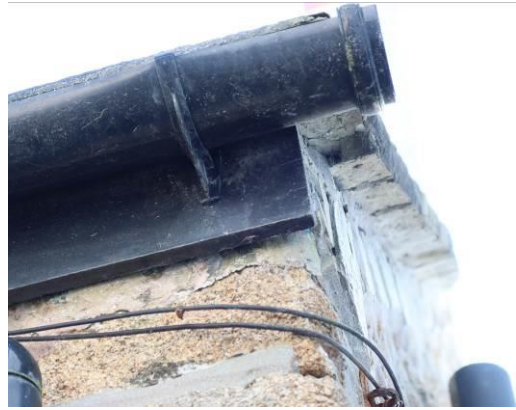
The building is of granite construction with a pitched scantle slate-tiled roof. The exterior facade is in good condition with exposed granite blocks with well-maintained pointing. The gable is well-pointed with no gaps along the roof verge. A wooden fascia board runs along the eaves with guttering attached – there are gaps beneath this boarding in places but these were generally wide and could be fully inspected from the ground with a torch and binoculars. Whilst discreet sections of the fascia provide cavities with dimensions suitable for bats to roost behind, these are infrequent and relatively exposed due to the irregular surface provided by the granite blockwork. The ridge tiles and concrete-rendered chimney are well-sealed and in good condition.

**Photograph 2:** Showing fascia board and guttering which runs along the eaves, along with the well-sealed gable end.

Fascia boards associated with both the pitched roof and the outbuilding have negligible risk of being used by roosting bats. These should be removed carefully by hand in such a way that in the highly unlikely event of a bat being present beneath, they are not crushed by the removal of the board.

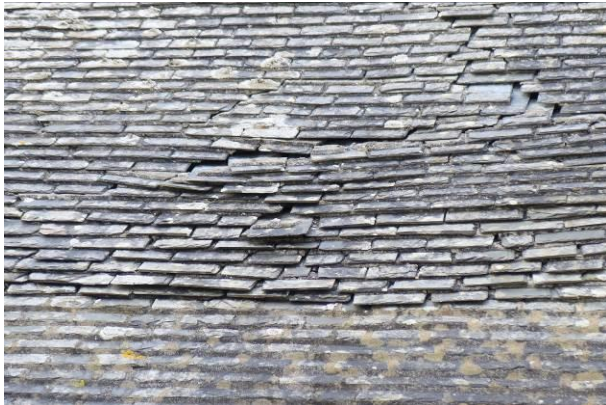
The scantle tiled roof itself is predominantly well-sealed with mortar beneath the tiles. The exceptions to this are areas where the roof has slipped, necessitating the proposed re-roofing works. Even in these instances, the mortar is often still present and intact; though in other places there are gaps beneath the tiles which provide direct potential access into the roof space.

No evidence of current or historic use by bats or nesting birds was identified during the survey and an overall negligible potential was determined; however it is noted that there is a small chance of opportunistic/transient use of gaps beneath slipped tiles within the pitched roof during the bat active season only.

**Photograph 3:** Showing the areas of slipped tiles on the roof.

There is a small risk of bats making transient use of minor cavities created by the slippage of the tiles which have necessitated the replacement works. Works to the pitched roof should therefore be conducted outside of the active season when the conditions would not be suitable for opportunistic or transient use of these features.

Roof replacement works should therefore be undertaken between November – March inclusive. This timing of works recommendation applies to the pitched roof replacement only and does not apply to the demolition of the outbuilding.

There is a small risk of bats making transient use of minor cavities created by the slippage of the tiles which have necessitated the replacement works. The tiles around the area where the slippage occurred should be removed carefully in such a way that in the highly unlikely event of a bat being present beneath, they are not crushed by the removal of the tile.

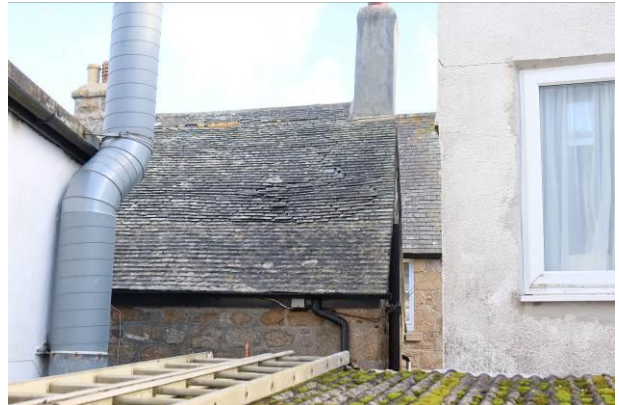
**Photograph 4:** Showing eastern pitch of the roof to be replaced.

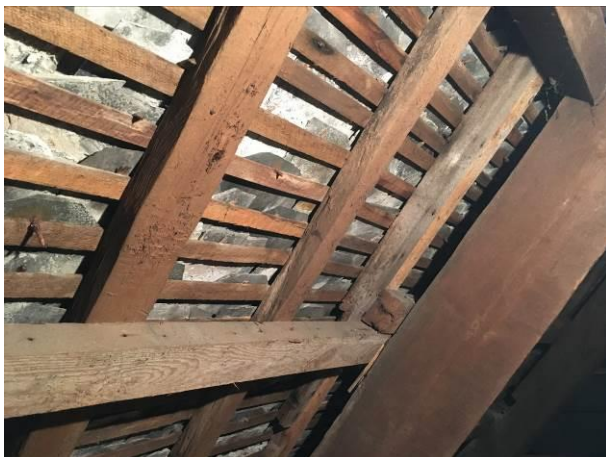
Internally, a full inspection of the loft space was conducted including the adjacent areas of the loft within the roof running parallel to Hugh Street which would not be directly affected by the proposals. The roof is built around an A-frame timber structure with no under-felting or insulation – the tiles are directly visible attached to battens. No ridge beam is present – instead the ridge tiles directly cap the scantle tiles of the roof. No evidence of bats or other species such as rats, mice or birds were identified.

**Photograph 5:** Showing the interior of the loft space with scandle tiles laid directly onto timber battens – no underfelting present.

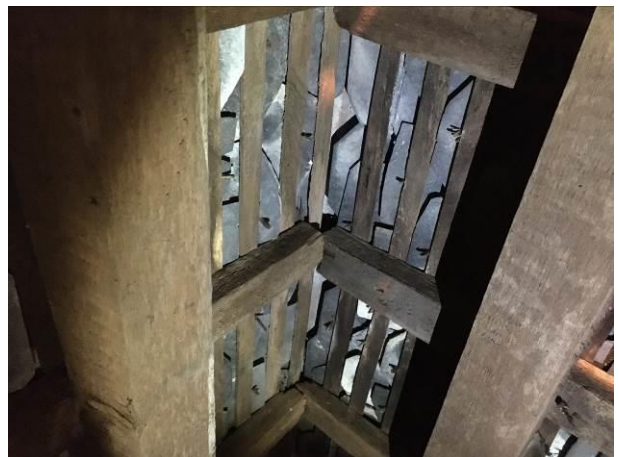
**Photograph 6:** Showing the internal pitch of the roof – no ridge board/beam is present.

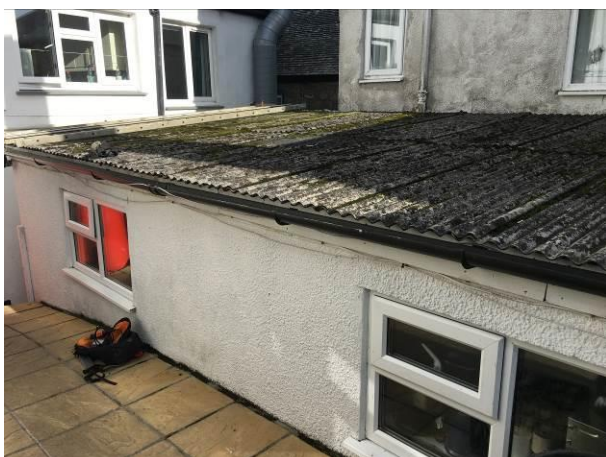
**Photograph 7:** Showing the western aspect of the outbuilding – this surrounding land is elevated on this side of the building resulting in low profile.

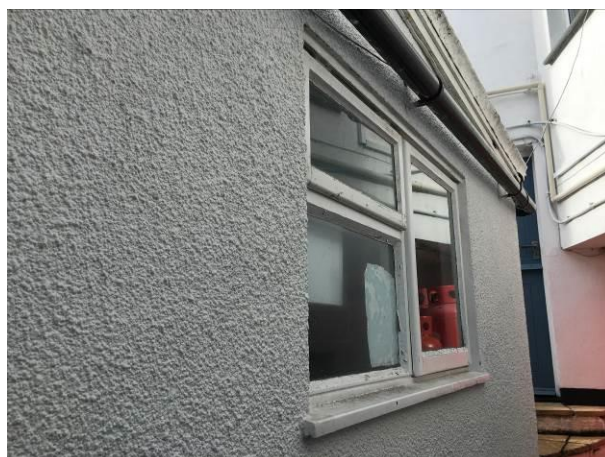
**Photograph 8:** Showing typical uPVC windows fitted tightly with rendering in good condition.

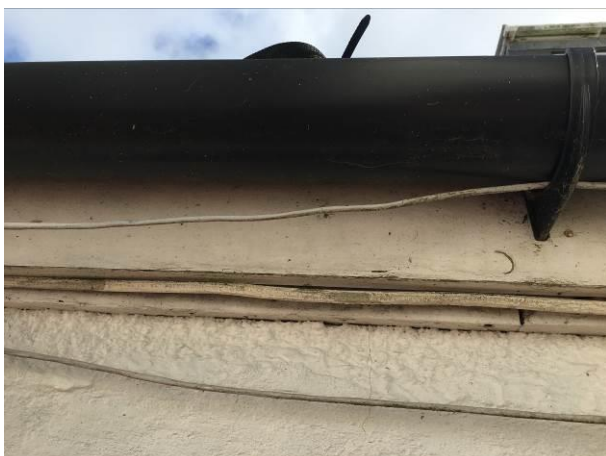
**Photograph 9:** Showing the timber fascia with guttering attached running along the western aspect of the outbuilding.

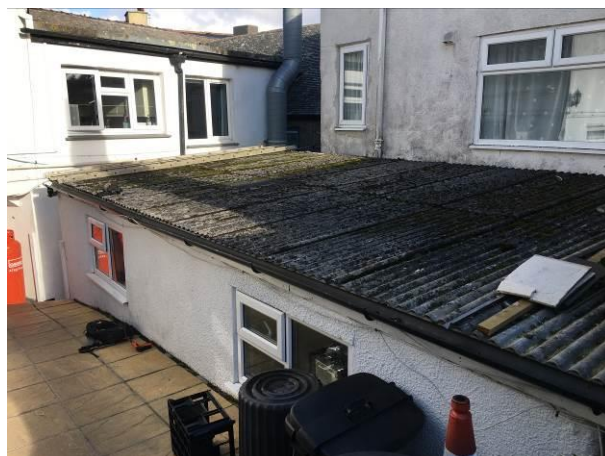
**Photograph 10:** Showing the western aspect with a pitched, corrugated roof.

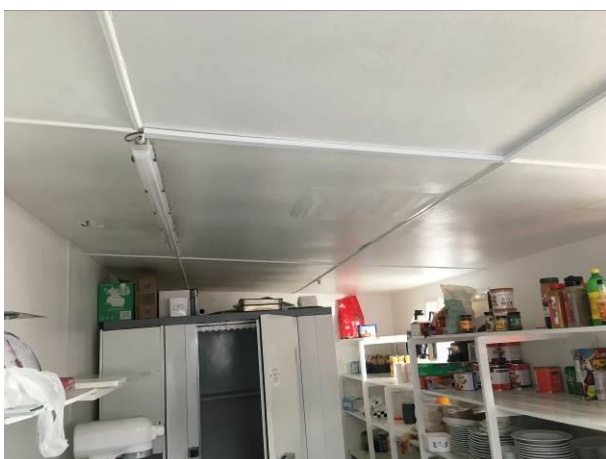
**Photograph 11:** Showing the interior of the outbuilding – well sealed to a high standard and used for storage of food produce.

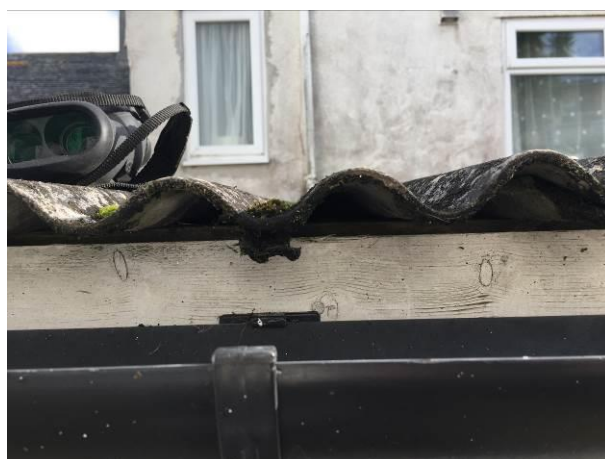
**Photograph 12:** Showing the view of the corrugated roof sheets viewed from the eaves on the western aspect.
