## PRELIMINARY ROOST ASSESSMENT (PRA)

BIRDS CORNER,  
OLD TOWN, ST MARY'S, ISLES OF SCILLY

*Our reference: 22-12-3*

*Report date: 16<sup>th</sup> January 2023*

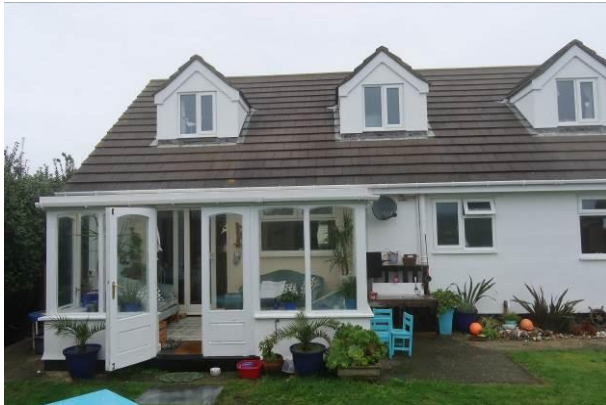
**Photograph 1:** Showing the property viewed from the south including the conservatory to be demolished.

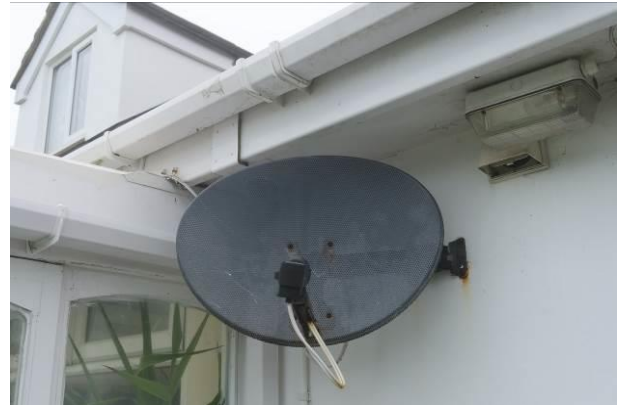
The conservatory roof attaches immediately below the uPVC boxed soffits of the main dwelling house – a very minor gap is present at the edges but this was fully inspected with a video-endoscope and did not provide suitable roosting opportunities for bats. The boxed soffits themselves were fully inspected and found to be tightly fitted with no potential access opportunities for bats.

**Photograph 2:** Showing the union between the conservatory (left) and the main dwelling with the well-fitted uPVC boxed soffits visible.

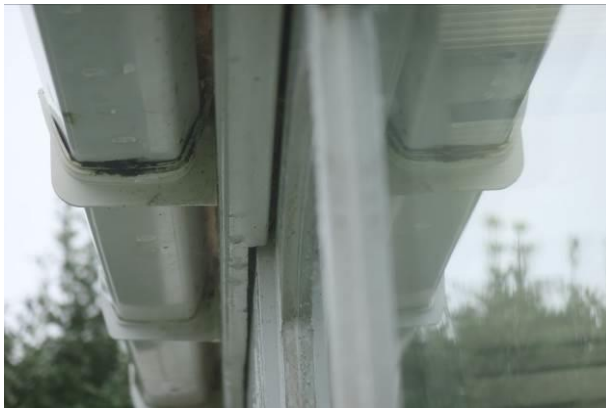
Externally, there are minor gaps at the fascia running along the top of the conservatory sides, but the cavities are too small to provide access for roosting bats.

**Photograph 3:** Showing the gaps in the fascia above the conservatory windows – these gaps are too tight and superficial to allow access by roosting bats.

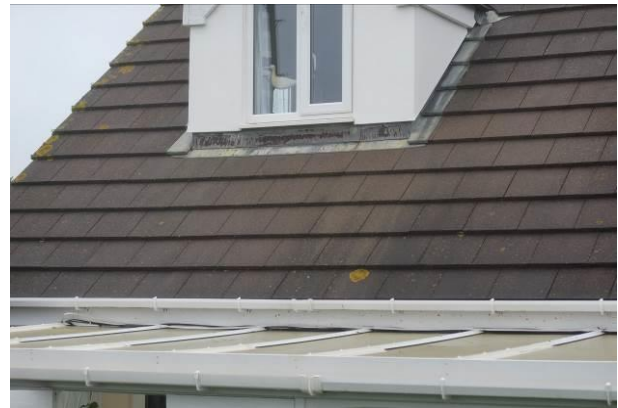
The interlocking concrete tiles are well-fitted externally with no gaps either between tiles or at the eaves, along which a guttering is located. The verge on the eaves is well-pointed with no gaps noted. The flashing where the dormer windows connect with the roof is well-fitted with no gaps. No potential access points for bats were noted in the location where the new extension roof would tie in.

**Photograph 4:** Showing the pitch of the roof where the new extension roof will tie in – the interlocking concrete tiles are well fitted and in excellent condition.

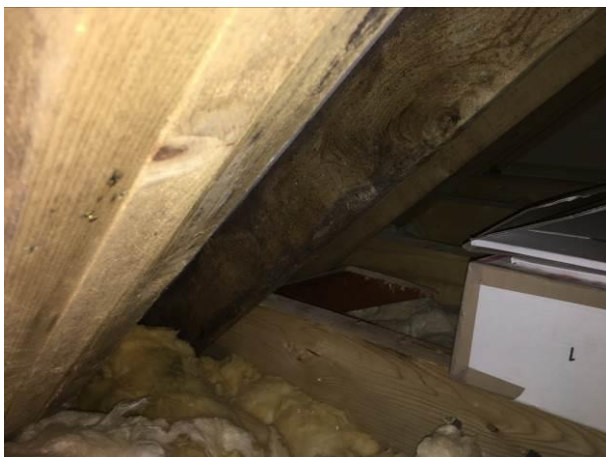
The loft immediately above the conservatory is small and discreet, occupying a space below the dormer windows and terminating at this height. The void was inspected internally – this was insulated and used for routine storage. The membrane above the rafters was in good condition with no apparent gaps allowing access to the void. Small numbers of mouse droppings were noted but no evidence of bats was identified. Further loft spaces on the northern aspect of the building, and the small void above the collar beam of the roof trusses, are not physically connected.

**Photograph 5:** Showing the interior of the eaves loft space where the new roof of the extension will tie in.
