PRELIMINARY ROOST ASSESSMENT (PRA)

6 BAY VIEW TERRACE, PORTHMELLON, ST MARY'S, ISLES OF SCILLY

Report date: 5th August 2021

Author: James Faulconbridge BSc (Hons), MRes, MCIEEM

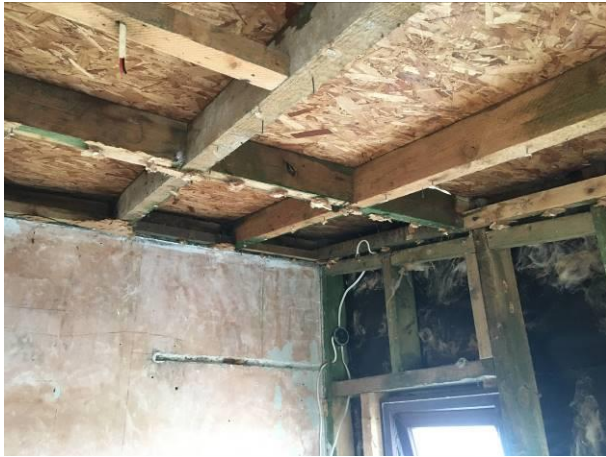
DORMER BATHROOM	<p>The dormer provides an upstairs bathroom and is located on the eastern aspect of the property. The two walls adjacent to the property comprise the exterior walls of the main dwelling whilst the remaining two walls which face externally are constructed from timber frames with membrane and a timber cladding externally. The external cladding is well-fitted thereby offering no voids between the cladding and the membrane. Where the dormer abuts the residential property to the north-west, there is a small retaining wall sealed with fibreglass and a gully where it meets the pitch of the adjacent roof.</p> <p>There is a well-fitted fibreglass roof which has a gentle single pitch. The roof is supported by timber battens – these are exposed internally with no ceiling void. Chipboard is visible above the timbers and the fibreglass is laid directly onto this offering no voids or gaps associated with the structure. The fibreglass is tightly lapped over the eaves offering no roosting opportunities associated with this area.</p> <p>The proposals involve tying the new structure into the existing roof of the residential property; therefore this roof was included within the assessment to fully assess potential impacts. The roof of the main dwelling is open internally due to ongoing renovation works and the felting upon which the tiles are placed can be seen – no loft void or other cavity is present. The slate tiles are very well fitted offering no access beneath. There are no potential access points beneath the tiles from the eaves – these are well fitted and guttering further blocks any potential access to these.</p> <p>The proposals will also involve the replacement of soffits along the north-eastern aspect of the residential property. Sparrows were observed accessing a hole in this soffit in a manner which indicates an active nest at the time of survey. This use by nesting birds close to the entrance would make it highly unlikely for bats to use this feature.</p>

Photograph 1: Showing the interior of the bathroom dormer. The wall of the residential building is visible to the left with the timber frame of the external wall visible to the right. The timber roof structure and chipboard can also be seen above.

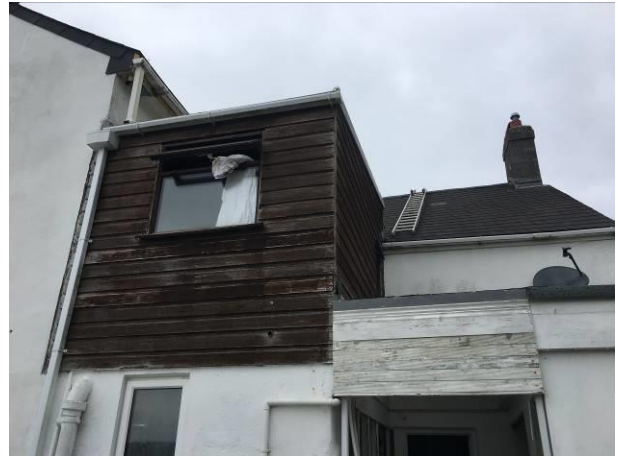
Photograph 2: Showing the timber cladding on the exterior of the bathroom dormer.

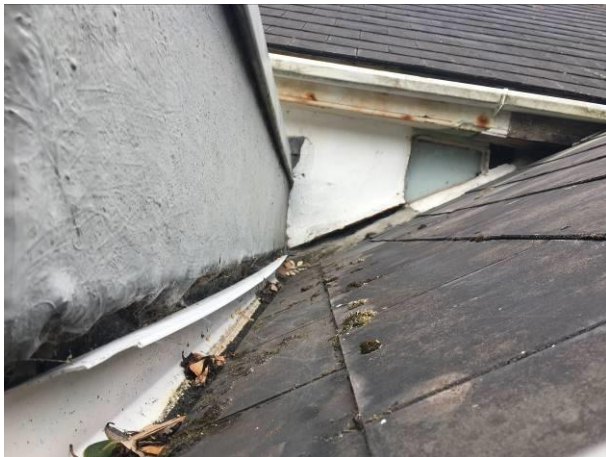
Photograph 3: Showing the existing gully between the fibre-glassed back wall of the dormer and the slate roof of the main property

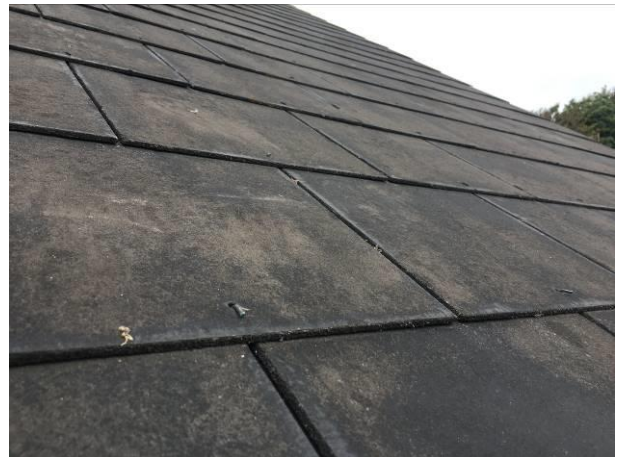
Photograph 4: Showing the tightly fitted slate roof on the existing property. This is the retained roof into which the new roof structure of the bathroom dormer will be tied.

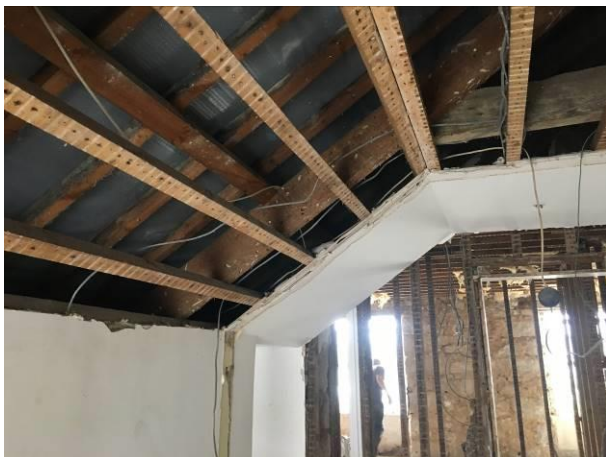
Photograph 5: Showing the interior of the roof of the main residential dwelling. This is the roof into which the new roof structure of the replacement bathroom dormer will be tied.

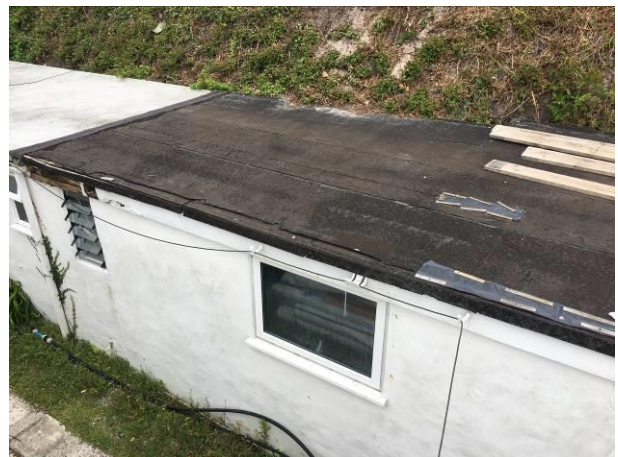
CHALET	<p>The chalet is a breeze-block structure situated to the rear of the main residential property. It has single-skin walls and a flat, bitumen felted roof. There is a small uPVC porch area at the entrance and uPVC windows continue throughout the building – all of these features are tightly fitted. The walls are rendered externally – this is in good condition providing an effective seal to the breeze block walls. The breeze blocks are exposed internally with no plasterboard remaining.</p> <p>The roof is supported by timber battens – these are exposed internally with no ceiling void. Chipboard is visible above the timbers and the felting is laid directly onto this offering no voids or gaps associated with the structure. The felting is tightly lapped over the eaves offering no roosting opportunities at this location.</p> <p>There is potential access for bats or birds to enter the building through a hole in the wall close to the eaves in the bathroom, or through open windows. Internally there are suitable niches for use by nesting birds including ledges. Potential roosting opportunities for bats entering through openings would be restricted to free-hanging from the timbers, or minor discreet gaps between the wall plate and the timber above. These gaps are occasional and were all well-cobwebbed showing no evidence of occupation at the time of survey.</p> <p>The chalet was stripped bare of fittings and internal decoration at the time of survey and was unused, awaiting renovation. A full inspection for signs of bat occupation including droppings or feeding remains identified no evidence of current or historic presence.</p>

Photograph 6: Showing the exterior of the chalet building with the rendered wall, uPVC window and felted roof visible.

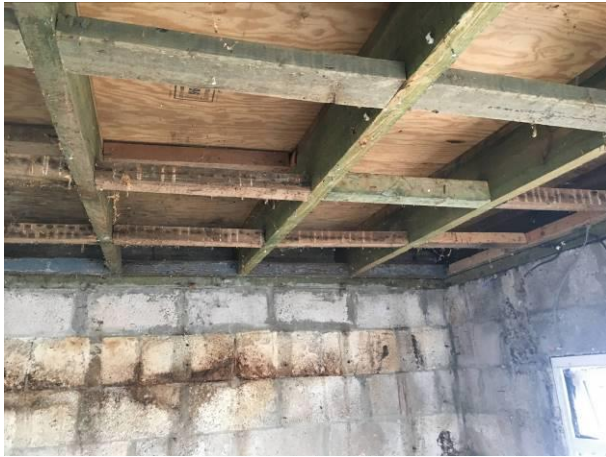
Photograph 7: Showing the interior of the chalet with exposed timber framework and chipboard above. The exposed breezeblock walls can also be seen.

There is a negligible potential for bats to find roosting opportunities on top of the wall plate in the chalet. Any roosting opportunities, if present, would be between the blockwork and attached timbers. These timbers should be removed carefully by hand such that, in the unlikely event of bats being present, they are identified before they are harmed.

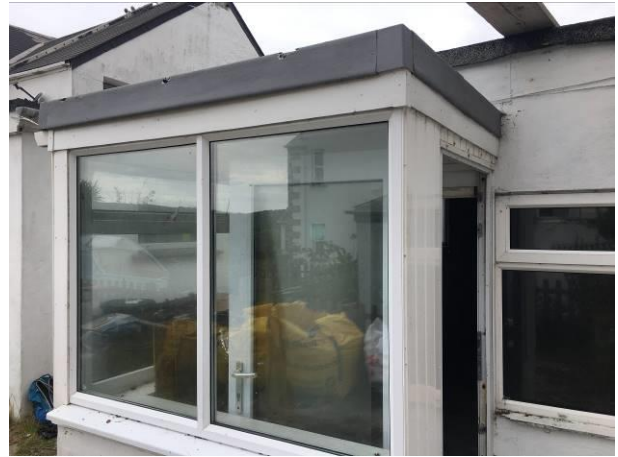
Photograph 8: Showing the porch entrance to the chalet.

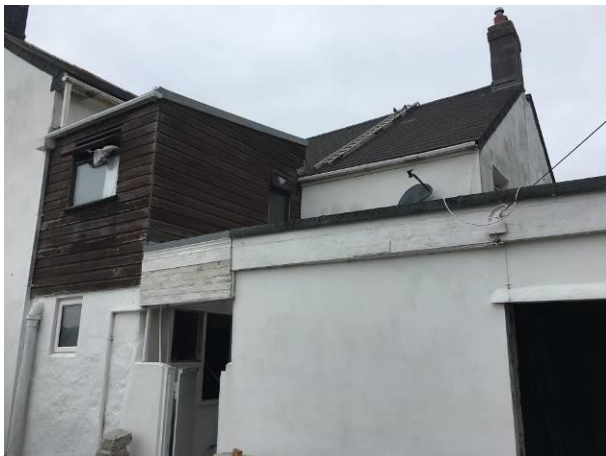
Photograph 9: Showing the garage (bottom right) with the open door visible. The bathroom dormer can be seen to the upper left of the image.

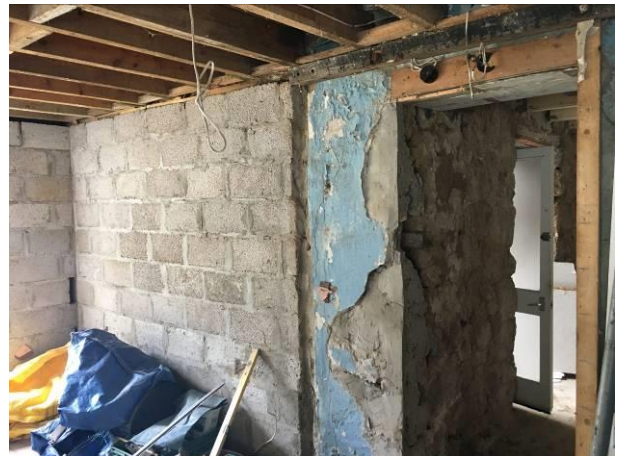
GARAGE	<p>The garage is a single-story construction attached to the main residential property on the north-eastern aspect. It is a twin-skinned breeze block construction with no insulation in the void between the blocks. It has a flat, bitumen felted roof. There is no external door fitted at present with the void partially filled allowing free access above. uPVC windows are present on the north-eastern aspect - these are tightly fitted.</p> <p>The walls are rendered externally – this is in good condition providing an effective seal to the breeze block walls which are exposed internally. The void between the blocks is accessible where the door has been removed, but this is open at the top internally which both minimises its suitability as a roosting opportunity (offering no apex niches) and ensures that in the unlikely event of bats accessing this temporarily exposed void, there is no risk of entombment.</p> <p>The roof is supported by timber battens – these are exposed internally with no ceiling void. Chipboard is visible above the timbers and the felt is laid directly onto this offering no voids or gaps associated with the structure. The felting is tightly lapped over the eaves offering no roosting opportunities.</p> <p>There is potential access for bats or birds to enter the building through the missing garage door at present. Internally there are suitable niches for use by nesting birds. Potential roosting opportunities for bats entering through openings are restricted to free-hanging from the timbers.</p> <p>The garage remained in use for storage at the time of survey. A full inspection for signs of bat occupation including droppings or feeding remains identified no evidence.</p> <p>A fibreglass roof connecting the garage to the main dwelling was also inspected – no potential features suitable for use by roosting bats or nesting birds associated with this element of the construction were identified.</p>

Photograph 10: Showing the interior of the garage with exposed breeze block walls and exposed timber roof structure above.

In the case of the garage and chalet, it is recommended that the internal ledges and niches within the buildings are carefully inspected before the roof is removed if undertaken during the nesting season. Nests are only protected if they are active (i.e. being used to rear young) or in the process of being built.
