## PRELIMINARY ROOST ASSESSMENT (PRA)

### CHIMNEY REMOVAL AT PINE TREES, BRYHER, ISLES OF SCILLY

*Report date: 24<sup>th</sup> July 2022*

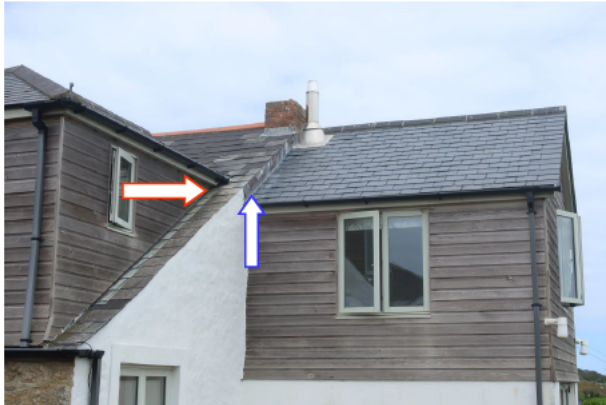
The soffits of the building appeared well-sealed with no gaps noted for the majority of the structure – however the point where the hipped roof section meets the main pitch of the two-storey dwelling may have accessible gaps at the point of union.

There are several locations where there is lead flashing associated with the roof structure– such as the point where the pitch of the roof changes adjacent to the chimney. This is generally in good condition though discreet sections were slightly lifted which could potentially offer

Adjacent structures such as the soffit to the hipped roof section and minor areas of lifted lead flashing could potentially support individual common pipistrelle bats, though this is considered to be **low potential**.

**Photograph 1:** Showing the brick-built chimney viewed from the west. The chimney is visible along with the change in ridge height. Examples of 'adjacent feature' locations are highlighted including the potential access to the soffit (red arrow) and lifted lead flashing (blue arrow).

The potential for individual common pipistrelle bats to make use of minor opportunities associated with adjacent structural features means that these features must not be impacted during works.

Care should be taken during works to ensure that these structures are not disturbed, obstructed, or damaged. This involves careful design of scaffolding installation and may include a contractor briefing to ensure that those working on the roof understand the requirement. Other measures such as a temporary sign, tape or physical barrier should be installed if deemed necessary.

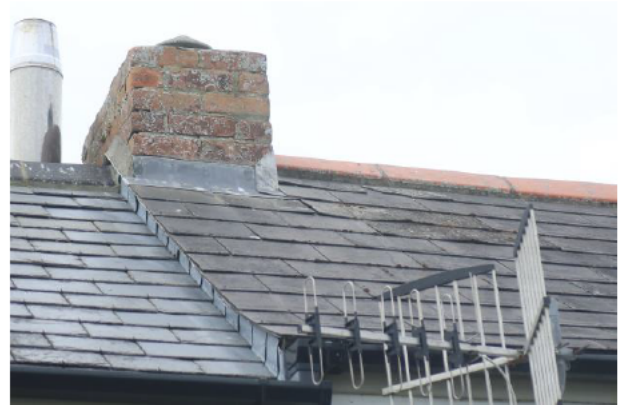
Externally, the chimney is low and brick-built comprising just three courses above the ridge. The union between the chimney and the roof has concrete flashing with lead flashing lapping the join. The brickwork of the chimney itself appears to be in good condition with very minor gaps in the mortar which appear superficial and too small to support roosting bats. A single small, low pot appears to be present.

**Photograph 2:** Showing a closer view of the chimney taken from the east.

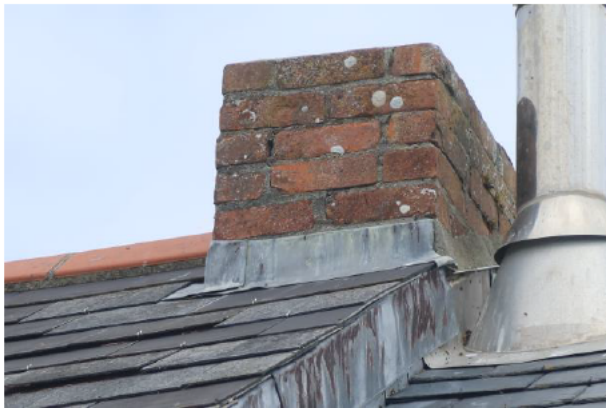
**Photograph 3:** Showing a closer view of the chimney taken from the west.

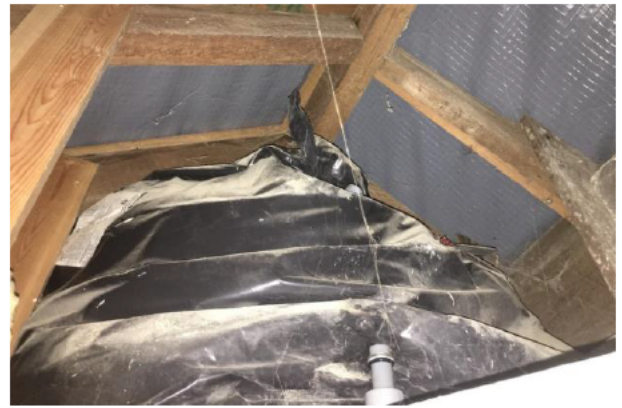
The limited inspection of the roof space revealed granite construction of end-walls with roofing membrane above the timber structure. The membrane looked to be relatively new and in good condition. The external condition and structure of the roof indicates that this internal condition is likely to describe the roof space beyond the location directly inspected.

No evidence of bats was identified, though access was significantly constrained.

**Photograph 4:** Showing the accessible loft space with water tank. The new roofing membrane above the timber roof structure is visible.

Contractors should be vigilant to the low risk of bats being present within the roof space away from the chimney itself, and the schedule and method of works should aim to minimise disturbance of the loft space. This includes working quickly to re-seal the roof following removal of the chimney; minimising noise and other disturbance; ensuring appropriate timing of works and weather conditions; and avoiding excess dust arising from the works.
