PRELIMINARY ROOST ASSESSMENT (PRA)

THE WHEELHOUSE, HUGH TOWN, ST MARY'S, ISLES OF SCILLY

Our reference: 22-12-1

Report date: 22nd December 2022

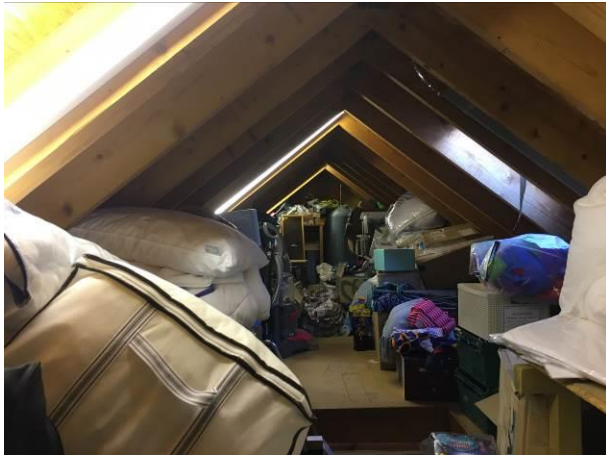
Internally, the loft space is converted to regularly accessed storage space – the area is well-used with a roof light window. The void is under-boarded throughout with recent and well-fitted membrane above – visible in places between ply sheets. No internal roosting opportunities were identified. The void connects internally with the void of the single-pitch roof which runs along the southern aspect of the property. No evidence of bats was noted.

Photograph 1: Showing the interior loft space of the single-storey pitched roof component of the building.

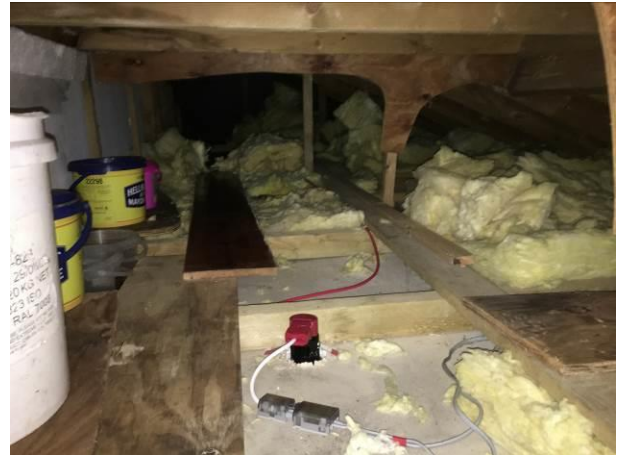
Internally, the roof has a low void which connects in with the internal void of the single-storey pitched roof component. There is underfelting in good condition, around a relatively recent

timber frame structure. Access for bats would be possible from the eaves on the southern aspect, though no evidence of access or recent occupation were noted. Internal roosting opportunities would be restricted to free-hanging from timbers.

Photograph 2: Showing the interior loft space of the single-pitch roof which runs along the southern aspect of the building.

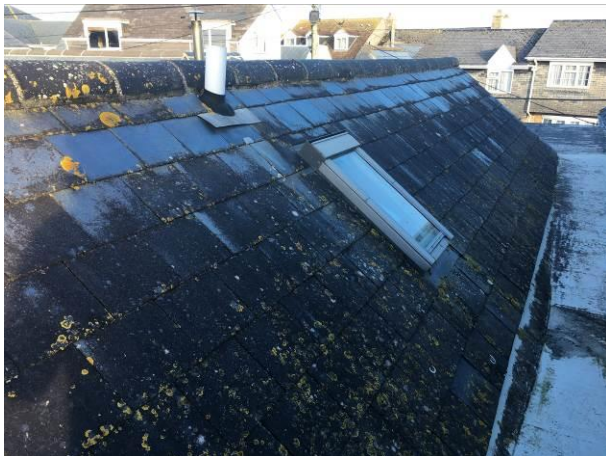
This is the component of the building which would be directly affected by the proposals. The structure is rendered in excellent condition with no gaps, cracks or damage noted. uPVC windows are well-fitted and in good condition. The roof is tiled with slate tiles and ridge tiles, all of which were well-fitted and in good condition. Wooden soffits and fascias on the gables were tightly fitted with no gaps noted. Superficial gaps beneath the terminal roof tiles on the gable were noted – these did not appear to lead to voids or other roosting opportunities.

Photograph 3: Showing well-fitted roof and ridge tiles of the single-storey pitched roof component. The skylight window can be seen along with the flat roof which connects this component of the structure with the two-storey pitched roof to the east.

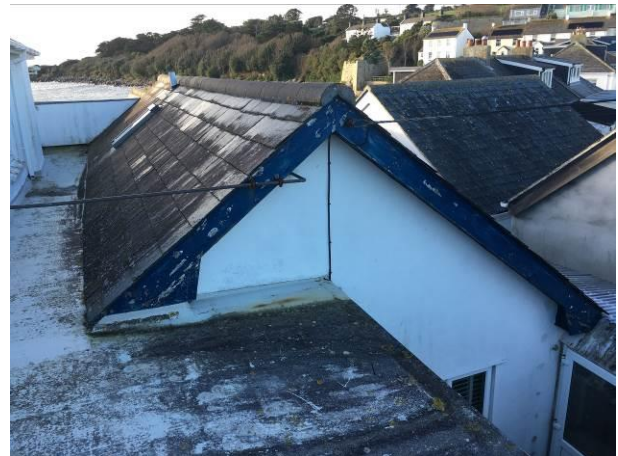
It is considered that the building components to be directly affected by the proposals have **negligible potential** to support roosting bats. The tiles at the gables have minor superficial gaps which have a very low probability of use by exploratory bats – this residual unlikely risk can be controlled through an appropriate Precautionary Method of Works (PMW).

There is a negligible risk of bats making transient use of minor cavities associated with the terminal roof tiles on the gables of the single-storey pitched roof component of the building. These appear superficial but temporary use by exploratory bats cannot be ruled out.

Photograph 4: Showing the northern gable of the single-storey pitched roof component of the building.

The terminal three rows of tiles at both gable ends should be removed carefully and by hand in such a way that if any bats are present beneath, they are not crushed or otherwise injured by the action. Once these tiles have been removed and it has been confirmed that no bats are present, works can proceed.

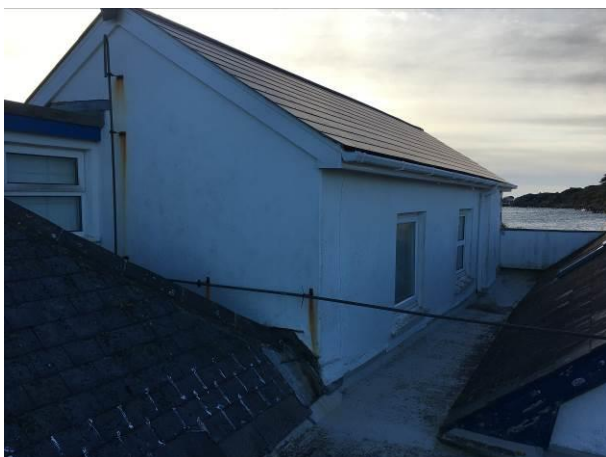
This two-storey structure rises from single-storey flat-roof components to the east and west with the single-pitched flat roof to the south and the hipped roof to the north. The walls are well-rendered with tightly fitted uPVC windows and frames. The roof has well-fitted slate tiles and ridge tiles with no gaps noted from inspection from the west. uPVC soffits and guttering on the eaves, and uPVC fascias on the gables are well-fitted with no gaps noted.

Internally, the loft space is under-felted in good condition, with a boarded floor and bare breeze-block walls. There is a ridge board present but no internal roosting opportunities were identified aside from free-hanging from internal timbers. Light showing at the gable identifies potential access for bats into the internal space, but no evidence of access or occupation were noted. As the potential access is on the southern gable, any works indirectly affecting the western aspect would not affect potential access to the void.

Photograph 5: Showing the two-storey pitched roof section of the building which lies to the east of the single-storey pitched roof.

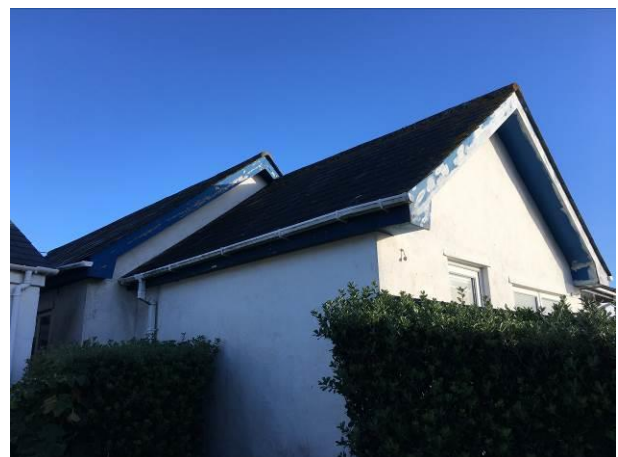
Photograph 6: Showing the southern gable and western aspect of the single-storey pitched roof section of the building which looks out onto Porthcressa.

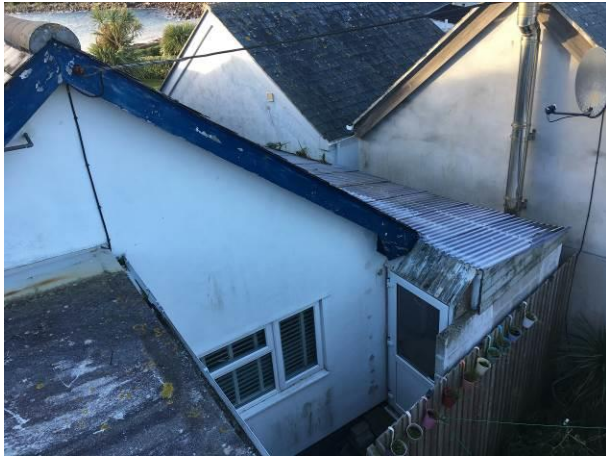
There is a lean-to utility area attached to the western aspect of the building. This is constructed around a breeze-block wall which is plaster-boarded internally. The roof comprises corrugated translucent PVC sheets which make the interior light. No roosting opportunities were identified associated with this structure.

Photograph 7: Showing the lean-to on the western aspect of the single-storey pitched roof component of the building.

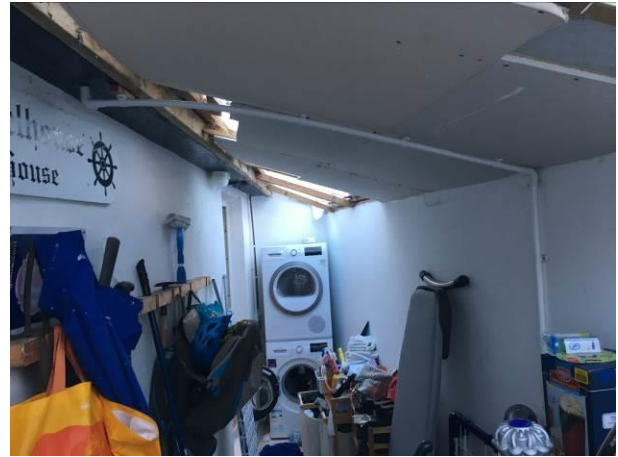
Photograph 8: Showing the inside of the lean-to building used as a utility and storage space.
