PRELIMINARY ROOST ASSESSMENT (PRA)

BISHOPS VIEW, ST MARY'S, ISLES OF SCILLY

Our reference: 23-7-1

Report date: 11th July 2023

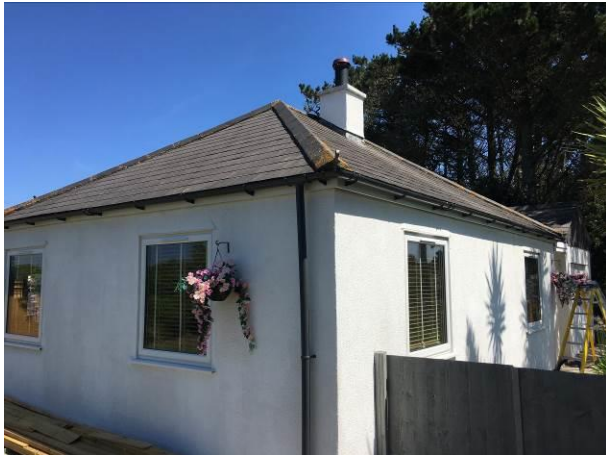
The main roof of the building is a hipped roof to the west. Tiles are flat-slate style and well-fitted throughout with no gaps or lifted sections noted. The ridge tiles, including those on the hipped sections, are well-fitted – occasional minor gaps in the mortar appeared superficial and did not offer roosting opportunities for bats. The only potential cavities were noted at the base of some hipped sections where they meet the eaves – here the mortar is damaged or missing in places. These offer minor niches but were inspected closely at height and found to be cobwebbed with no evidence of historic or current use by bats. However there remains a low potential for these features to be used in the future, especially if their condition changes. A vent is present close to the ridge on the western aspect, though this is likely to have a grill or fly-screen installed to prevent access. The lead flashing around the well-pointed chimney was tightly fitted.

Photograph 1: Showing the property viewed from the south-west showing the hipped roof Section A.

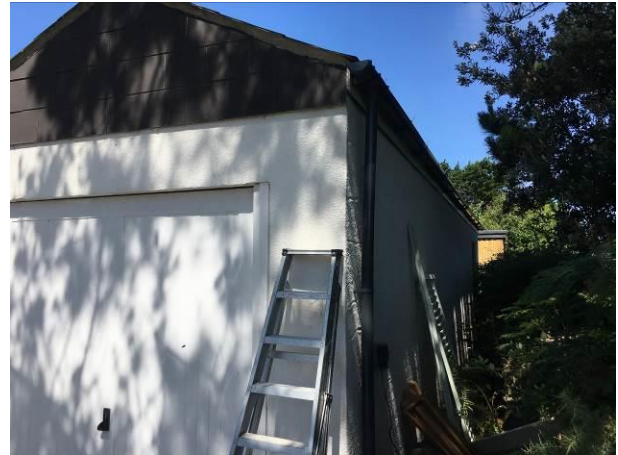
The pitched roof to the east of the building is structurally separated from the hipped roof (Section A) by the flat roof (Section C). The roof structure itself is covered with the same materials as Section A and is similarly well-sealed with no gaps noted associated with the roof or ridge tiles.

There is potential access for bats via gaps at the eaves of the building which are too wide to

provide roosting features in their own right, and lack a terminal apex for a crevice-dwelling species such as common pipistrelle, but would provide potential access to roosting features associated with the loft space.

Photograph 2: Showing the property from the south-east with the pitched roof Section B over the garage unit.

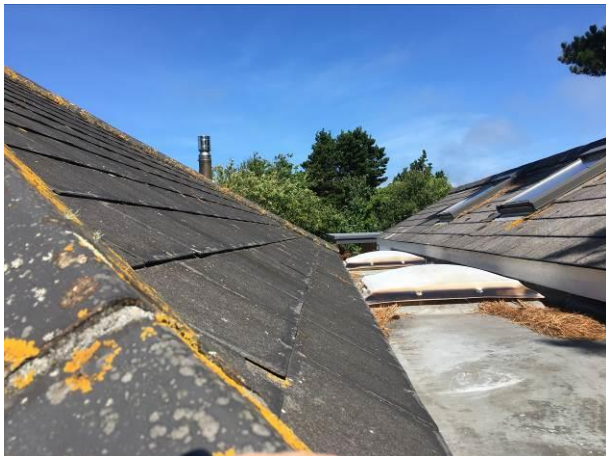
There is a flat-roof structure which links the hipped and pitched roof sections – this was in good condition. The junction between this roof and the surrounding structures was generally good – there is a single section of lifted flashing in the northern corner at the junction with Roof Section B but this was inspected and found to be cobwebbed with no evidence of historic or recent occupation by bats.

Photograph 3: Showing the flat roof Section C at the point where it links the other two roofs.

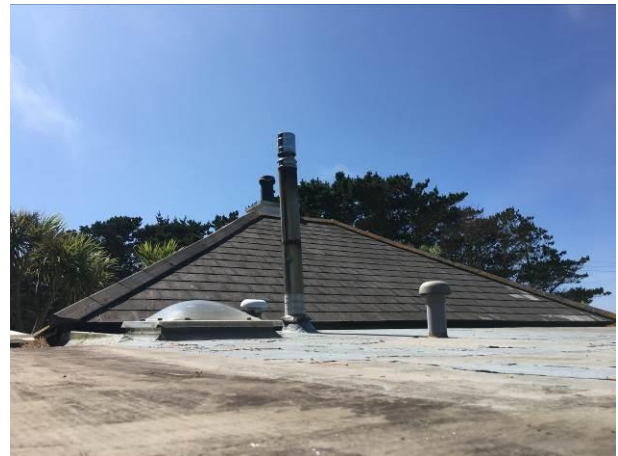
Photograph 4: Showing the flat roof Section C to the north of the property with the hipped roof Section A visible behind.

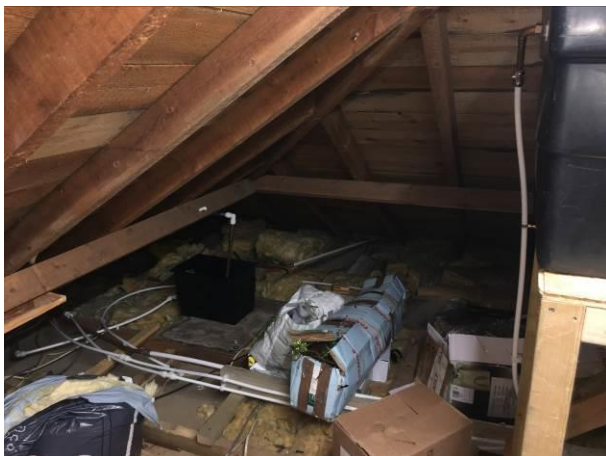
Internally, the loft space is used for storage but is clean with insulation between the joists. There is sarking internally which is in good condition throughout. The roof is built around a typical timber truss framework and appears well-sealed at the eaves. A breeze-block chimney rises through the loft space and roof – this is well pointed with no gaps noted between the blocks. No evidence of bats was identified, though occasional rodent evidence was present. The potential features internally are restricted to minor gaps between timber joints, or free-hanging from timbers.

Photograph 5: Showing the interior of the loft space of the hipped roof Section A – the sarking boarding above the timber trusses can be seen.

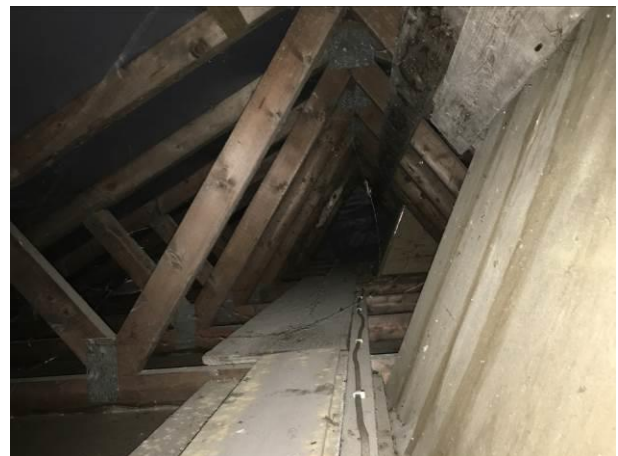
Internally, the small loft space could not be fully accessed due to restricted size and the obstructions caused by roof-light columns which pass through the void. The roof is built around a timber-truss framework - there is no ridge present and the roof is under-felted throughout in good condition. Rodent droppings were noted. No evidence of bats was identified, but the restrictions on access to the void represent a constraint to survey.

The size of the loft space in Section B restricted comprehensive inspection of the void, especially towards the eaves. This is accounted for in the recommendations provided for a further PAS survey.

Photograph 6: Showing the loft space of the pitched roof Section B which could not be fully inspected due to the size and construction.

In accordance with the criteria outlined in the Best Practice Guidance, one further Presence/Absence Survey (PAS) would be required to provide an appropriate evidence-base upon which to support a planning application.

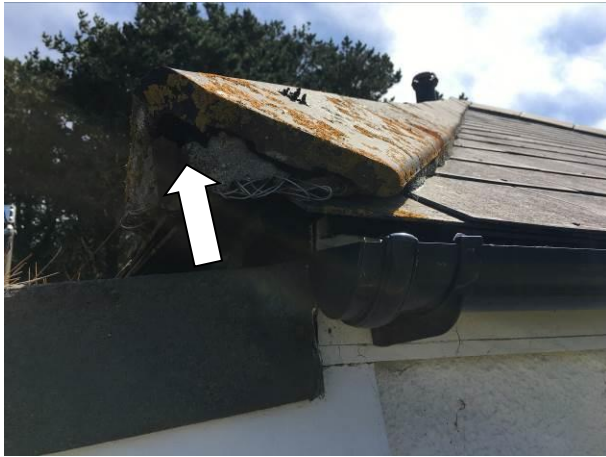
Photograph 7: Showing an example of the minor sections of missing pointing at the base of the hipped ridge tiles in roof Section A.

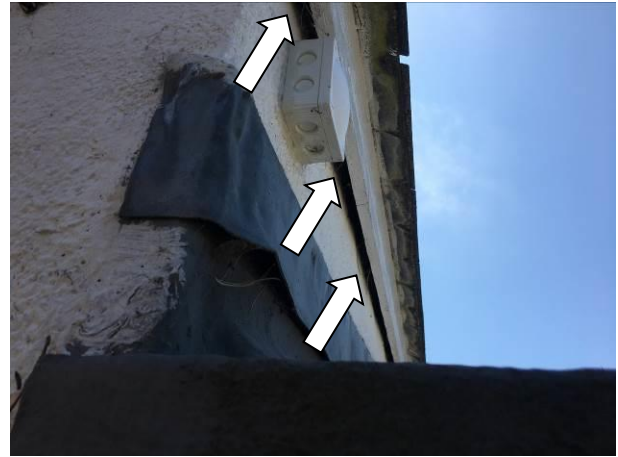
Photograph 8: Showing an example of potential access for bats beneath the fascias at the eaves of roof Section B. The individual instance of lifted lead flashing associated with the junction between flat roof Section C and the surrounding structures can be seen below this.
