PRELIMINARY ROOST ASSESSMENT (PRA)

DOLPHINS, OLD TOWN, ST MARY'S, ISLES OF SCILLY

Report date: 18th June 2023

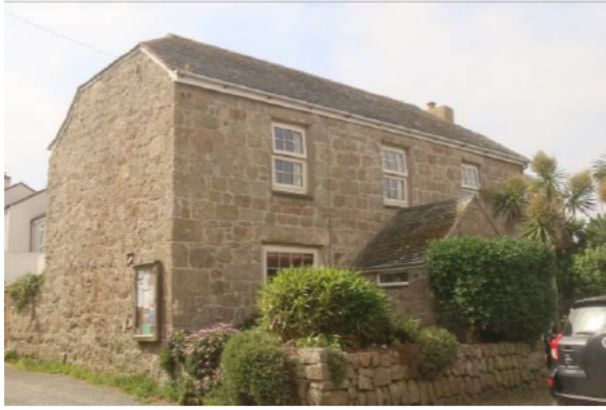
Photograph 1: Showing the property viewed from the northern corner

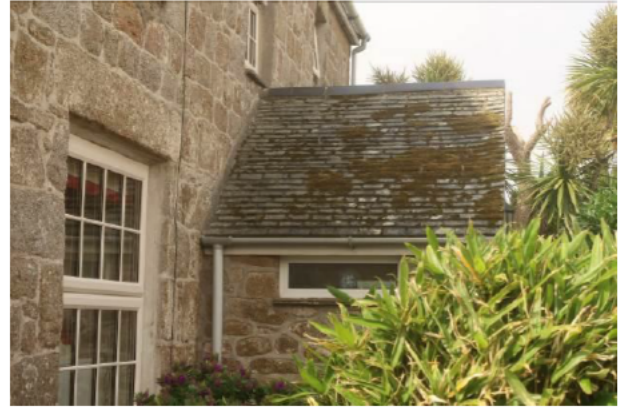
A porch is present on the north-eastern aspect – this is open to the apex internally with no void present. Tiles appear to be well-sealed and the fascia boards appeared to be tight although minor gaps may occur in places.

Photograph 2: Showing the porch on the northwestern aspect.

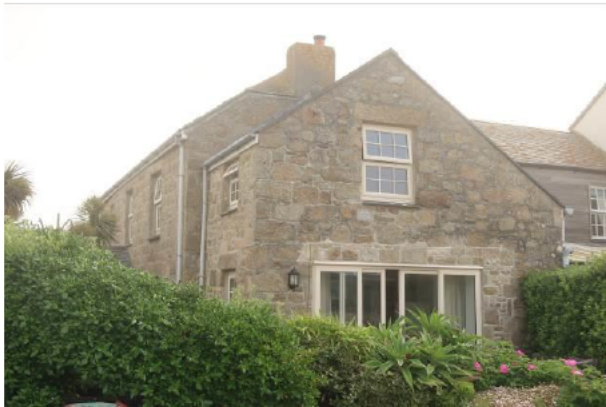
There is a small extension on the south-western aspect – there is a slight change in ridge height and the room within is built into the rafters with no void present. This section has dry-laid slate and provides lower potential for use by roosting bats due to the condition and structure.

Photograph 3: Showing the extension on the western edge of the property – the second-storey room in this location is built into the rafters with no void present.

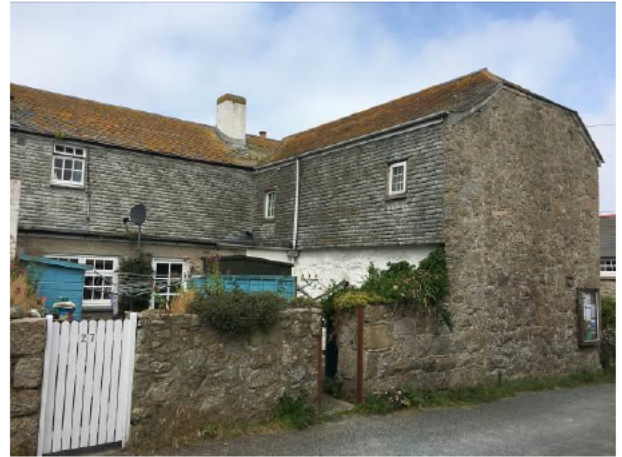
Photograph 4: Showing the courtyard on the south-eastern aspect with hanging tiles visible.

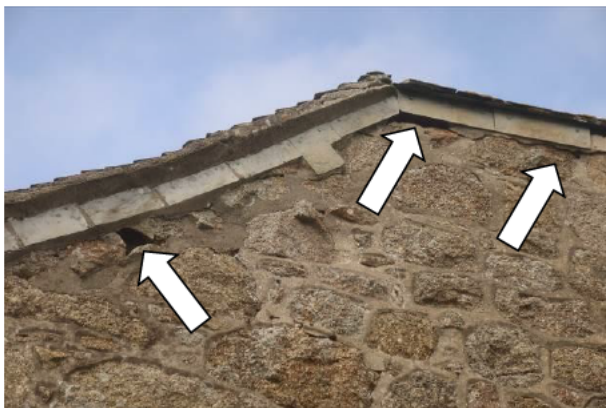
House sparrows were confirmed nesting in features associated with the eastern gable of the property. Further minor opportunities may also be found elsewhere within the structure.

Photograph 5: Showing an example of the gaps on the north-eastern gable with confirmed nesting sparrows – these features would also allow access to potential roosting opportunities for bats.

The proposed works are likely to involve the removal of nesting habitats for sparrows at the gable, in the absence of appropriate mitigation measures. It is recommended that retention in situ is designed into the scheme where practicable. Alternatively the installation of communal nest boxes supporting several pairs of birds could ensure continuity of nesting habitat. Consideration would need to be given to the location and aspect of these boxes to minimise disturbance and risk of predation, as well as avoid nuisance to guests in the holiday let accommodation.

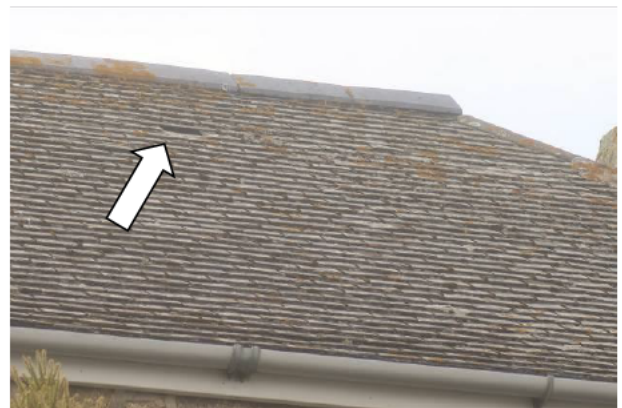
There is missing mortar between the tiles in places which would potentially allow access to cavities between the tiles suitable for use by roosting bats. Fascia boards run around the eaves and slate tiles hang at the gable – these are often lifted from the wall due to the irregular nature of the granite blocks and whilst these are clearly sealed in places, smaller gaps could both provide roosting opportunities in their own right and provide access to roosting opportunities either associated with the wall plate or between tiles. On the northern gable, sparrows were confirmed nesting in a gap providing access to the wall plate and confirming the potential for access to roosting opportunities for bats.

Photograph 6: Showing an example of the occasional gaps in the pointing of the tiles which could provide access or roosting opportunities for bats.

In accordance with the criteria outlined in the Best Practice Guidance, two further Presence/Absence Surveys (PAS) would be required to provide an appropriate evidence-base upon which to support a planning application.

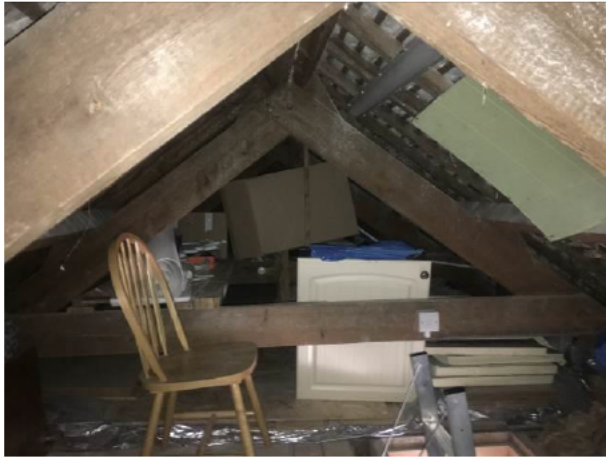
The loft space of the main roof is used for storage – it is built around a timber truss framework and is relatively low with a height-to-ridge of around 1.5m. Insulation is present between the joists only. The party wall to the adjacent property appeared to be tightly fitted with no apparent access for bats between the voids. The gable walls were a combination of granite and brick-built – the pointing was relatively good and no gaps suitable for use by bats were noted. Daylight is visible both at the eaves and occasionally between tiles where mortar is missing. A single dropping characteristic of common pipistrelle was confirmed – however the small size of the loft and the use for storage as well as water tanks etc. precluded comprehensive inspection of the void.

The size of the loft space, and its use for storage, restricted comprehensive inspection of the void, especially towards the eaves. This is accounted for in the recommendations provided for further surveys.

Photograph 7: Showing the interior of the loft space built around a timber truss framework.. The use of the space for storage, restricting comprehensive inspection, can be seen.

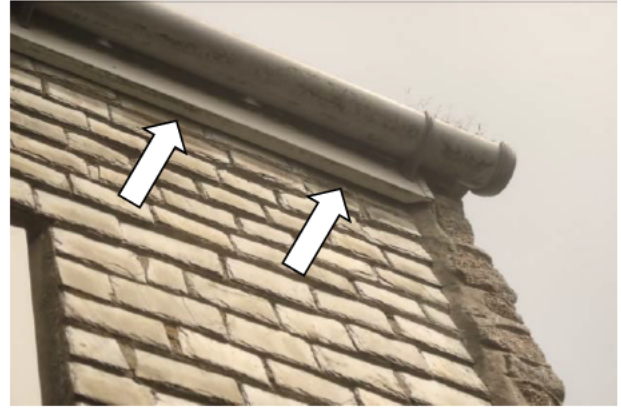
Photograph 8: Showing an example of the gaps beneath the fascias which occur around the structure. These offer potential roosting opportunities for bats in their own right, as well as access to further opportunities associated with the wall plate and slate tiles.
