## PRELIMINARY ROOST ASSESSMENT (PRA)

KENWYN,  
ST MARY'S, ISLES OF SCILLY

*Report date: 1<sup>st</sup> February 2024*

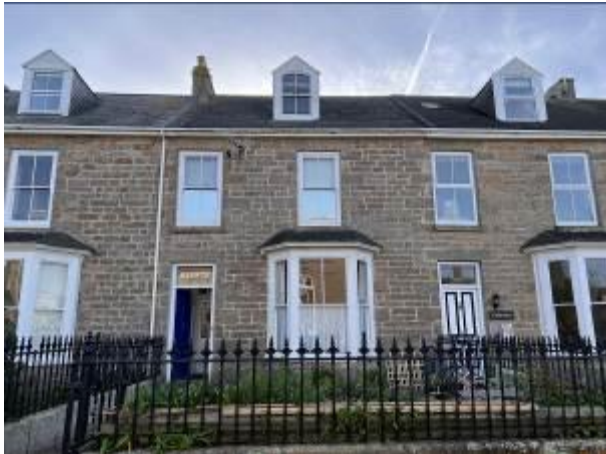
**Photograph 1:** Showing the northern aspect of Kenwyn

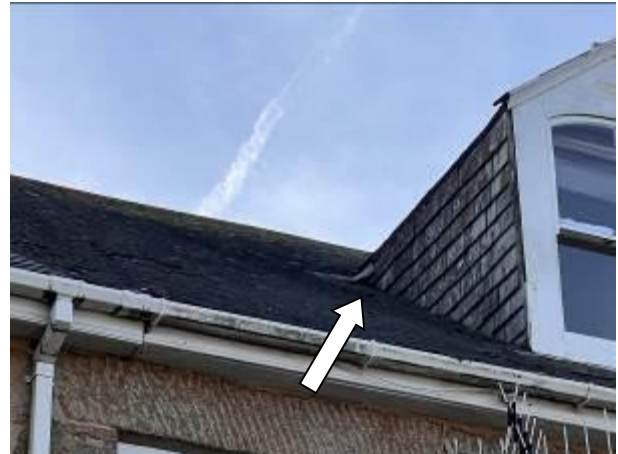
**Photograph 2:** Showing the minor lifted section of lead flashing around the junction between the dormer and the main roof

Minor lifted sections occur within the lead flashing where the dormers meet the roof tiles below, and in the valley between the pitch of the dormer and the adjacent roof.

If these are to be removed as part of the works, locations where the flashing is lifted should be exposed carefully such that if any bats were present behind the lifted element, they would not be crushed or otherwise injured by the operation. Contractors should satisfy themselves that no bats are present before proceeding with works in these areas.

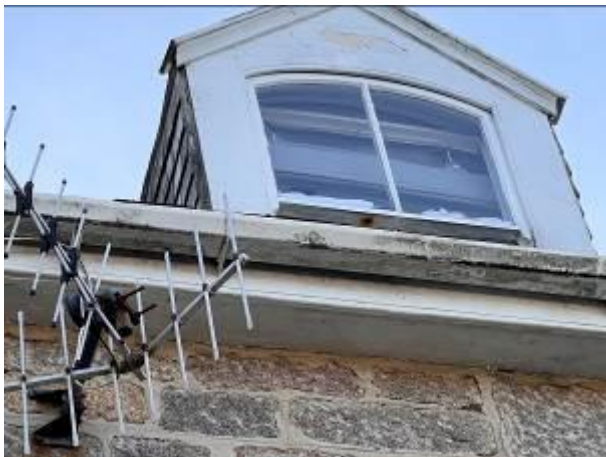
The boxed soffits, supporting guttering, are well-sealed and in good condition.

**Photograph 3:** Showing the well-sealed boxed soffit on the northern aspect with guttering attached

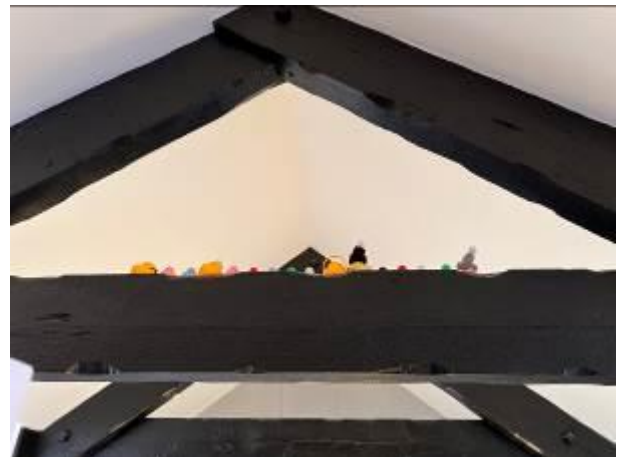
**Photograph 4:** Showing the top floor residential accommodation built into the apex of the roof throughout much of the span

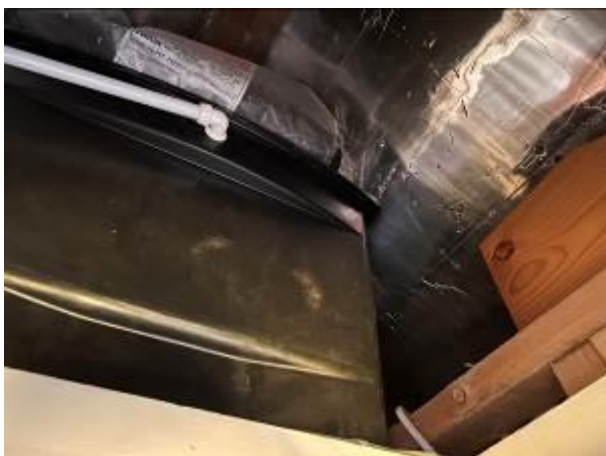
No evidence of bats or other species (such as rodents) were identified within these voids and there appeared little or no scope for bats to access these spaces.

**Photograph 5:** Showing the water tank within the small loft void present in a portion of the roof. The insulation boards between the rafters can be seen.
