Ref: P/24/021/HH and 022/LBC **Address**: Parkside, The Parade, St Mary's

Grade: II First Listed: 1975

Site Visits Notes: 13/05/2024

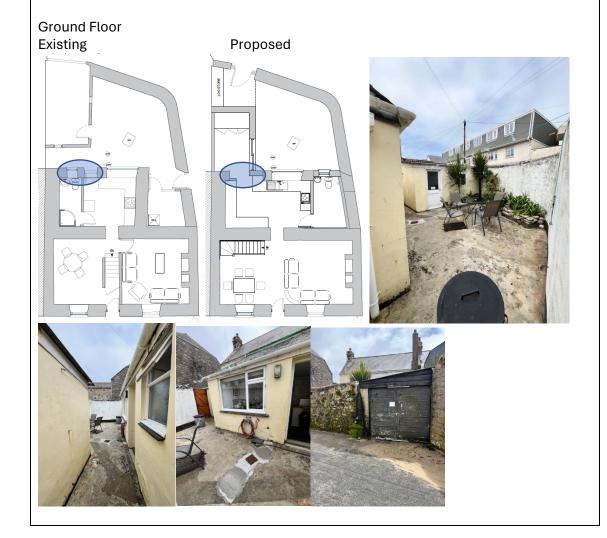
Removal of existing garage and construction of an extension to the kitchen in the same location

There is no issue with this in principle as the existing garage appears to be a relatively modern addition and detracts from the rear of the house. Details of the new door / gate to the back lane should be provided. It would appear that this is used for storage only, not vehicles. The plans will need to be drawn to an appropriates scale with full details of all proposed materials (doors, windows, roof finish, any rooflights, wall finishes etc) and service routes especially showing how it will link to the main house. The existing opening from the g/f bathroom is a small window and the new opening will need to be detailed more clearly in addition to the new gate:

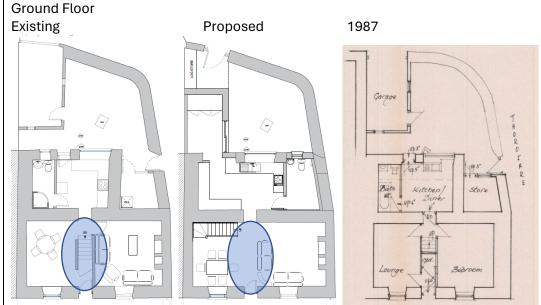
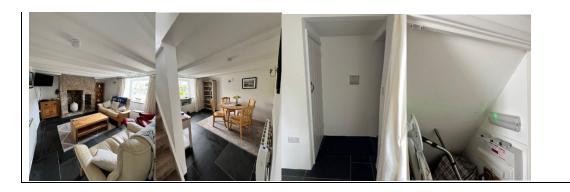
Relocation of the non-original staircase

The listing description specifically notes that the stairs are central, forming the two rooms on the ground floor. This seems to be a feature of these houses and is therefore likely to be the original layout. I note that all finishes are sealed with no visible parts beneath render or stairs could be seen. Similarly, no banister details were evident. Based on submitted plans from 1987, and nothing to suggest the stairs are modern, I have to assume that the stairs are original. Although they could have been repaired I don't consider an adequate case has been made to demonstrate these are not original—should the applicant wish to remove the stairs we would need to be presented with evidence that these are not original. As it stands there is no justification to reposition the stairs and create an open plan layout. I consider it is likely to have a significant impact on its historic layout and character of the cottage as well as requiring potentially historic joists to be cut through. Plans approved previously for works to this property appear not to have been implemented and the plans at the time also reflect the current stair arrangement. This aspect of the proposal is not supported.

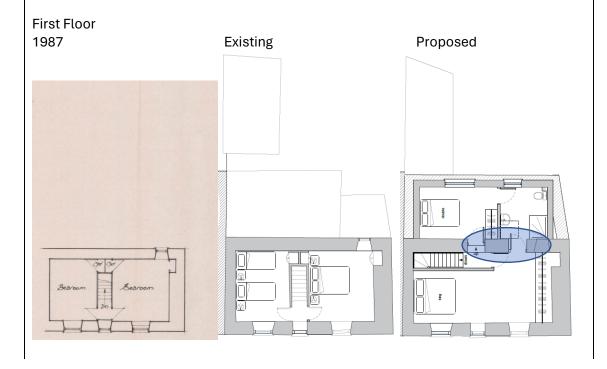
Construction of first floor extension above kitchen to provide improved bedroom facilities and Jack & Jill en-suite.

This large extension requires an additional opening in the upper external wall, and as it has already lost some of historic character and features due to some unsympathetic previous alterations, it is important to retain as much as possible now. I would suggest that the proposals are amended to reconfigure the upstairs layout, significantly reducing the size of the proposed extension, so it can use the existing opening (above the shed) without having to open up the rear wall further. Although there are large extensions within the terrace but I note that Pelistry Cottage (next door but 2) was permitted to have a rear floor roof replaced with a pitched roof in 2007 (P/07/005 and 006) but this would appear to have made substantial improvements to a lower quality existing extension, next door but 1 (Bar Escapade) is not listed, and the immediate neighbour, Armorel, although has a pitched roof extension, this would appear to predate its listing.

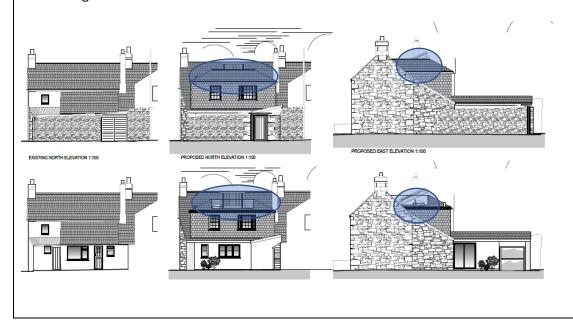
• Installation of solar water heater within rear roof extension.

Although this is acceptable in principle, I would suggest that it is repositioned to somewhere less obvious, although it is difficult to see any details from the proposed drawings. Details of any ancillary cabling, pipework or other peripheral equipment and fixings (of the panels to the roof) will need to be provided. If these are solar panels then details of battery, inverters etc. which would need to be accessible, should also be provided, together with details of the type of panel which should closely match the roofing slate and that are the least reflective.
