## PRELIMINARY ROOST ASSESSMENT (PRA)

### BISHOP AND WOLF PUBLIC HOUSE, HUGH TOWN, ST MARY'S, ISLES OF SCILLY

**Our reference:** 24-5-2

**Report date:** 5<sup>th</sup> June 2024

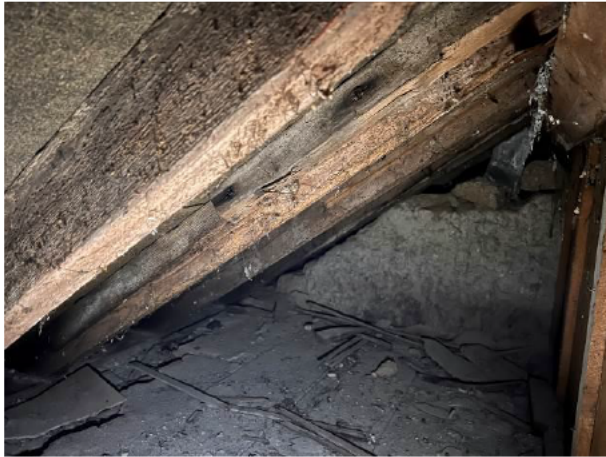
There is a loft space above the tie-beam of the main pitched roof which was too small to access for inspection but which could be viewed from a loft hatch. Timbers appear to be in good condition; though the internal gable walls have gaps in the pointing in places which could potentially offer roosting opportunities. Tar paper occurs above the rafters but this is incomplete and tiles are visible through gaps in places. No insulation was apparent. Light is visible in a number of places identifying the potential for bats to access the void itself, as well as reach potential roosting opportunities between the tar paper and the tiles. The void is also boxed in at the eaves in the top floor – some of these spaces are used for routine storage but others are sealed or inaccessible but would provide similar roosting opportunities to those described for the apex void. Rodent droppings were identified in the voids, but no direct evidence of bats was identified from the restricted inspection undertaken.

**Photograph 1:** Showing the interior of the roof void of B&W A at the eaves – the typical tar paper and poorly pointed gable can be seen

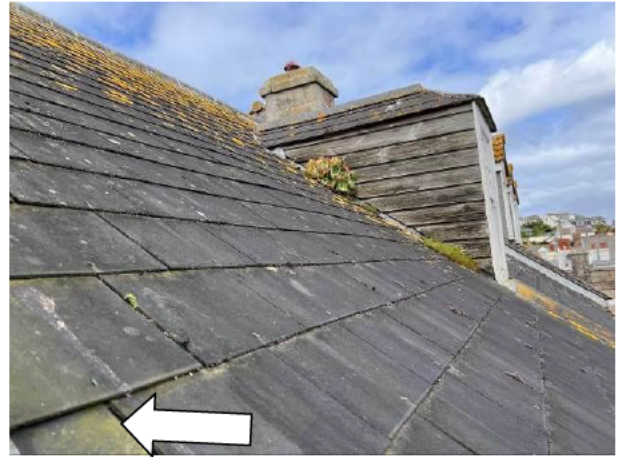
The roof covering is synthetic slate tiles which are generally well-fitted though occasional minor lifted elements do occur throughout the structure. These, along with gaps around ridge tiles at the junctions with the two chimneys, could provide potential access for bats to roosting opportunities beneath roof tiles. Further access to these potential roosting opportunities occur beneath the fascias – the irregular shape of the granite blockwork interacting with the linear plane of the fascia creates a number of minor cavities which could also provide roosting features in their own right.

There are dormer windows on both aspects of the pitched roof – these have timber window frames which are generally well fitted although there are minor cavities beneath the sills. Hanging tiles/dilapidated timber boarding on the sides present potential minor access niches in places. The valley junction between the dormers and the main pitch of the roof are lined with lead flashing which is lifted in places allowing access to potential roosting features. There are sealed voids between the internal ceiling and the pitch of the dormer roofs which are not connected to the main roof void and could not therefore be accessed to inspect for evidence of bats.

**Photograph 2:** An example of occasional lifted tiles in B&W A along with the timber-clad dormer.

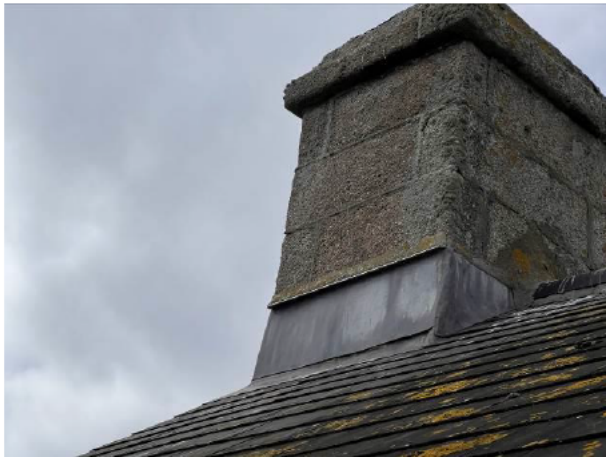
This is built from granite-blocks which are generally well pointed throughout, though occasional gaps in the pointing do occur providing minor potential access points for bats. The wooden window frames are well-fitted throughout. Granite-block chimneys are present at either end of the roof structure – the junctions between these and the roof are lined with lead flashing with

occasional lifted elements offering potential minor access or roosting opportunities for bats.

**Photograph 3:** Showing the lead flashing lining the junction between the chimney and the main roof of B&W A

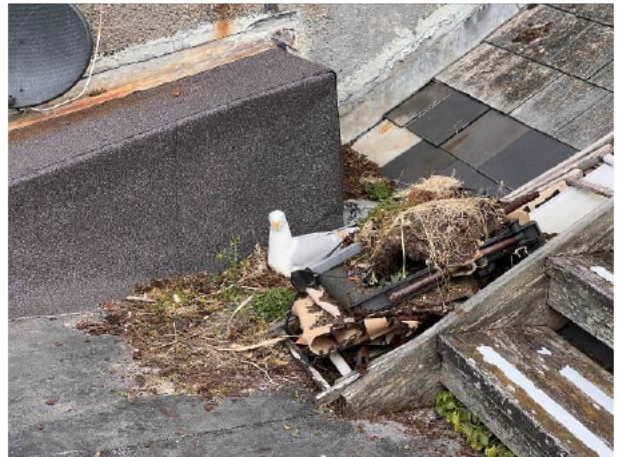
Herring gulls are nesting on the flat roof.

- Nesting herring gulls on the flat roof of B&W B;
- Nesting birds (historic nests likely starling and sparrow) in the roof space of B&W C.

**Photograph 4:** Showing one of the herring gull nests on the flat roof of B&W B.

Works affecting potential nesting sites associated with the roof (including fascias and soffits) should be undertaken outside of the breeding season which runs from March – September inclusive, where practicable. This would provide the most robust means of avoiding risk of impact to nesting birds.

If the recommended timing of works is not possible, then contractors should visually inspect the work area internally and externally before they are affected by the works, in order to confirm that no nests are present. In the event that a bird nest is present, it must be left undisturbed until chicks have fledged the nest, at which point works can proceed.

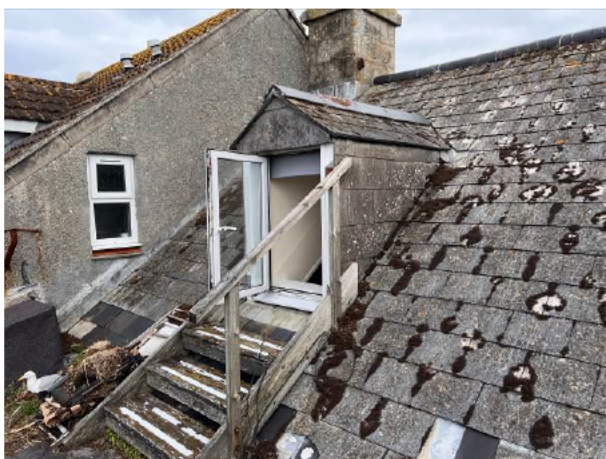
**Photograph 5:** Showing the access from the dormer of B&W A to the flat roof section B&W B. The synthetic tiles on the side of the dormers on this aspect are visible.

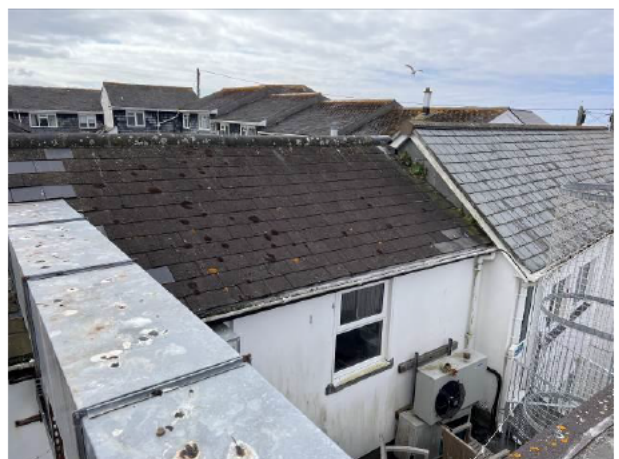
A two-storey pitched roof building is attached on the southern gable of B&W C – the pitch of the B&W D building is slightly higher providing a partial gable. There are gaps in the verge pointing on this partial north-eastern gable as well as the south-western gable; both of which could potentially provide access to roosting opportunities either in their own right or within the roof space itself.

**Photograph 6:** Showing the heights and alignments of roof pitches on B&W C and D

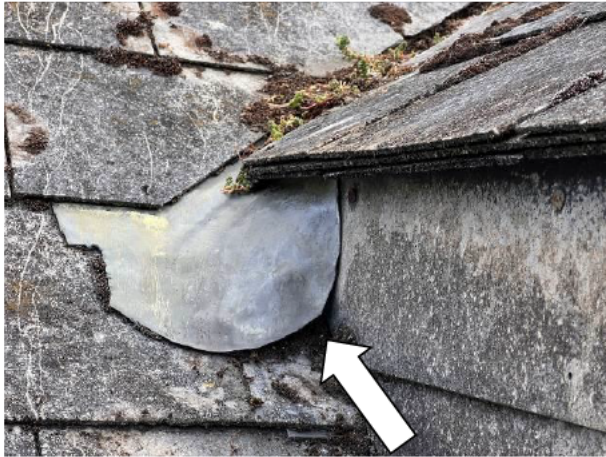
**Photograph 7:** Showing an example of the lifted flashing around the valley join between the dormer and the main roof on B&W A

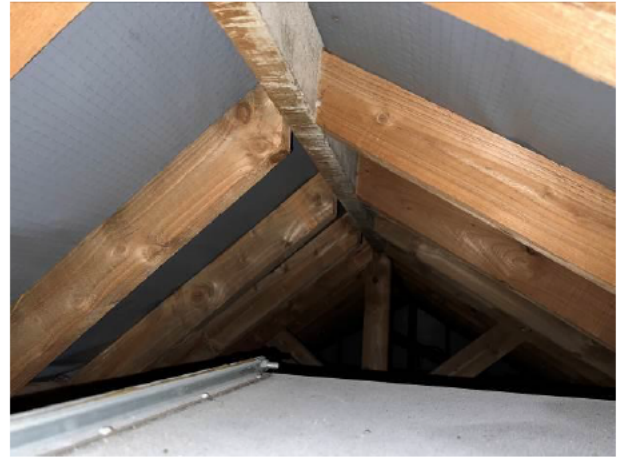
A loft space internally could not be fully accessed for inspection due to extraction ducting obstructing access – however the void could be viewed from a loft hatch. Tightly fitted plastic roofing membrane is present above the rafters with insulation between the joists. Light visible at the eaves confirms potential access to roosting features for bats; and several nests are present along this aspect confirming historic use by breeding birds.

**Photograph 8:** Showing the interior of the loft space above B&W C with more modern felting.

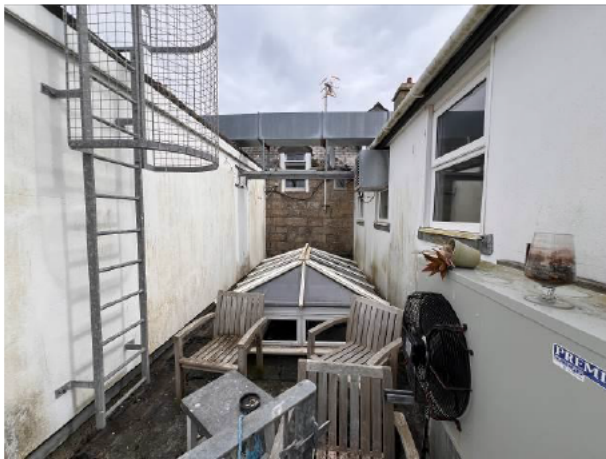
**Photograph 9:** Showing the 'courtyard' at first floor level created by the intersection of B&W A, B and C above B&W E.

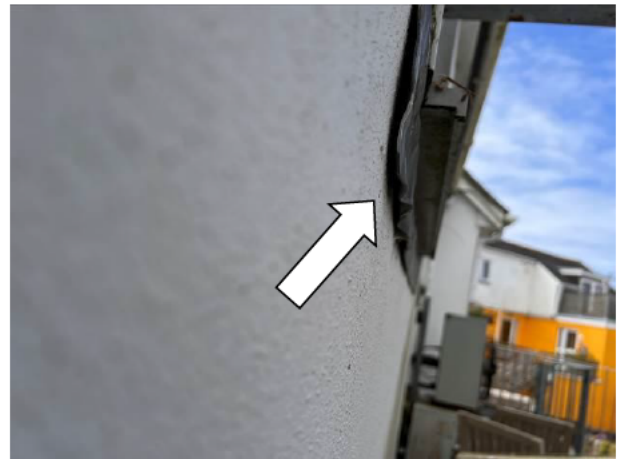
The building is rendered externally with the covering in good condition – no cracks or other cavities were noted. The uPVC window frames appeared to be well-fitted. These are joined to the wall by lead-flashing beneath the sills in places – this was occasionally lifted which could potentially provide roosting opportunities for individual bats but no evidence of current or

recent occupation was noted at the time of survey.

**Photograph 10:** Showing an example of lifted flashing beneath the window of B&W C

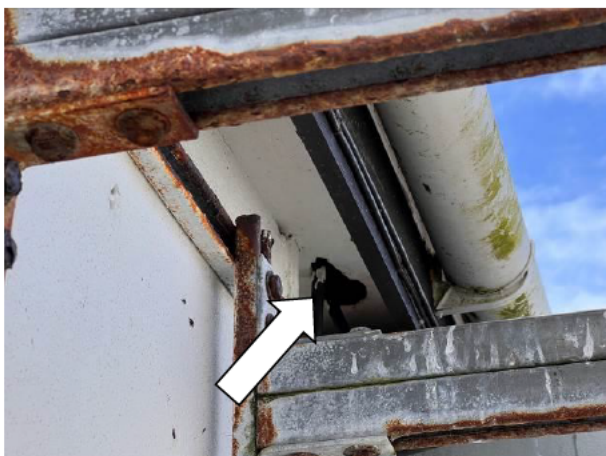
There are boxed soffits and fascias with guttering attached which run along the eaves on the western aspect of this structure – some utility holes are present which could potentially provide access to roosting opportunities within this feature.

**Photograph 11:** Showing gaps in the soffit where services enter on B&W C

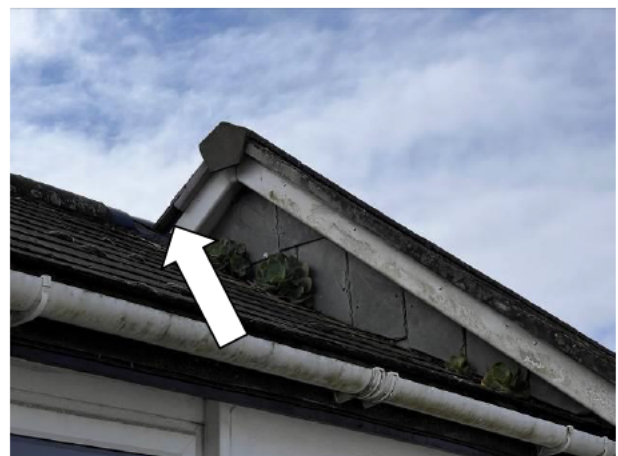
**Photograph 12:** Showing the gable of B&W D with missing pointing

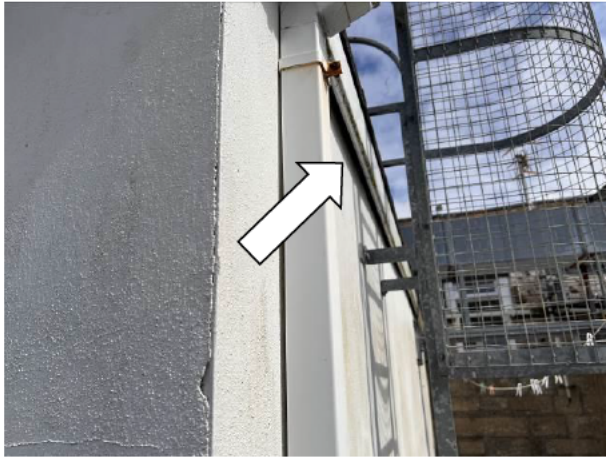
The structure is rendered externally with the covering in good condition – no cracks or other cavities were noted. The wooden window frames are well-fitted. There are gaps behind the fascia at the top of the wall on the south-eastern aspect which could potentially provide access to roosting opportunities for bats.

**Photograph 13:** Showing the gap behind the fascia on B&W B

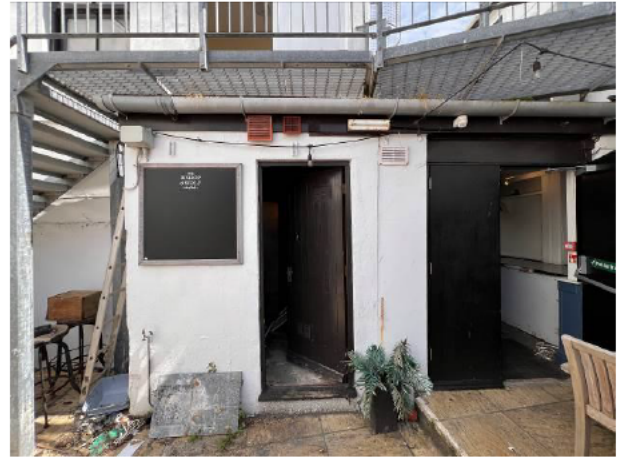
**Photograph 14:** Showing B&W E on the ground floor

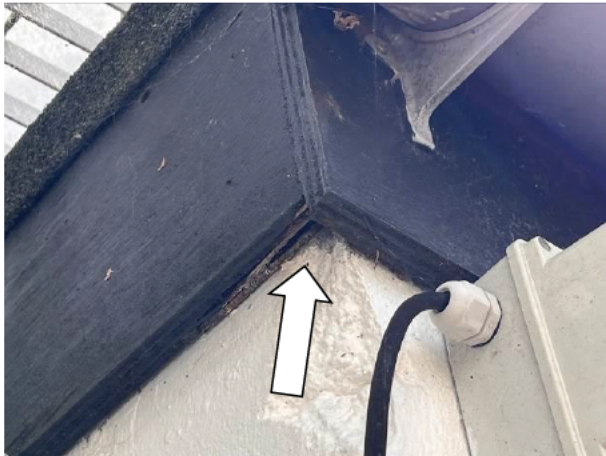
The only potential roosting features associated with this structure (as distinct from the surrounding structures on the storey above) are minor gaps associated with the timber fascia on the southern aspect.

**Photograph 15:** Showing an example of a minor gap behind the fascia on B&W E

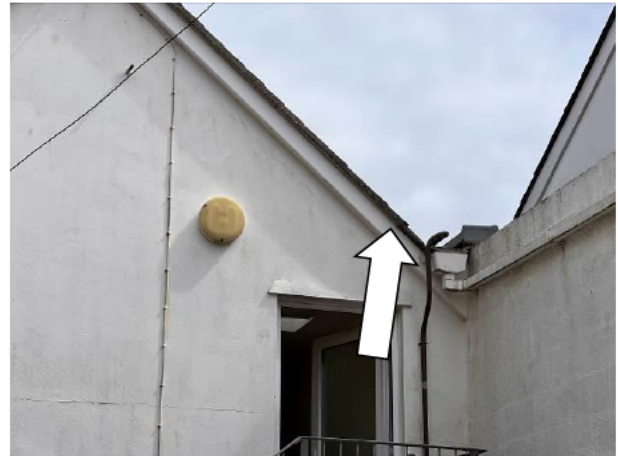
**Photograph 16:** Showing the gap in the verge pointing on B&W D

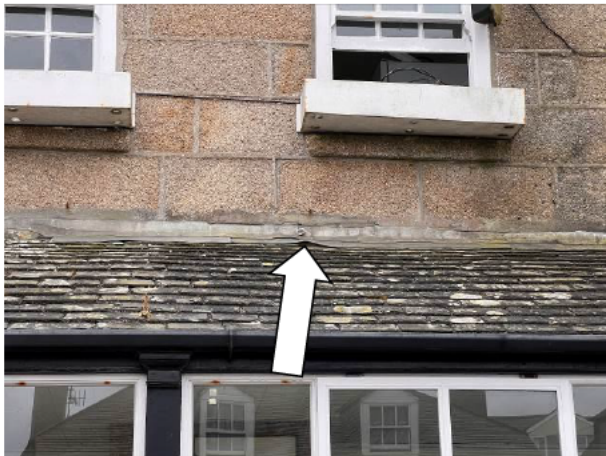
The single-pitch roof has wet-laid scantle tiles which appear to be well-pointed. Minor gaps under the lead flashing where this roof is joined to the main B&W A building are noted and could potentially offer minor roosting opportunities for individual bats. There is an under boarded porch at the western end of this roof which appears well-sealed though a minor gap occurs behind the fascia at this location.

**Photograph 17:** Showing an example of lifted flashing where the roof of B&W F meets the main structure of B&W A

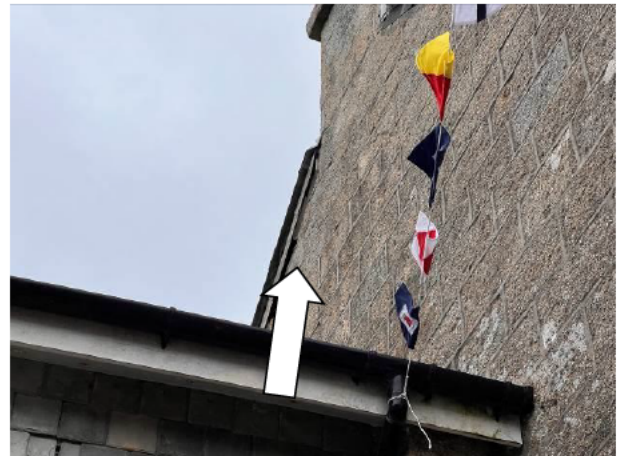
**Photograph 18:** Showing gaps in the gable verge of B&W A
