BAT PRESENCE/ABSENCE SURVEYS (PAS)

RIVIERA HOUSE, ST MARY'S, ISLES OF SCILLY

Client: Mark Hampton Our reference: 23-11-2/24-6-8 Planning reference: Report produced in advance of submission Report date: 20th August 2024 Revision: A Author: James Faulconbridge BSc (Hons), MRes, MCIEEM Contact: ios.ecology@gmail.com

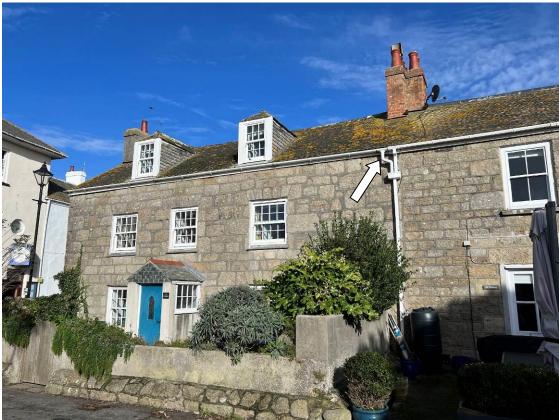
Photo 01 – showing the location where 2x common pipistrelle bats were recorded entering a roosting site behind the fascia board.

The two bats entered the roosting opportunity beneath the fascia behind the gutter hopper towards the southern end of the western aspect of the property at 9:36 and 9:39pm respectively. The NV camera field of view (FOV) on this occasion did not cover this aspect at the junction between Riviera House and the adjoined property to the south; however the following factors in the absence of NV confirmation allow confidence in this assessment:

• A transient non-breeding summer roost used by two common pipistrelle bats behind the fascia on the front of the property.

- Key elements of the works should be undertaken under a 'soft strip' methodology whereby the fascia boards are removed by hand, as well as tiles within 1m of the eaves (if required) under the ecological oversight of a Licensed Bat Worker. If bats are identified, they would be captured by hand and moved to a place of safety.

- Following completion of the works, the roost would be restored in situ. This would involve the incorporation of a cavity 100mm wide and 25mm deep behind the fascia board to permit continued access for bats. This would be completed under the direction of the Licensed Bat Worker who would confirm and sign off the restored roosting feature at the end of works.

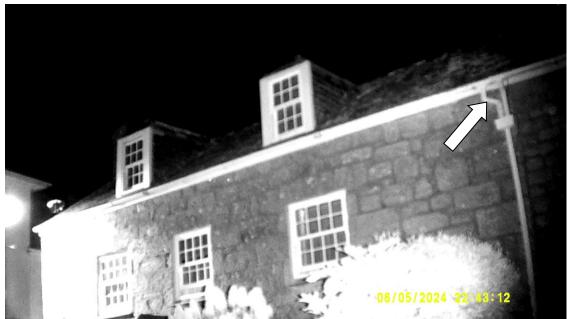
Surveyor S1 – showing footage from the Nightfox Whisker at surveyor position S1. Note the artificial light on the LHS of the image which provides an elevated level of visibility for the surveyor watching this aspect. The roost site is in the location indicated with the arrow – this illustrative image is taken from the PAS2 survey – the FOV clipped this feature (at the junction between Riviera and the adjacent property) from the recording in PAS1.

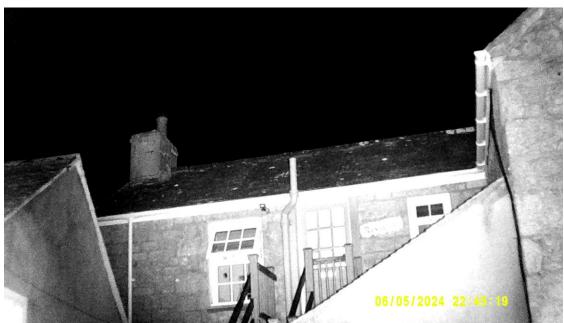
Surveyor S2 – showing footage from the Nightfox Whisker on surveyor position S2. No potential access features were identified associated with the gable on the RHS of the image – it is also illuminated by the artificial light which provides the surveyor with excellent visibility without requiring IR and NVA; therefore this camera position was focussed on the potential features within the portion of the building on which the camera and IR is focussed.

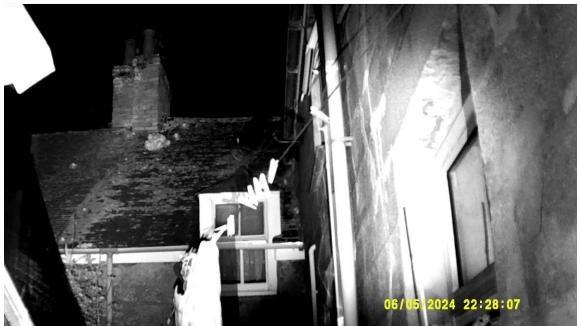
Surveyor S3 – showing footage from the Nightfox Whisker on surveyor position S3. The small size of the courtyard restricts the FOV from covering the pitch of the roof on the RHS of the image; this constraint was addressed through positioning of surveyors (including indirect observation by surveyor S2) and careful review and cross-reference of results between surveyors.
