PRELIMINARY ROOST ASSESSMENT (PRA)

RIVIERA HOUSE, ST MARY'S, ISLES OF SCILLY

Our reference: 23-9-2

Report date: 28th October 2023

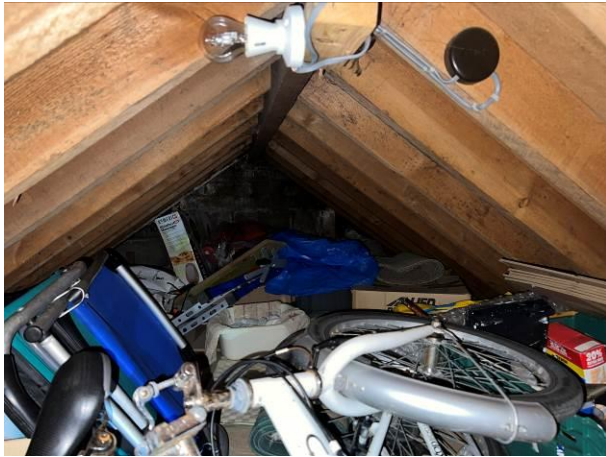
The north/south oriented pitch has a loft space which was accessed for inspection. This was boarded out above the rafters and appeared well sealed. It was used for routine storage which precluded a comprehensive inspection of the void. The floor is boarded out. No droppings or other evidence of bats was identified within those areas which could be accessed for inspection.

Photograph 1: Showing the loft space above the kitchen in the north/south aspect of the pitched roof.

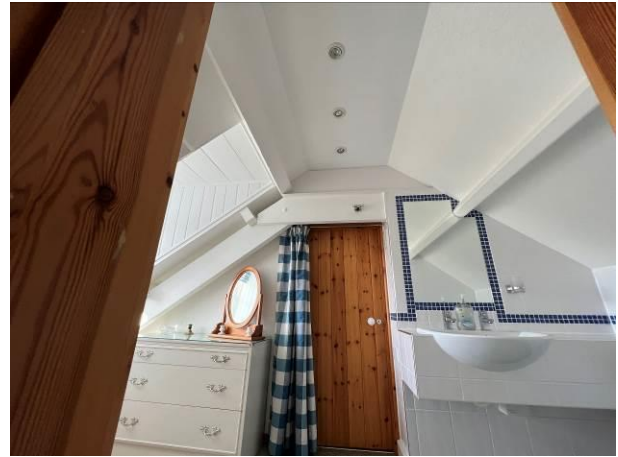
The rooms are built into the rafters throughout the majority of the east/west pitch, with the exception of a minor void at the apex in one room. However these rooms also have eaves storage, only some of which were accessible at the time of survey. Those which could be inspected appeared to be sealed in a manner which would preclude access for bats.

Photograph 2: Showing the rooms in the east/west pitched roof which are largely built into the rafters with the exception of minor sealed voids at the apex in one room.

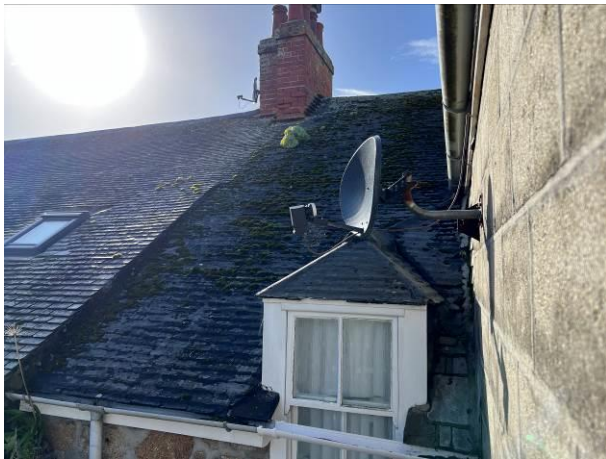
There is a single dormer on the east-facing pitch and two dormers on the west-facing pitch. Hanging tiles appear well sealed but there are gaps beneath the flashing in the valley where the dormer roof meets the main pitch.

Photograph 3: Showing eastern pitch of the roof with the small dormer present. The surface covering above the scantle tiles can be seen.

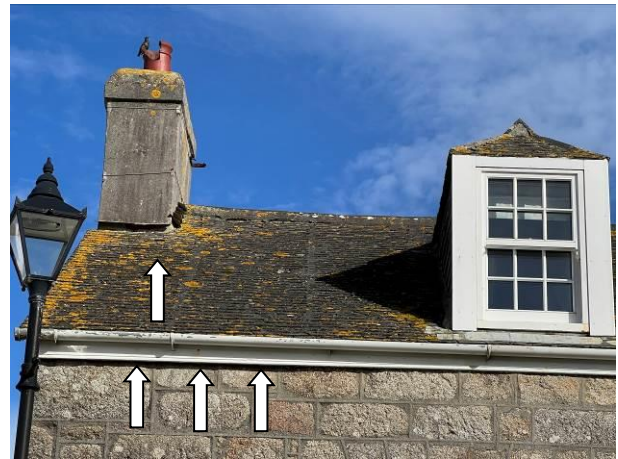
The roofs were inspected externally from ground level with close-focusing binoculars. The north/south pitch could only be inspected from the north – the southern pitch could not be viewed due to intervening buildings and other obstructions. Minor gaps at the ridge of the west-facing pitch were noted, but the remaining roof structure appeared well-sealed. There is an external covering on the east-facing pitch which seals the exterior. Drop tiles are present on the northern gable only – these appear well-pointed. The roof verge on the eastern gable appears well pointed.

The fascias on the east/west facing pitch have gaps throughout which could provide access to potential roosting opportunities for bats either as a feature in their own right or as access to roosting opportunities beneath the tiles or associated with the wall plate.

Photograph 4: Showing the western pitch of the roof – the gaps beneath the fascia are indicated along with an example of a gap beneath a tile below the chimney.

In accordance with the criteria outlined in the Best Practice Guidance, two further Presence/Absence Surveys (PAS) would be required to provide an appropriate evidence-base

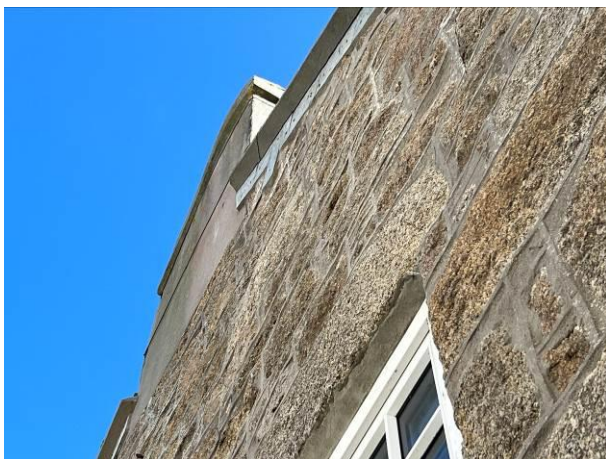
Photograph 5: Showing the well-pointed drop tiles on the northern gable.

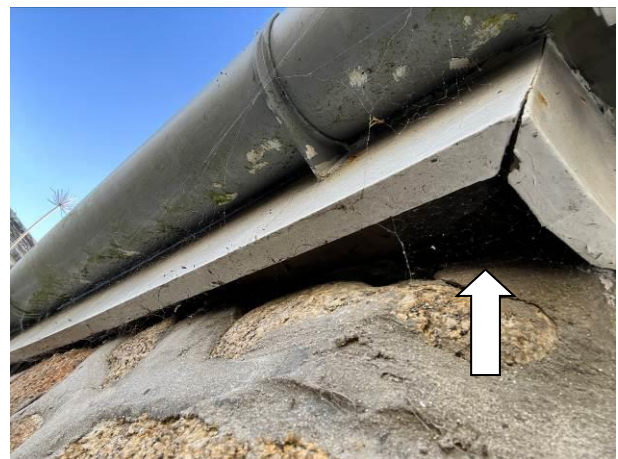
Photograph 6: Showing the gaps behind the fascia boards on the eastern pitch.

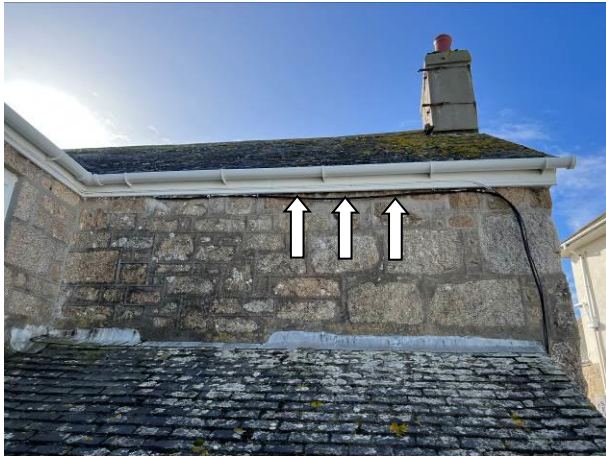
This single-pitch roof occupies the ground-floor junction between the two pitches of the main dwelling. The wet-laid scantle-tiled roof is well-sealed and the lead-lined junction between the roof and the adjacent wall is tightly fitted. The fascias are also well-sealed.

Photograph 7: Showing the single pitch #1 in the foreground with the gaps behind the fascia of the east-facing pitch indicated.

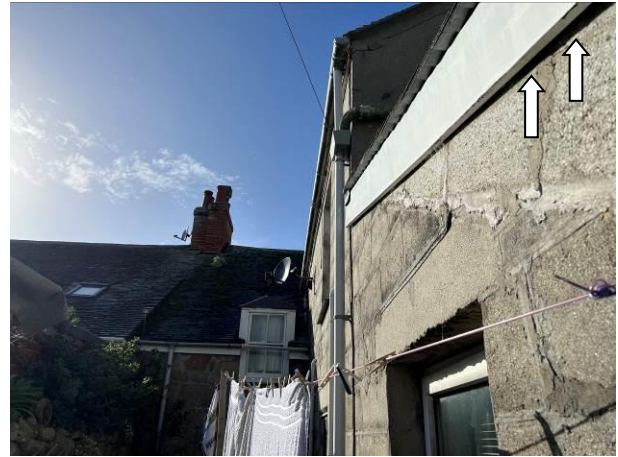
This single-pitch roof lies at the eastern end of the main house. The wet-laid scantle-tiled roof is well-sealed but there are gaps behind the fascias which could provide access to potential roosting opportunities for bats either as a feature in their own right or as access to roosting opportunities beneath the tiles or associated with the wall plate.

Photograph 8: Showing the gaps behind the fascia on single pitch #2.

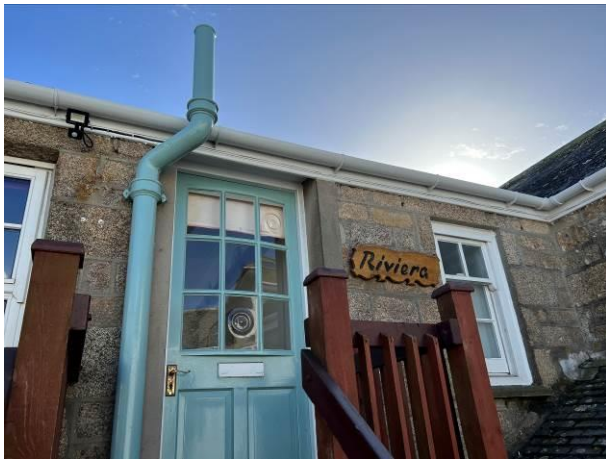
Fascias on the north/south facing pitch are well-sealed.

Photograph 9: Showing the entrance on the northern aspect – this is at the first-floor level. The fascias on this aspect are well-sealed.

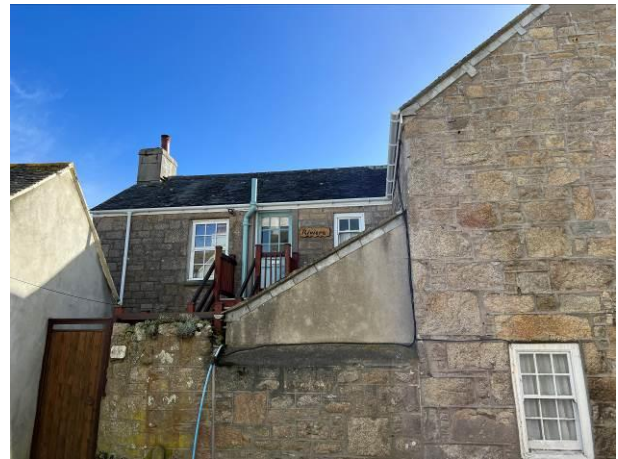
Photograph 10: Showing the northern gable of the pitched roof and the single pitch #1 in the foreground.
