**PA/23/118** Photographs in support of planning application

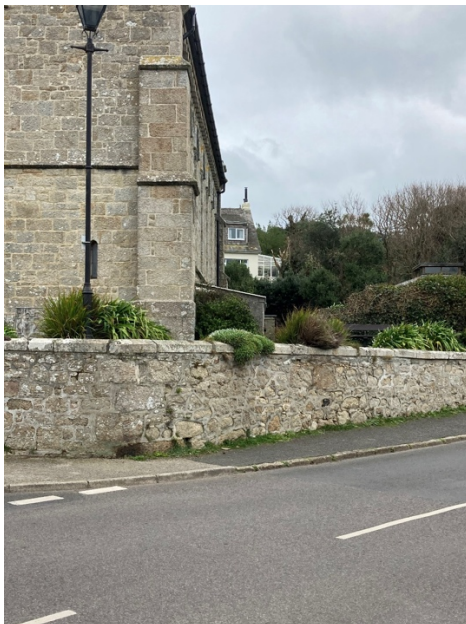
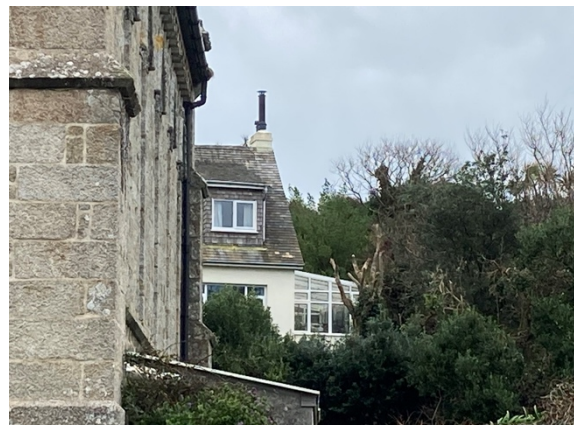
Photo 2. A. View of the conservatory from Church Road, SW elevation. B. Zoomed in and cropped. The Guardian warm roof will blend far better with the weathered cedar shingle roof of the property and the reduced number of open windows will reduce the 'lattice' effect of the current conservatory frame.

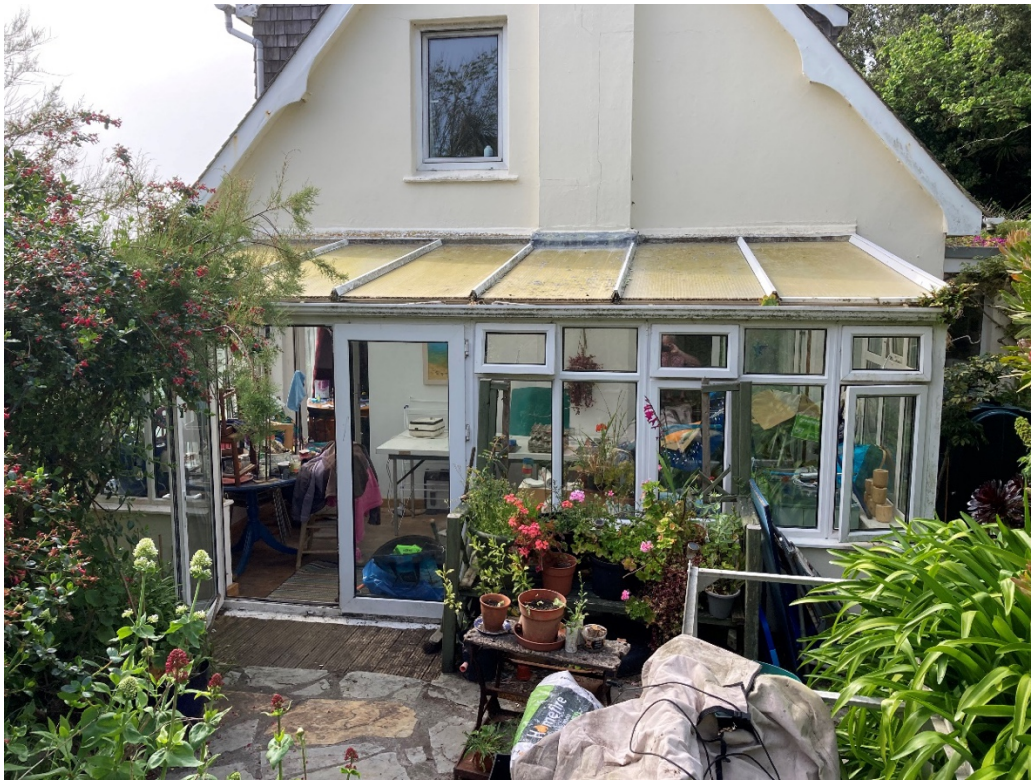
Photo 3. View of the conservatory from E elevation facing W. The conservatory roof is in very poor condition.

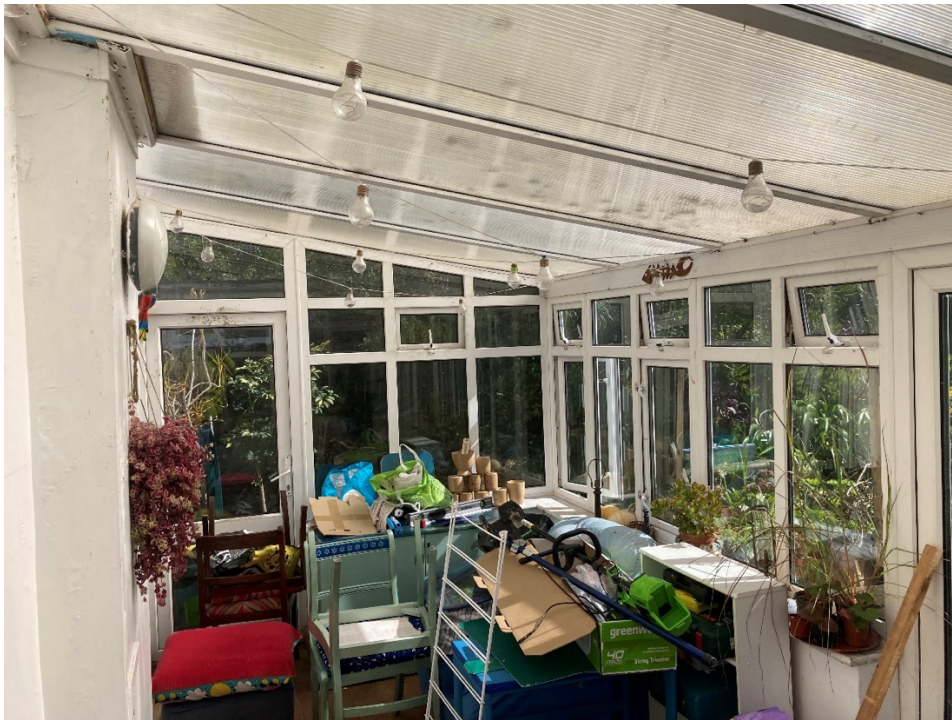
Photo 6. Interior of conservatory, SW elevation facing NE. Leaking water has caused blistering to paintwork and damage to oak flooring, while an electrical socket is no longer working and is isolated.

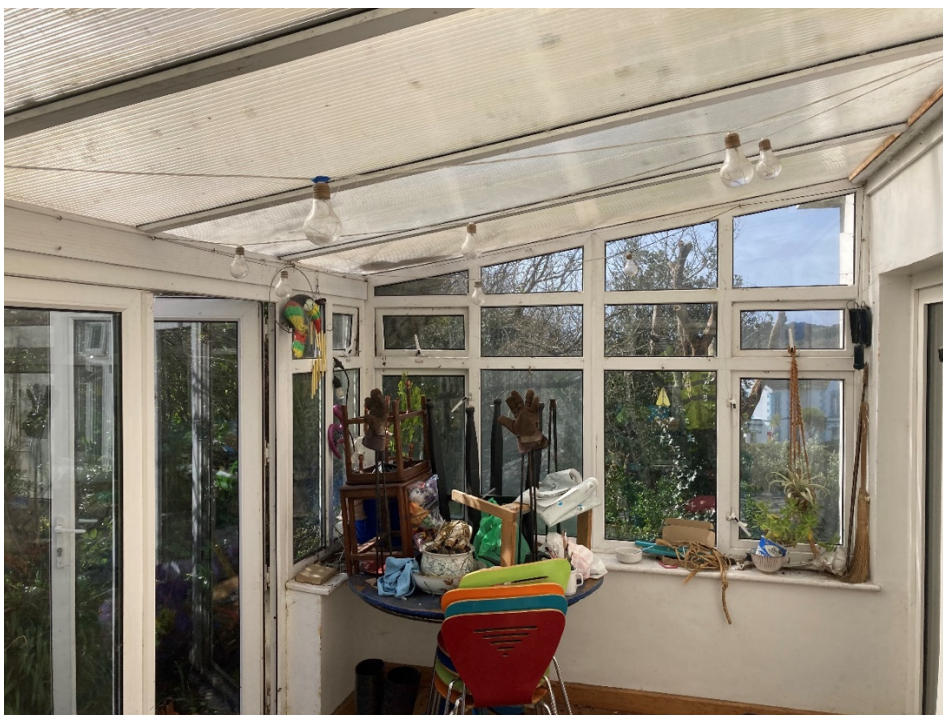
Photo 7. Interior of conservatory, NE elevation facing SW. Granite rocks holding roof down visible in lower left corner.
