BAT PRESENCE/ABSENCE SURVEYS (PAS)

1 BUZZA STREET,
ST MARY'S, ISLES OF SCILLY

Report date: 20th August 2024

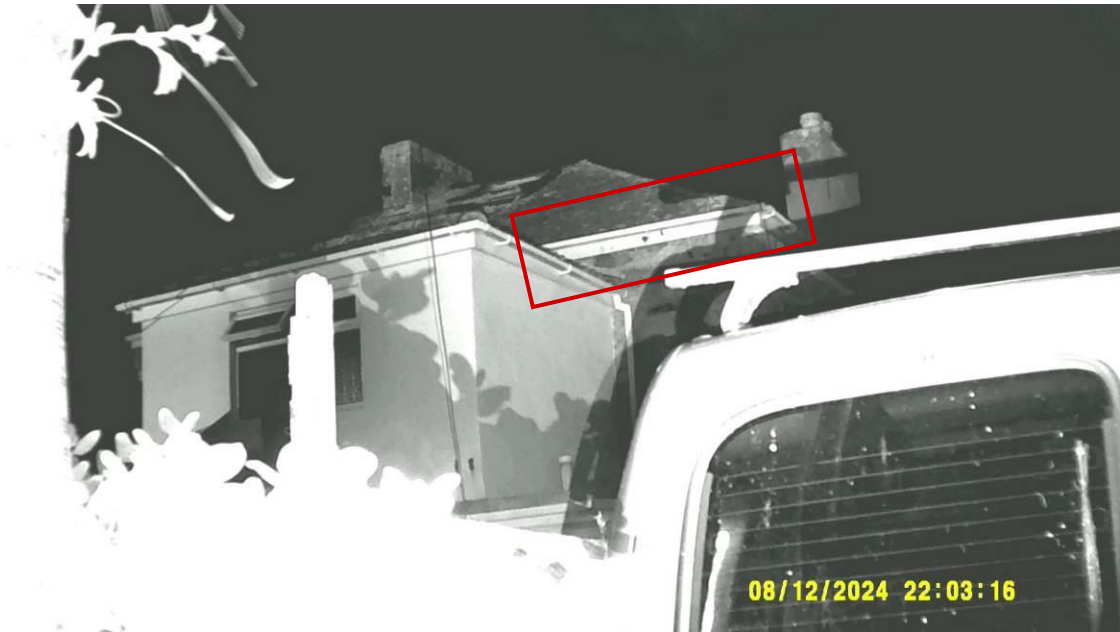
NVA1 – showing a screenshot from the Nightfox Whisker at position NVA1. This is covering the northern side of the eastern aspect. The fascia (potential access feature) is indicated with the red box.

There are intermittent gaps where the eastern fascia meet the wall. Where this is to be removed or impacted as part of the proposed works, the fascia should be carefully removed and the gaps behind it exposed in such a way that, in the unlikely event that bats are present, they are not injured or killed by the action.

Once these areas are fully exposed, they can be visually inspected by contractors. Any cavities exposed by this action should also be carefully inspected and features dismantled by hand where necessary until absence of bats can be confidently confirmed.

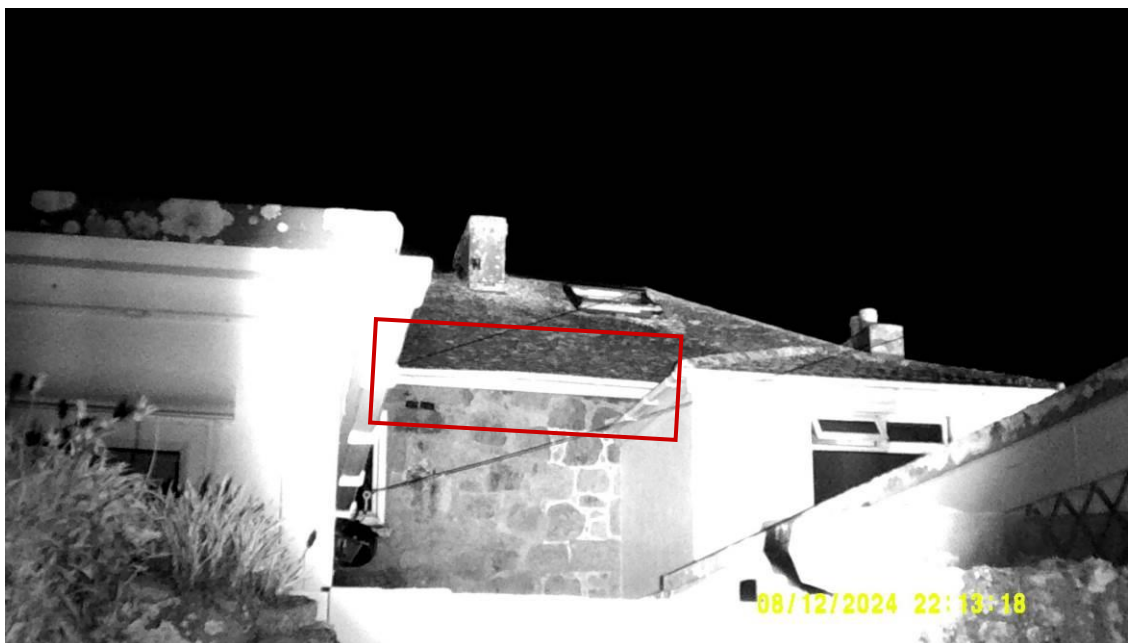
NVA2 – showing footage from the Nightfox Whisker on position NVA2. This is covering the southern side of the eastern aspect. The fascia (potential access feature) is indicated with the red box.
