PRELIMINARY ROOST ASSESSMENT (PRA)

COASTGUARD'S RETREAT, ST MARY'S, ISLES OF SCILLY

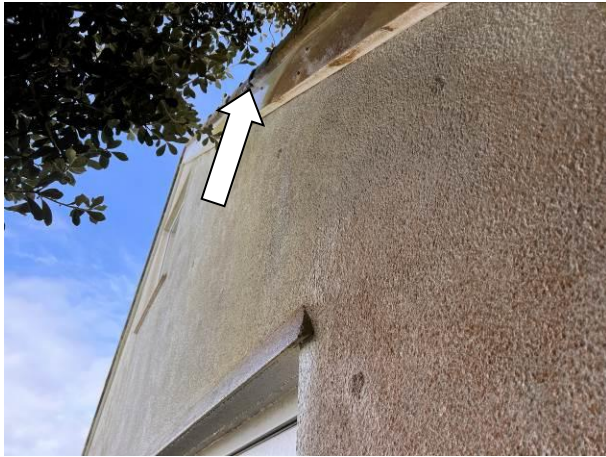
Photograph 7: Showing the southern gable where the uPVC cladding is otherwise tightly fitted. The location of the missing pointing in the verge is indicated.

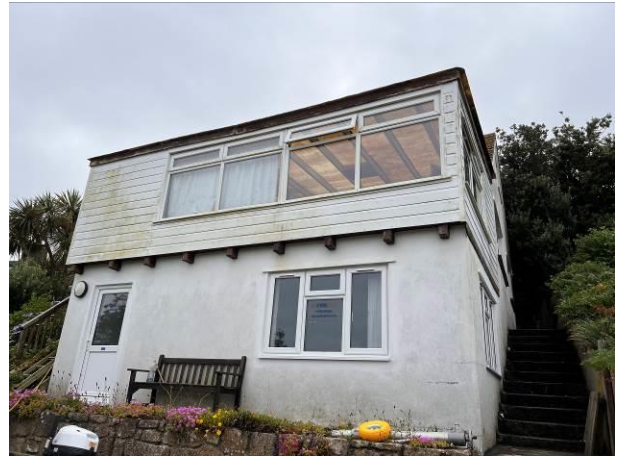
Photograph 8: Showing the flat-roof extension on the western aspect of the property. The fibreglass roof can be seen through the upper floor window.
