20 DECEMBER 2024

Prepared by: Keith Sanders ACIOB

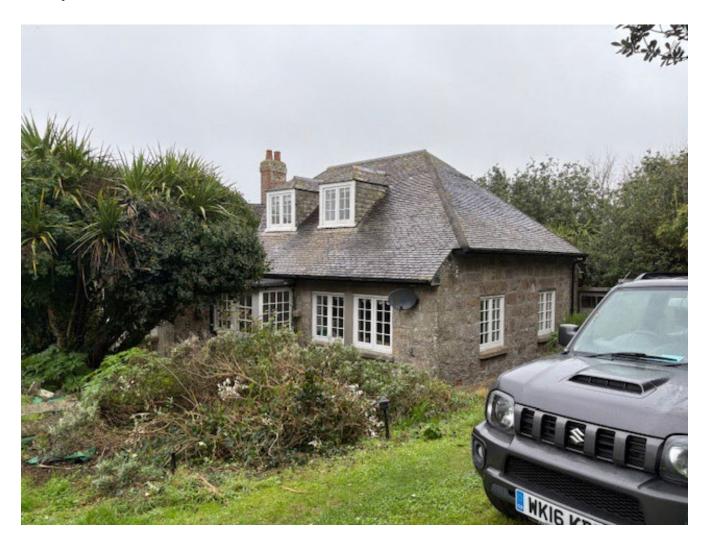
Rocky Hill Cottage is a 2 bedroom Chalet bungalow dwelling found in a cluster of dwellings at Rocky Hill. The property is constructed of coursed granite with a Cornish scantling wet bedded roof finish of slate with angular clay ridge tiles, mortared hips, lead valleys and lead finish to bay window roof and built up felt to the porch.

The proposal is to remove the defective existing slate roof covering, carry out repairs as found necessary and provide a new natural slate roof covering using natural SSQ Riverstone slates of size 400 x 250 with the addition of a continuous breathable roofing membrane.

The angular clay ridge tiles will be removed with care and will be rebedded on the new slate coverings. Valleys will be relined with lead and the mortar hip finishes will not be reinstated but the hips will be finished with a mop stick roll and lead capping.

The existing leaded bay window roof and the built up felt roof to the porch will be replaced in grey coloured fibreglass.
