BAT PRESENCE/ABSENCE SURVEYS (PAS)

ROCKY HILL COTTAGE, ST MARY'S, ISLES OF SCILLY

Our reference: 24-8-7

Report date: 17th September 2024

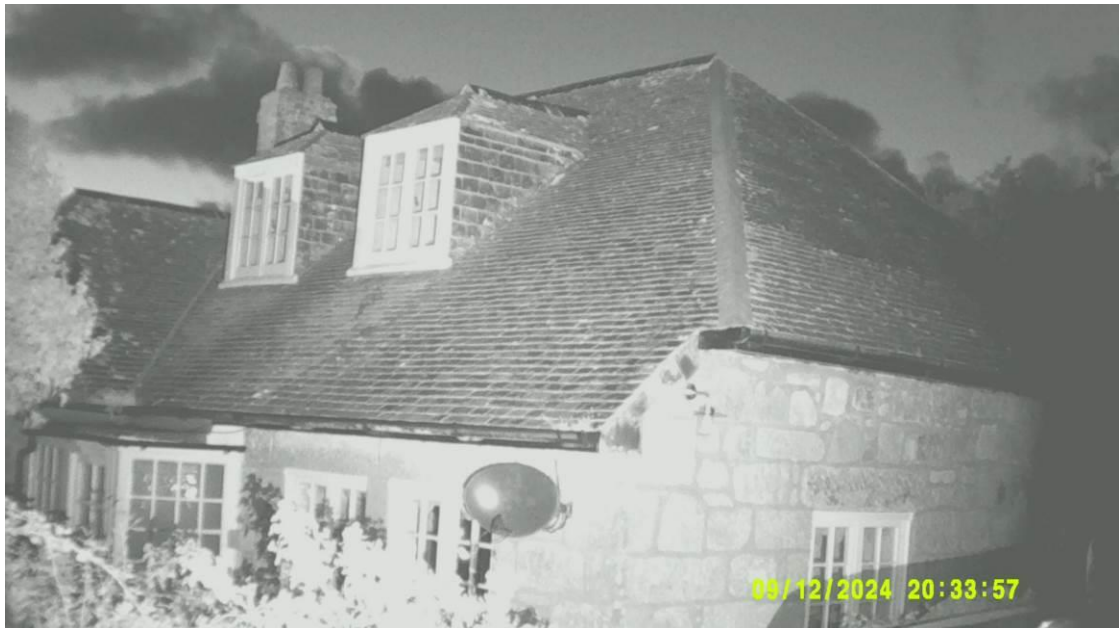
NVA1 – showing a screenshot from the Nightfox Whisker at position S1. This is covering the northern and eastern aspects of the property ensuring coverage of the potential access features associated with the soffit beside the porch; the drop tile on the gable and the missing tile on the dormer.

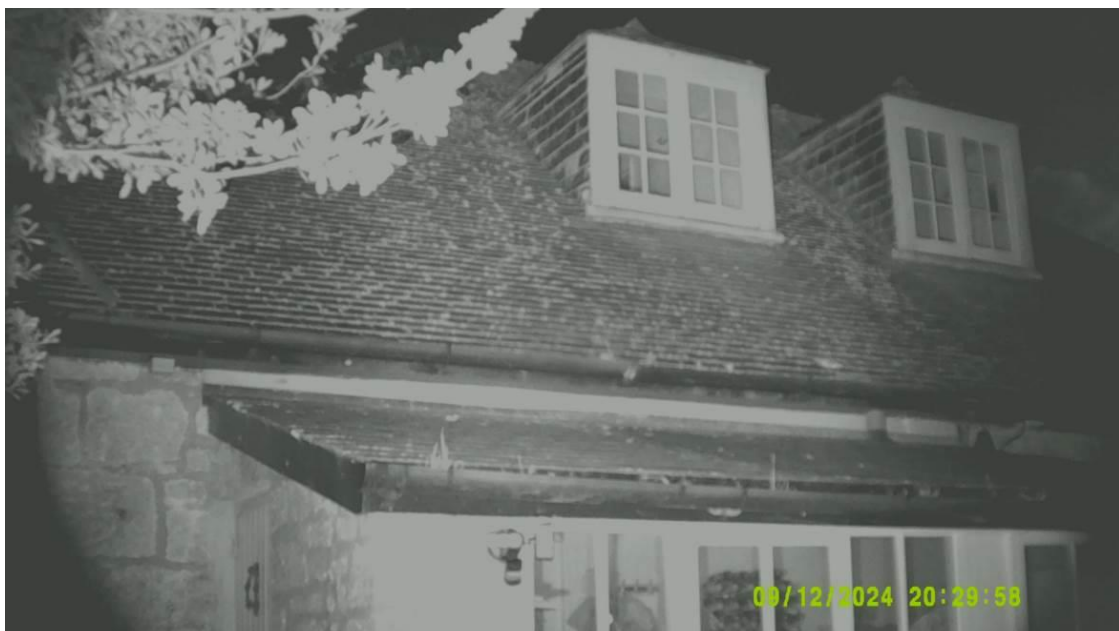
NVA2 – showing footage from the Nightfox Whisker on position S2 This is covering the northern aspect of the property ensuring that the soffits/fascias with minor gaps are included in the FOV along with the lifted tile on the upper dormer window.

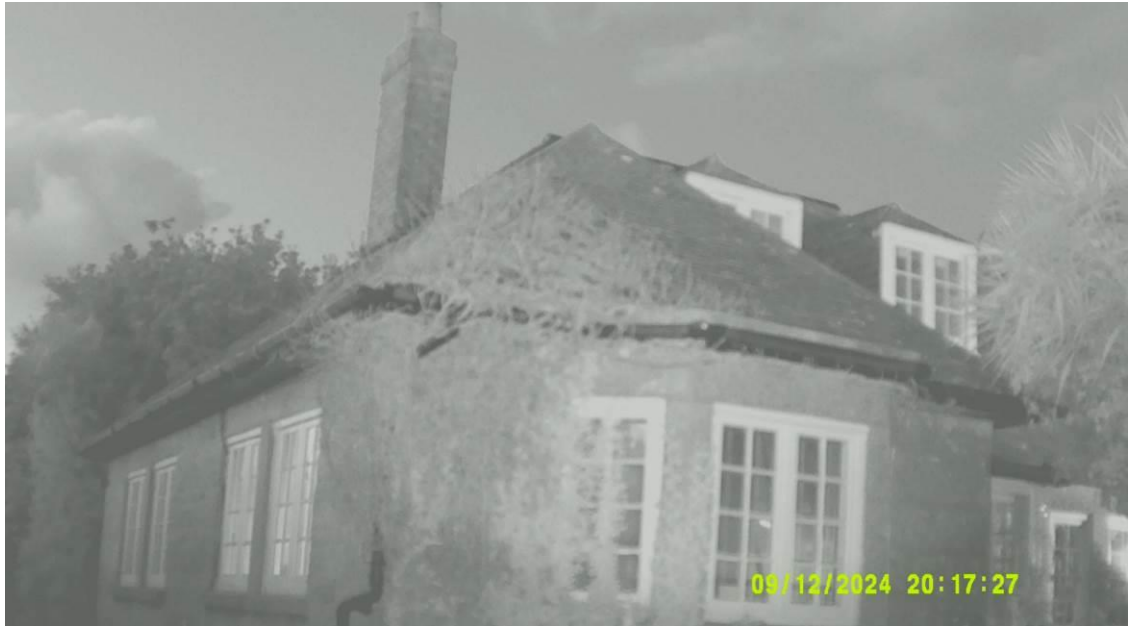
The NVA3 camera was positioned on the south-western corner of the property to observe the western aspect as a precaution; however no potential roosting features were identified on the western aspect of the property. The camera footage from this aspect was watched back carefully to rule out any potential emergence from this aspect.

NVA3 – showing footage from the Nightfox Whisker on position NVA3. This is covering the western aspect of the property – as well as the hipped section of the roof on the southern aspect which is outside the FOV of the camera in position S1 du to the intervening vegetation.
