PRELIMINARY ROOST ASSESSMENT (PRA)

ROCKY HILL COTTAGE, ST MARY'S, ISLES OF SCILLY

Report date: 27th August 2024

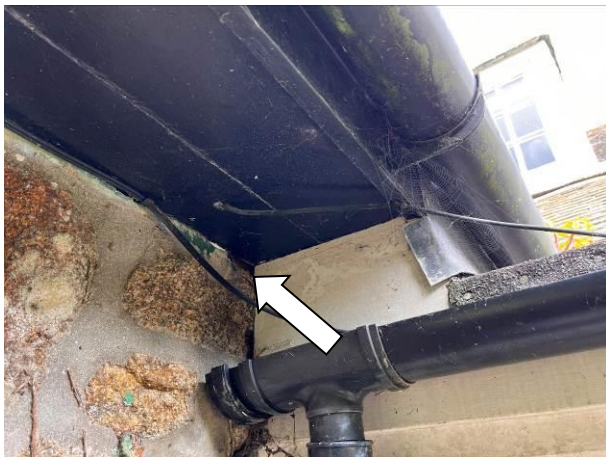
The boxed soffits around the edge of the roof are generally very well-fitted with minor gaps noted around the front porch and adjacent to the rear extension on the north-east corner of the property.

Photograph 3: Showing an example of the minor gaps behind the soffit beside the front porch.

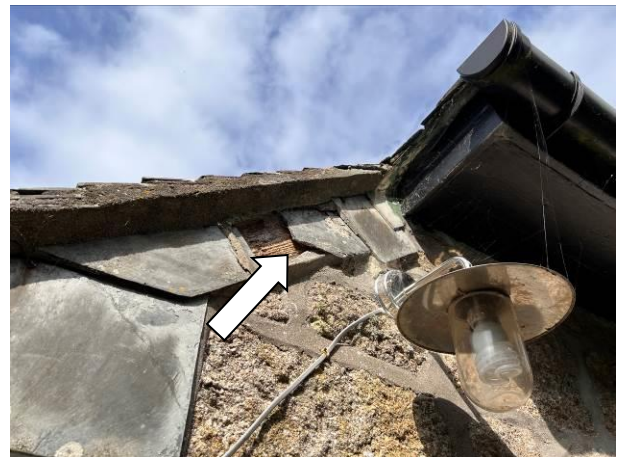
The hipped nature of the roof structure precludes any true gable and so the boxed soffits are continuous around the perimeter of the roof with the exception of a small runs on the eastern aspect where the eaves of the north/south pitches protrude beyond the hipped junction. Here there are drop tiles for a small section between the boxed soffits. These drop tiles are generally in good condition though there is a missing tile on the south-eastern corner and potential for minor access gaps associated.

Photograph 4: Showing the missing drop tile – this may provide access to potential roosting features though the gaps appear largely superficial in this location.

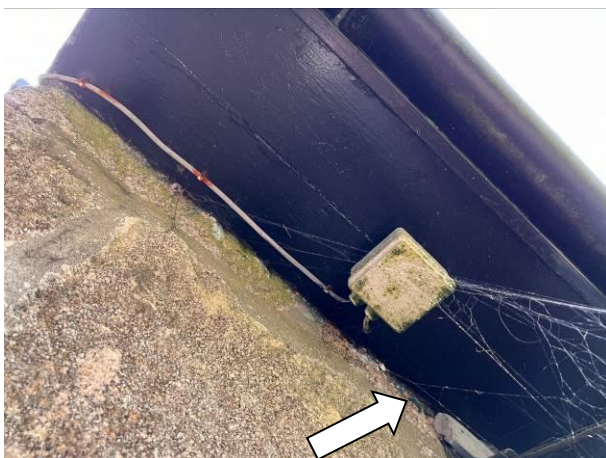
Photograph 5: Showing an example of the gaps between the soffit and the wall on the north-eastern corner of the property

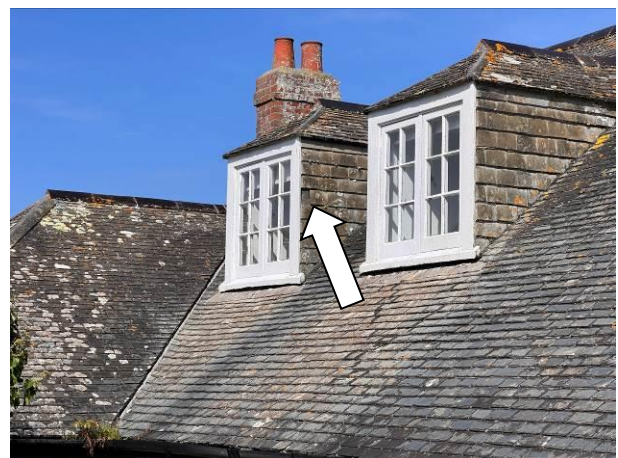
Dormer windows are present on both the northern and southern pitches of the roof – these dormers themselves have hipped roofs and both the roof and sides are covered by slate tiles. These tiles are generally well-fitted although a lifted tile was noted on a northern dormer whilst a missing tile is present on a southern dormer.

Photograph 6: Showing the missing tile on the dormer window of the southern aspect of the property

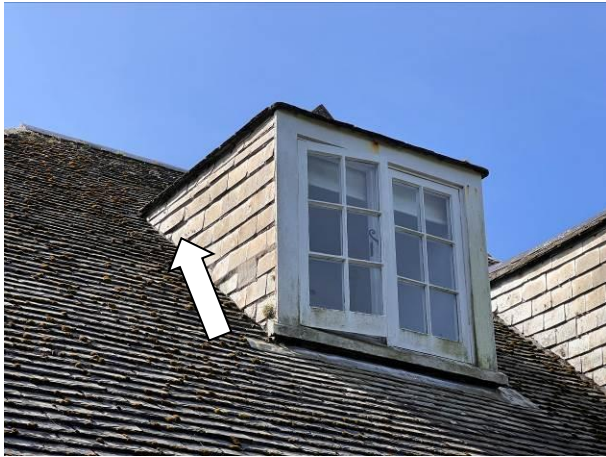
Photograph 7: Showing the lifted tile on the northern dormer of the property

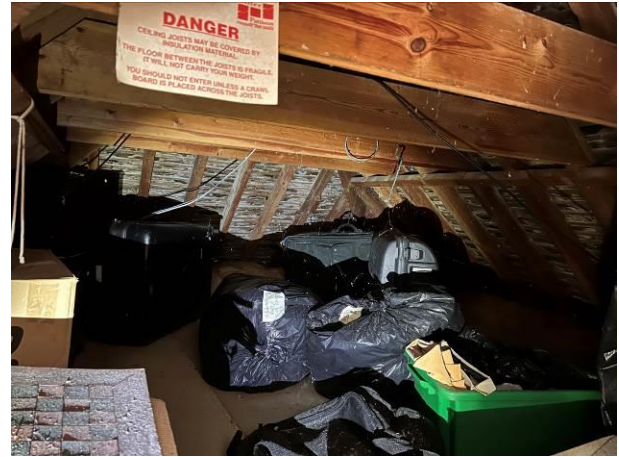
Internally, the property has a void above the tie-beam of the roof timbers and further boxed-in voids at the eaves. The hipped section which extends to the south-west of the property is not converted to accommodation and represents the largest of the voids present. Some of these voids are used for storage but the majority is largely un-finished though there is insulation between the joists and the floor is boarded in places. Roof-timbers appear to be well-fitted with no gaps noted at the junctions. A ridge board is present. The tiles are pegged directly above the battens with no underfelting or other membrane present between the tiles and the loft space beneath. There are a large number of old suspended cobwebs in the void indicating no recent or regular flight within the loft spaces. No droppings or other evidence of bats were noted; however both mouse and rat droppings were recorded. The voids were partially accessible for inspection but it was not possible to fully inspect the apex void (due to the small size) or portions of the eaves voids to the north of the property.

Photograph 8: Showing an example of the interior loft space – this is in the hipped section which extends to the south-west of the property and represents the largest of the voids present.
