PRELIMINARY ROOST ASSESSMENT (PRA)

HIGH STEPS, HUGH TOWN, ST MARY'S, ISLES OF SCILLY

Report date: 1st February 2025

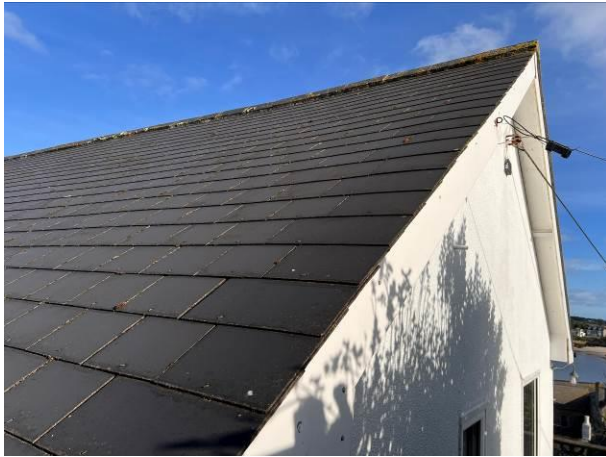
The roof is dry-laid natural slate – this is in good condition throughout with no lifted, cracked or damaged tiles noted. The ridge is well-pointed throughout. A single skylight is present on the northern aspect.

Photograph 1: Showing the well-fitted dry-laid natural slate tiles

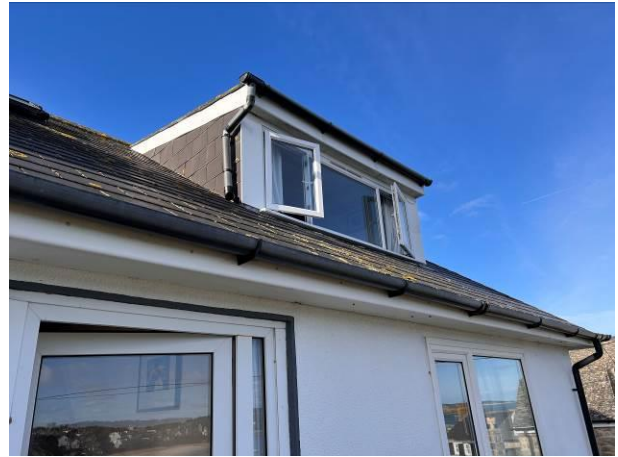
Existing dormers are present on the northern aspect of the property – these have gently sloping roofs covered with natural slate in the same manner as the main roof. The sides of the dormers are covered with hanging tiles which appear to be well-fitted and in good condition. Potential minor niches which could potentially support roosting bats are noted where the lead flashing which lines the joint between the dormer and the main roof is occasionally slightly lifted; and in the location where the fascia overtops the hanging tiles on the side of the dormer. There is also a minor gap within the soffit on the north-west corner of the eastern dormer. The majority of these were inspected with a video endoscope and no evidence of current or recent occupation by bats could be seen. These potential features are likely to be technically capable of supporting a single roosting bat on an opportunistic basis at best; however the structural position and poor fly-in would reduce their suitability.

Photograph 2: Showing the front aspect of the property with one of the dormers present in the northern pitch visible

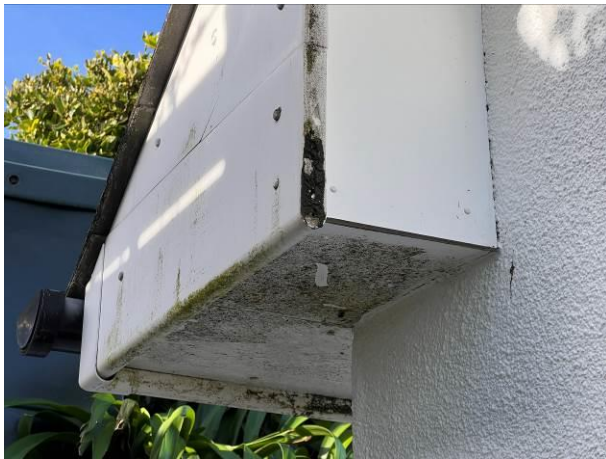
uPVC soffits run along the eaves and the gable of the property – these appear to be well-fitted throughout. Minor potential gaps occur where the soffit meets the wall on the western gable, though these were inspected with close-focusing binoculars and appear to be superficial. Guttering runs close to the terminal tiles along the eaves of the property and obstructs the potential for a direct fly-in access at these locations.

Photograph 3: Showing an example of the well-fitted soffits

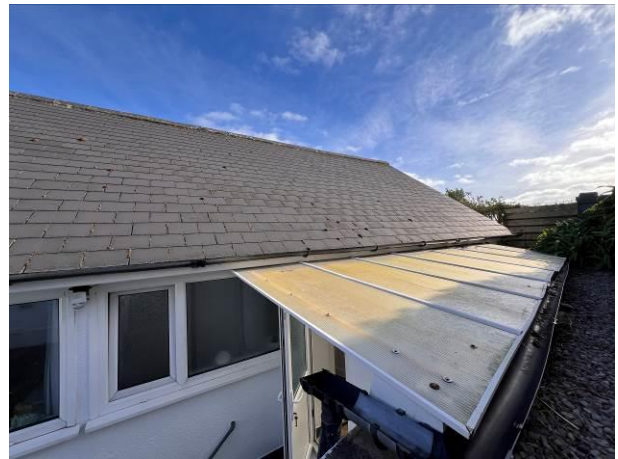
There is a lean-to porch which spans the gap between the southern aspect of the property and a stone wall behind. This has translucent uPVC roof panels and is light and airy. No potential roosting opportunities for use by roosting bats could be identified associated with this portion of the structure.

Photograph 4: Showing the rear southern pitch of the roof with the lean-to structure visible

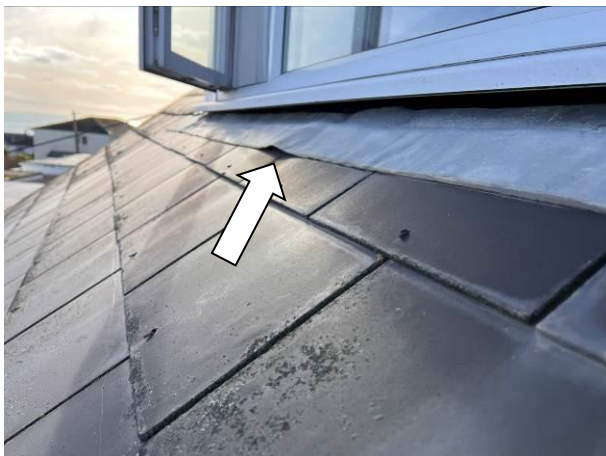
Minor lifted sections occur within the lead flashing where the dormers meet the roof tiles below.

Photograph 5: Showing an example of the minor lifted flashing where the existing dormer meets the roof

Locations where the flashing is lifted should be exposed carefully such that if any bats were present behind the lifted element, they would not be crushed or otherwise injured by the operation. Contractors should satisfy themselves that no bats are present before proceeding with works in these areas.

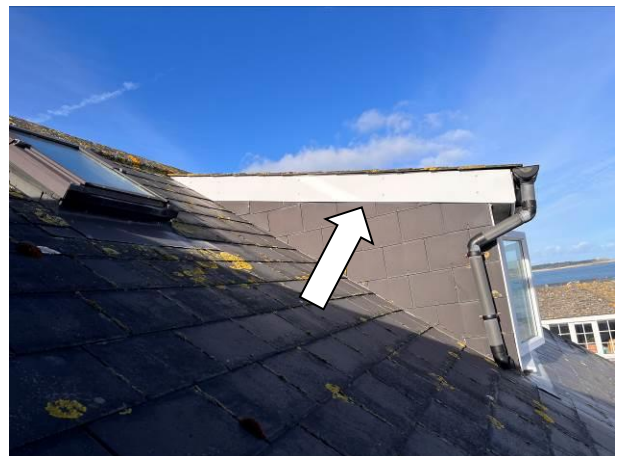
There are minor superficial gaps where the fascias meet the hanging tiles on the sides of the dormers. A minor gap also exists in the north-western corner of the eastern dormer.

Photograph 6: Showing the side of the dormer – the fascia overtopping the hanging tiles is indicated

They should be carefully removed and the gaps behind them exposed in such a way that, in the highly unlikely event that bats are present, they are not injured or killed by the action. Contractors should satisfy themselves that no bats are present before proceeding with works in these areas.

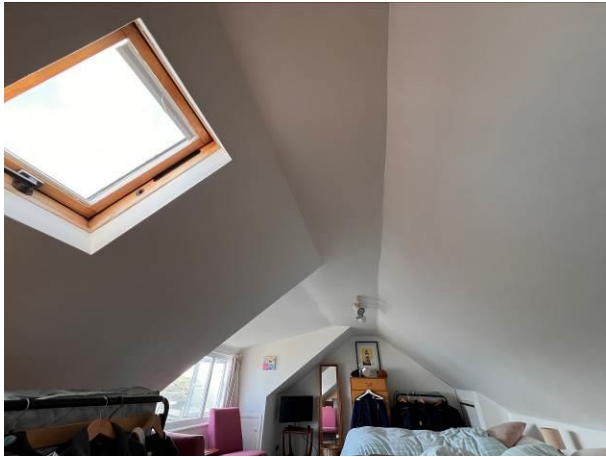
Internally, there is a minor sealed apex void which could not be accessed for inspection; however the external inspection provides high confidence that no access to this feature can be gained by bats due to the absence of suitable features.

Photograph 7: Showing the interior of the loft conversion – the sealed apex void is visible

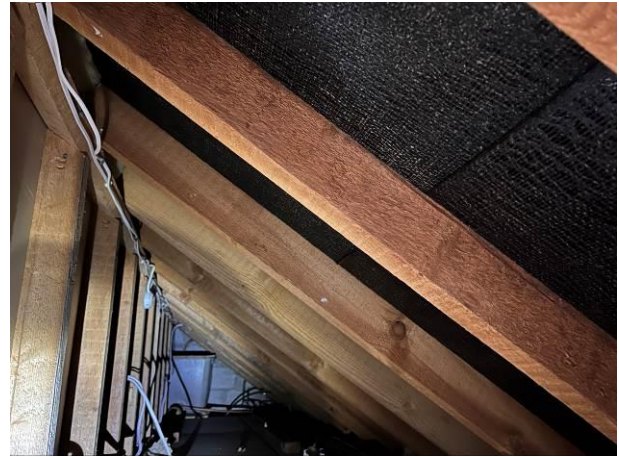
There is a storage space built into the eaves of the property which is accessed via hatches in the side walls of the upper floor rooms. These are largely unfinished internally and used for regular storage; panel-insulation is installed in the adjoining wall between the void and the internal accommodation. These areas were fully accessed and inspected – no evidence of bats or rodents was identified. The roofing felt above the timber trusses is in good condition throughout. There are exposed breeze-block walls at the gables though the pointing here appears to be good. No light (indicating potential direct access for bats) could be seen at the eaves.

Photograph 8: Showing an example of the eaves storage with well-fitted roofing felt visible above the timber trusses
